The Organ of King's College Chapel, Cambridge

Method for Repairing Collapsed Façade Pipes

Report by Nigel Turner (Pipemaker)
January 2009

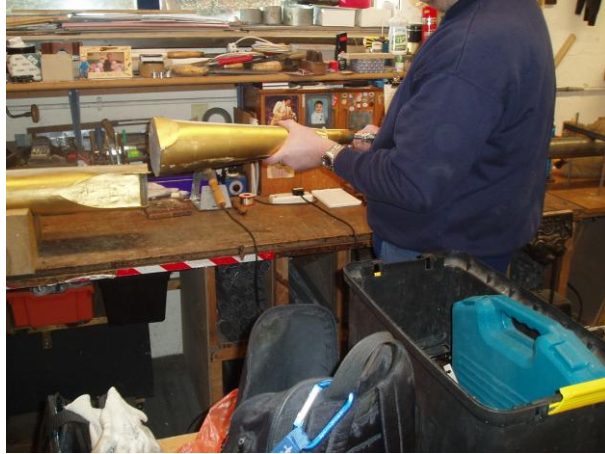
A foot has just been removed from a front pipe

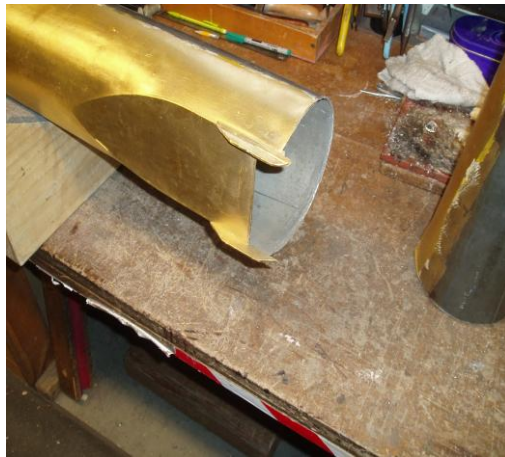
*Pipe body with foot removed.
Note that the pipe ears are still in place*

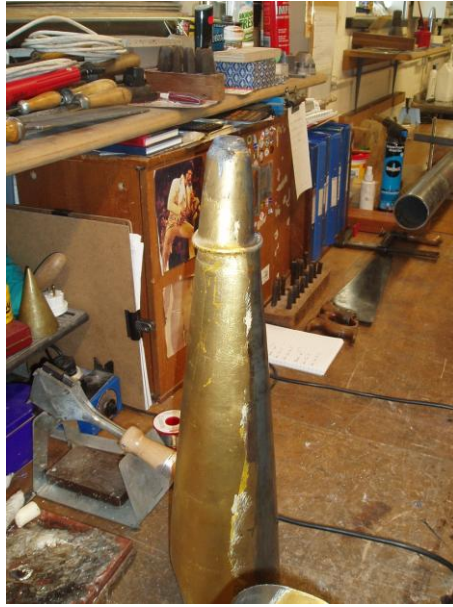
The damaged tip of a pipe foot

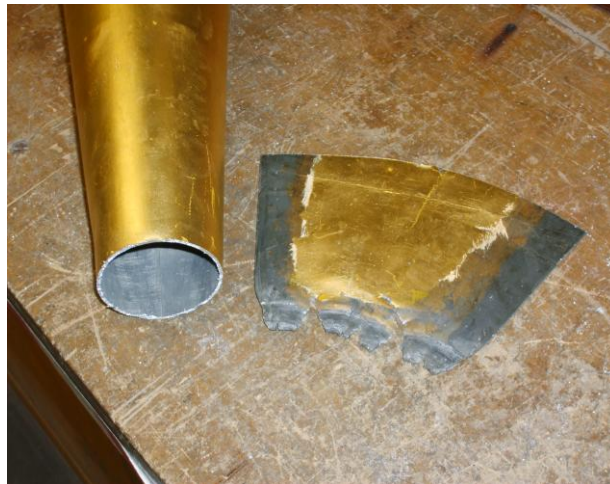
*A pipe tip removed and flattened.
The shape can now be used to prepare a new tip in pipe metal*

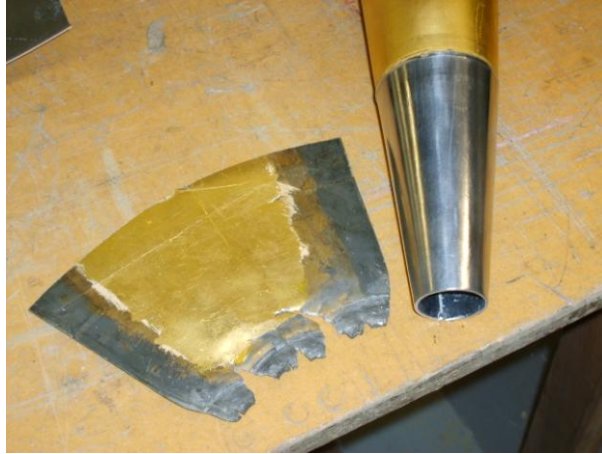
*A new tip formed from the pattern of the original.
With the foot now in one piece, a zinc lining can be fitted*

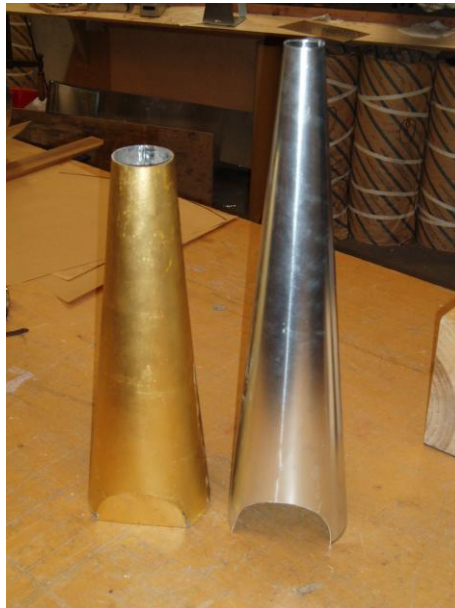
*A zinc liner before it has been soldered into the foot.
The same taper or pitch of the foot is recreated for
the liner by making a paper outline of the pipe foot shape.
The tight fit of the liner inside the foot holds the tired metal in place
and stretches the foot metal taut adding strength back into the pipe*

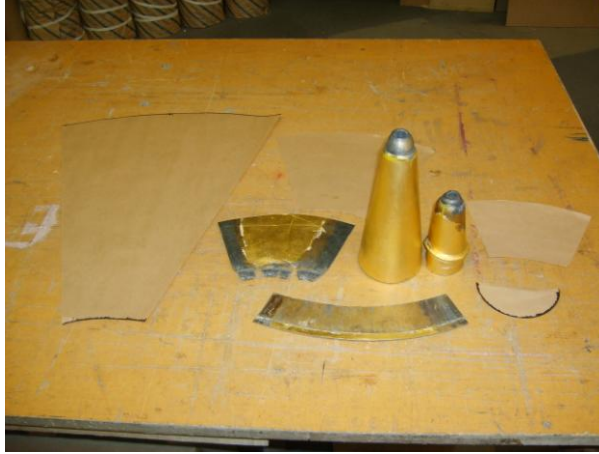
*Paper patterns used to produce the zinc liners and new pipe tips
(the old tips are shown in the middle)*

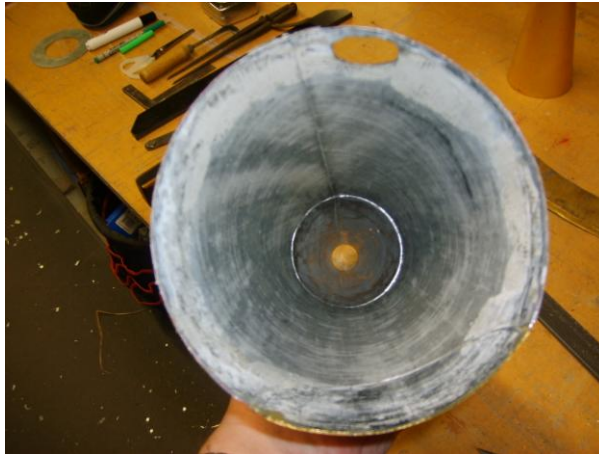
The inside of a pipe foot without a liner in place

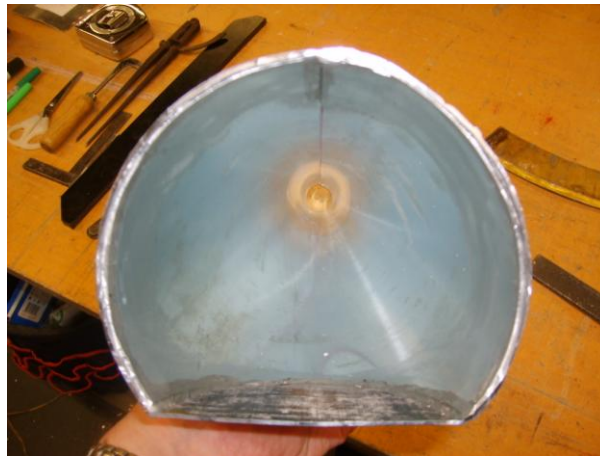
The inside of a foot with a liner in place

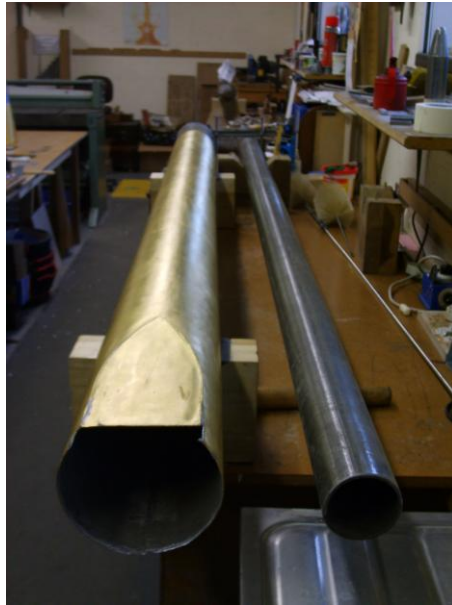
Pipe bodies are repaired by rounding them out on a mandrel, taking care not to distort the pipe face on the end of the mandrel. After this, any splits on the seams or cracks caused by fatigue are repaired

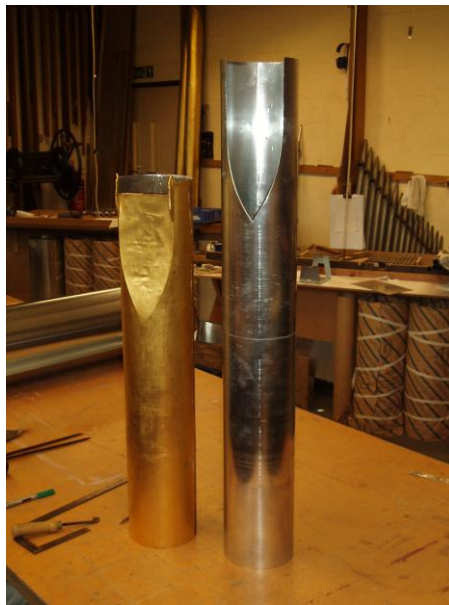
The liners for the bodies are made in the same way as those for the feet. The body shown here was so badly damaged that it had to be cut across its length so that a full liner, that also provides support behind the pipe face, could be fitted. The other pipes only required open-cylinder liners that could be inserted after the pipe feet were removed

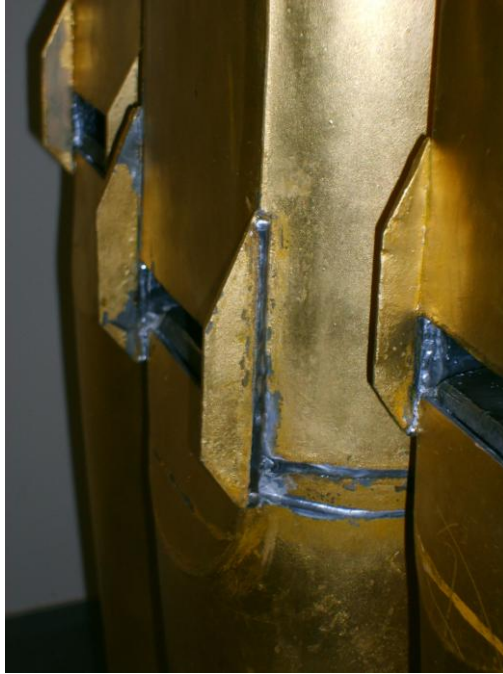
*The mouths of the three front pipes after repair
(before re-gilding)*

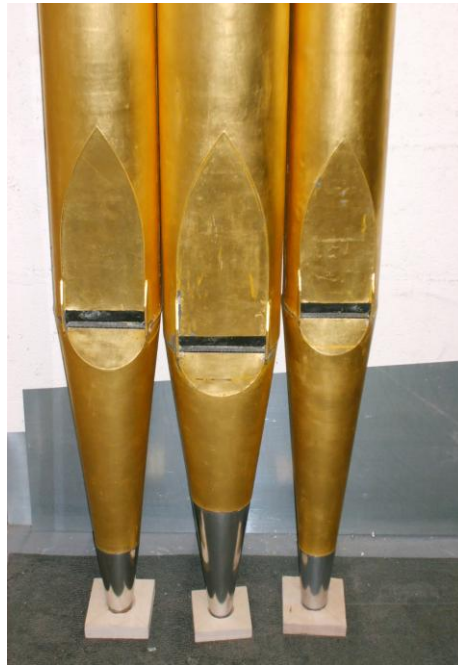
*Another view of the repaired front pipes, before re-gilding,
showing the new pipe tips*

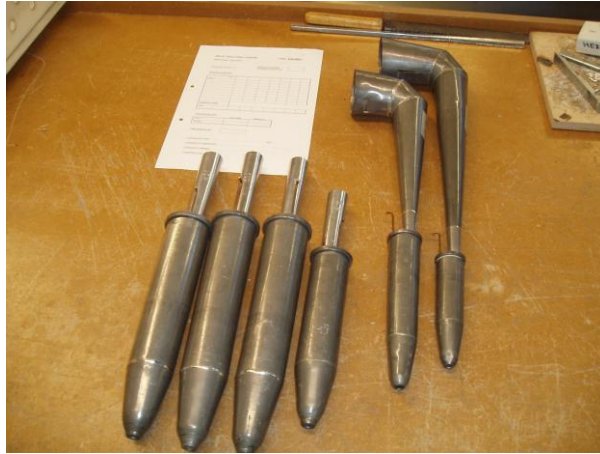
*Some pipes of the Tuba stop (from inside the organ)
ready for repair*

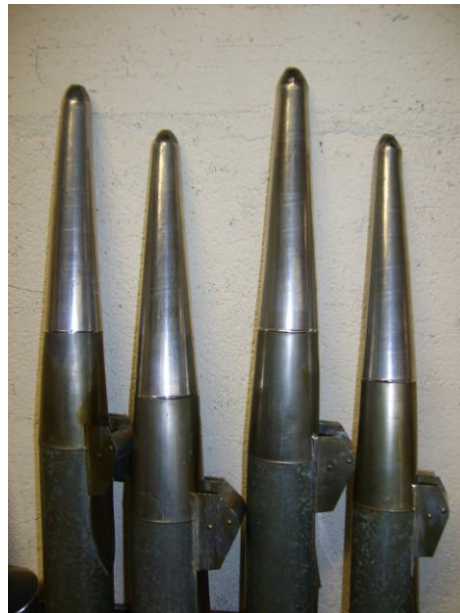
New tips for pipes of the Violes stop

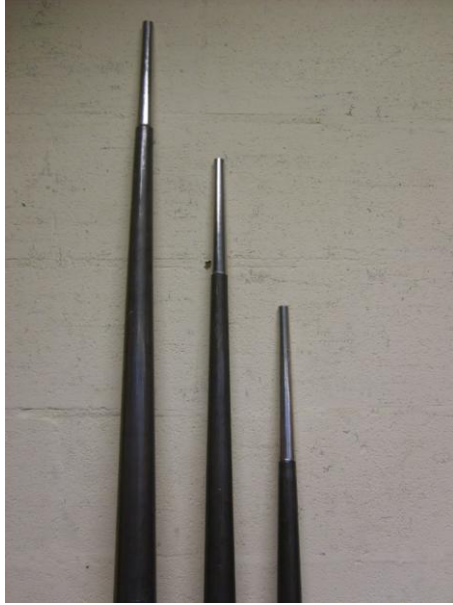
New tips for resonators of the Pedal Ophicleide stop
