## CONDITION REPORT/ CONSERVATION PROPOSAL

LOCATION: King's College Chapel, Cambridge.

The Side- Chapels

Date of survey: 12<sup>th</sup> November 2020

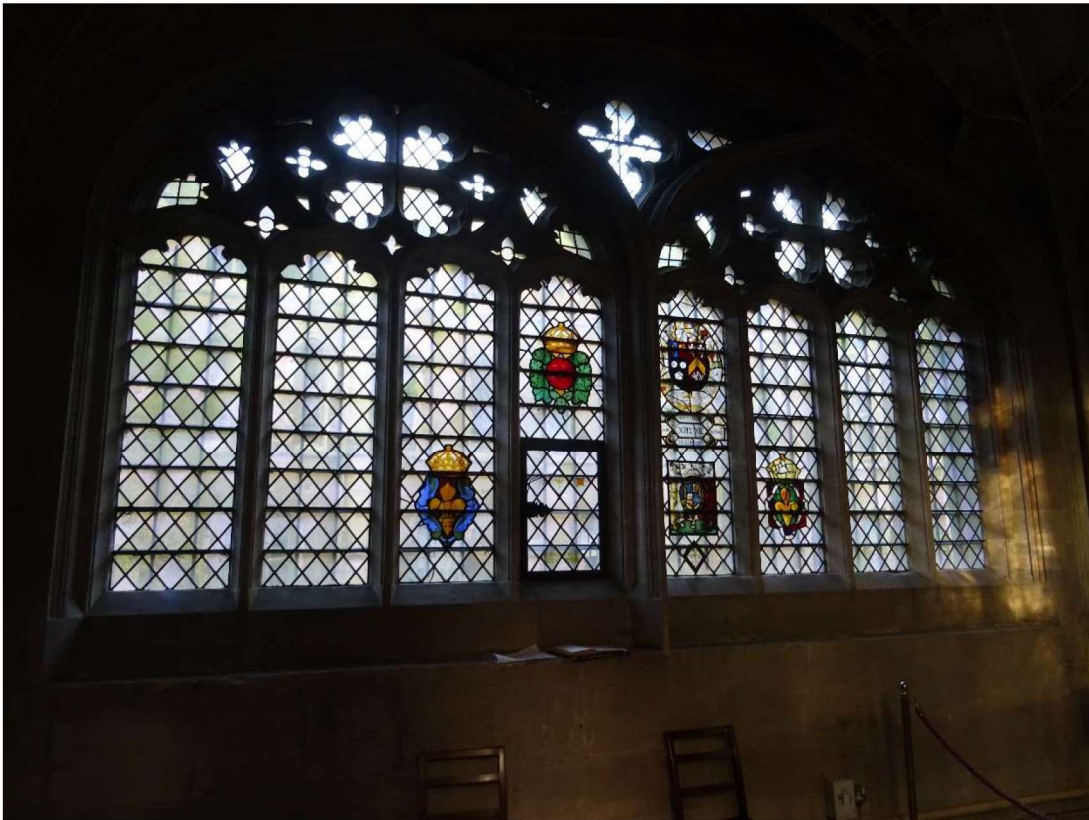
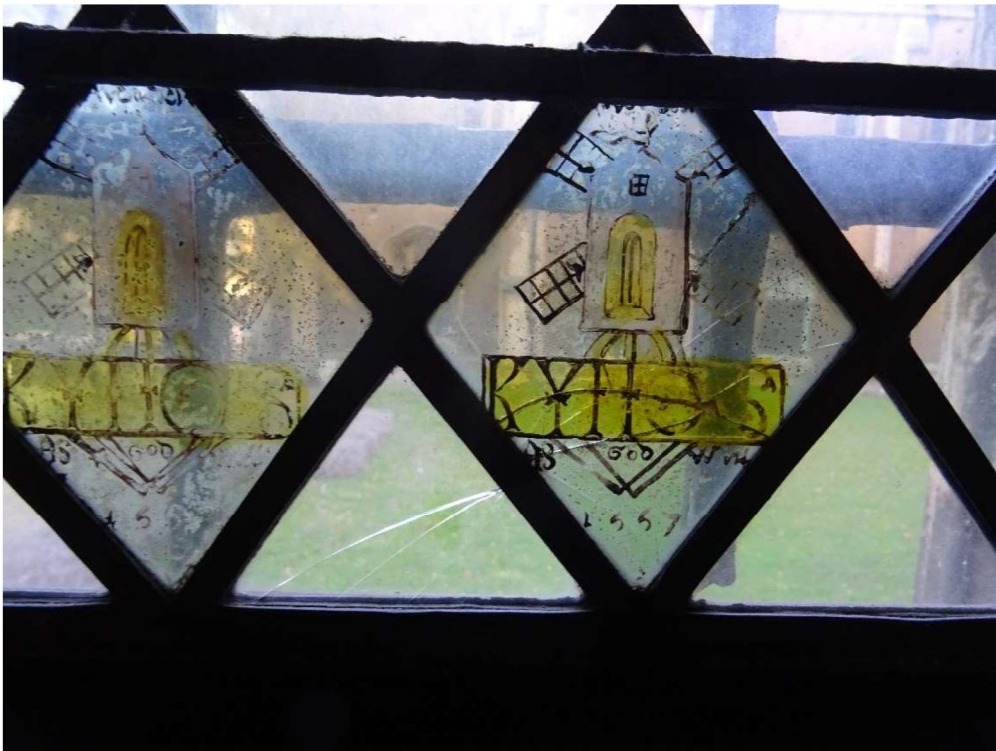
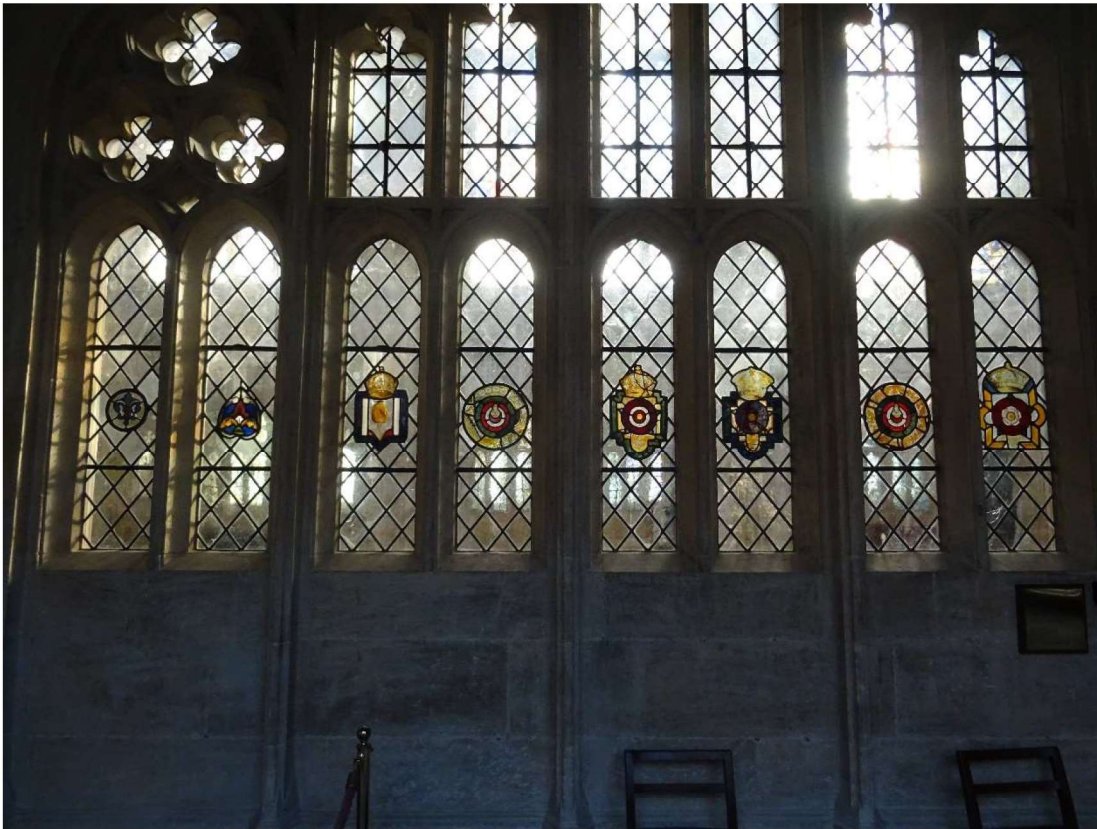
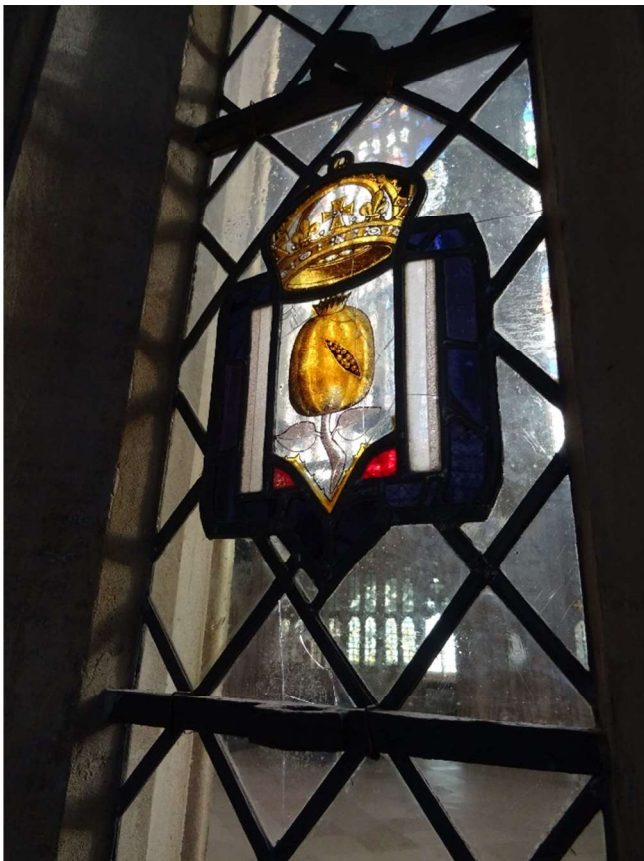
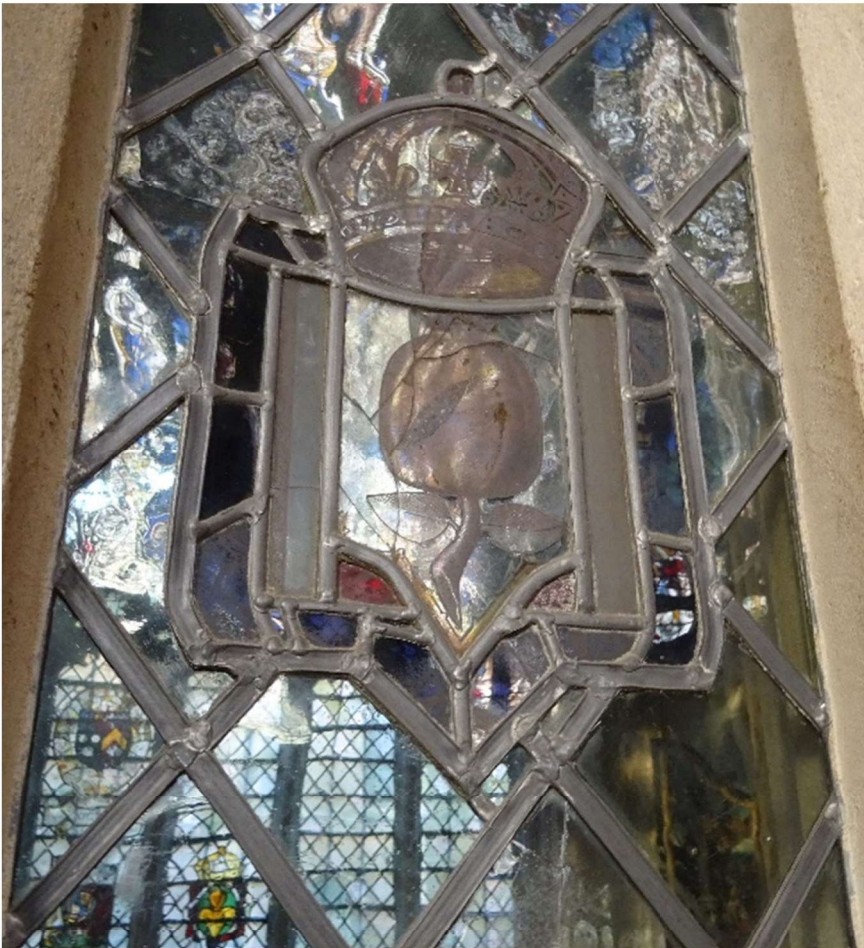
### **Chapel H:**

**The catch to the casement light in light d, does not engage properly, and requires in-situ filing and re-decoration to fit properly. The right- hand 16<sup>th</sup> century painted and stained windmill to this panel is cracked, with previous resin repair and backing glass broken- probably due to slamming of the casement to close.**

**The inner wall glazing has a lovely crowned pomegranate rebus 15<sup>th</sup> century. This has previous repairs, but has sustained an impact and is markedly bowed, with cracked glass.**

**The light has a horizontal division, meaning that only the lower section need be removed for remedial works.**

**Condition/ Priority Code – C 3**

**Remove casement frame by lifting off pintels. Partially dismantle and re-lead, carry out resin edge bond to windmill refit on pintels ensuring that catch engages properly. Remove lower section of inner wall pomegranate panel. Dismantle and re-lead panel, carry out resin repairs to damaged sections, provide 1mm protective backing glass to repaired areas.**

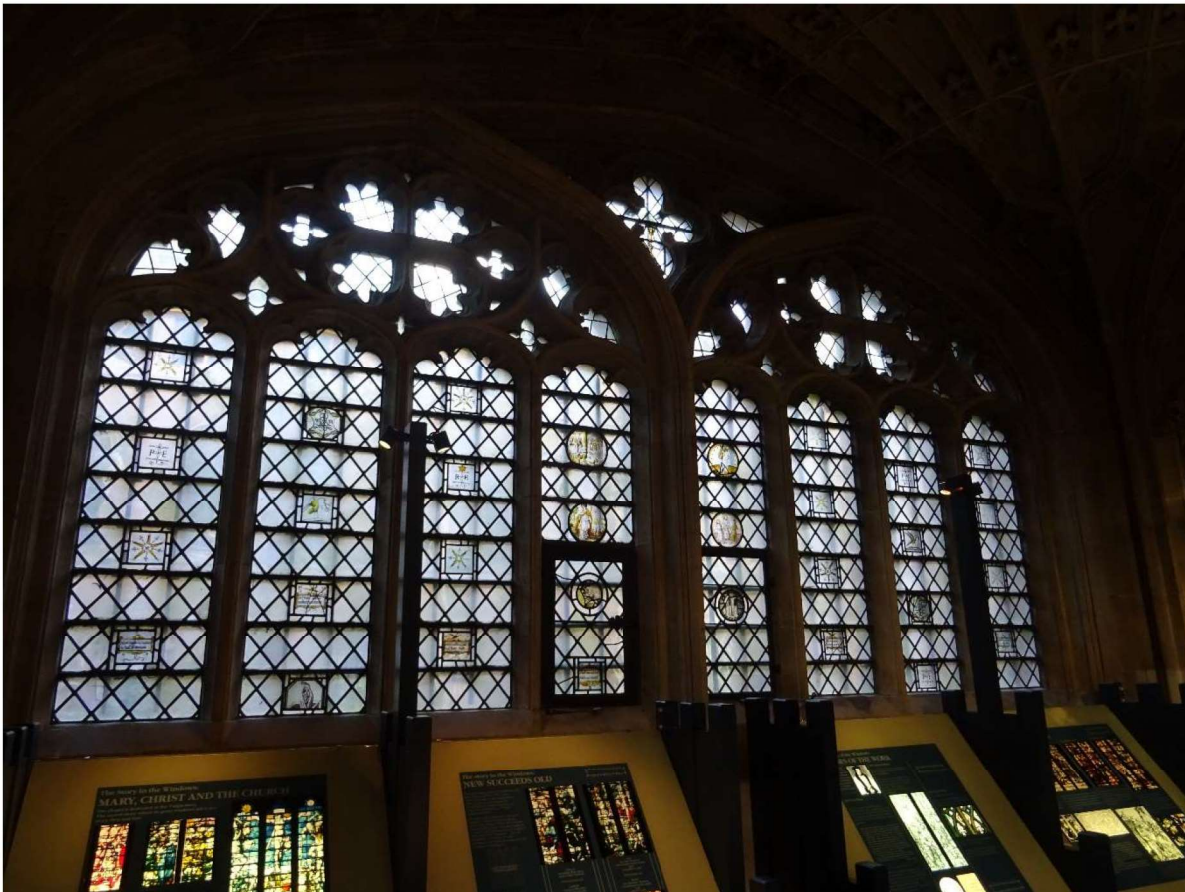
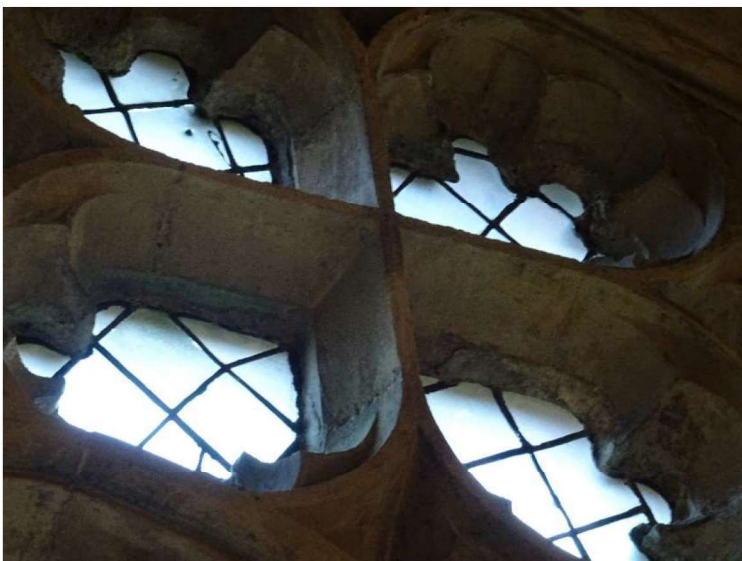
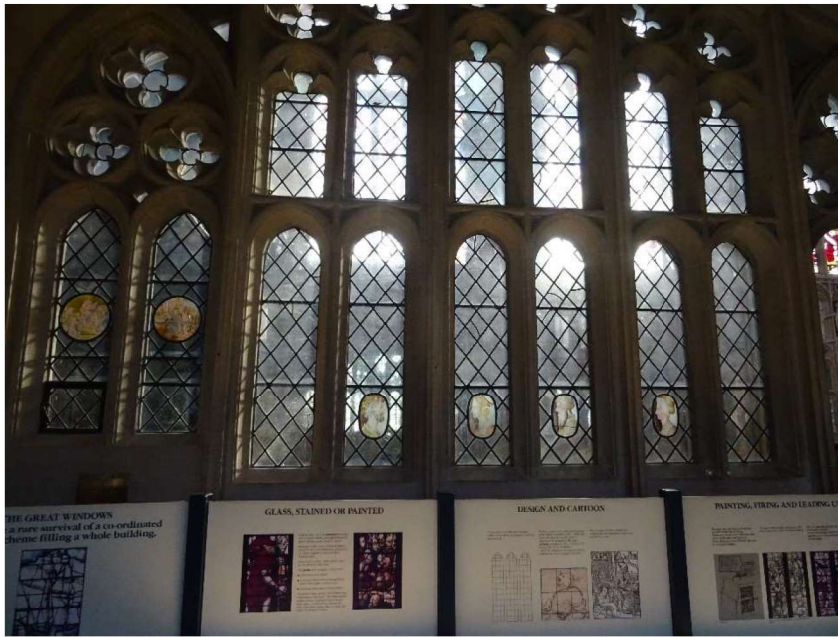
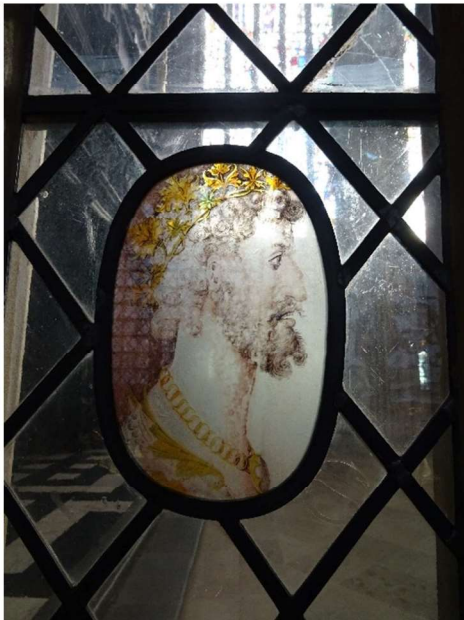
## Chapel G

The stained glass to the chapel is in generally good order. The exception is the small-scale tracery of the outer wall glazing. A number of these have what appears to be ancient very slender cast lead comes. The glass is broad glass probably 17<sup>th</sup> century.

12 of the largest tracery panels should be removed for conservation works when practicable, as they are very bowed and weakened. However, this will be a conservation exercise. The panels should be carefully flattened, and the comes re-cemented to firm them and ensure that they are watertight. Any broken solder joints to be re-soldered. They should not be dissembled. Panels to be re-instated into lime mortar.

The stained glass to the inner wall glazing has superb portrait heads, reputedly by Arnold of Nijmegen. The stained glass sections are in good order, but the plain glazing to the upper tier is rather rickety, with glass rattling in the comes. However, these panels are not set against the weather, and only a watching brief should be kept on them.

**Condition/ Priority Code – C 3**

**Remove 12no larger tracery panels, temporarily glaze openings. Carefully flatten and re putty conserving early lead. Refix into lime mortar**

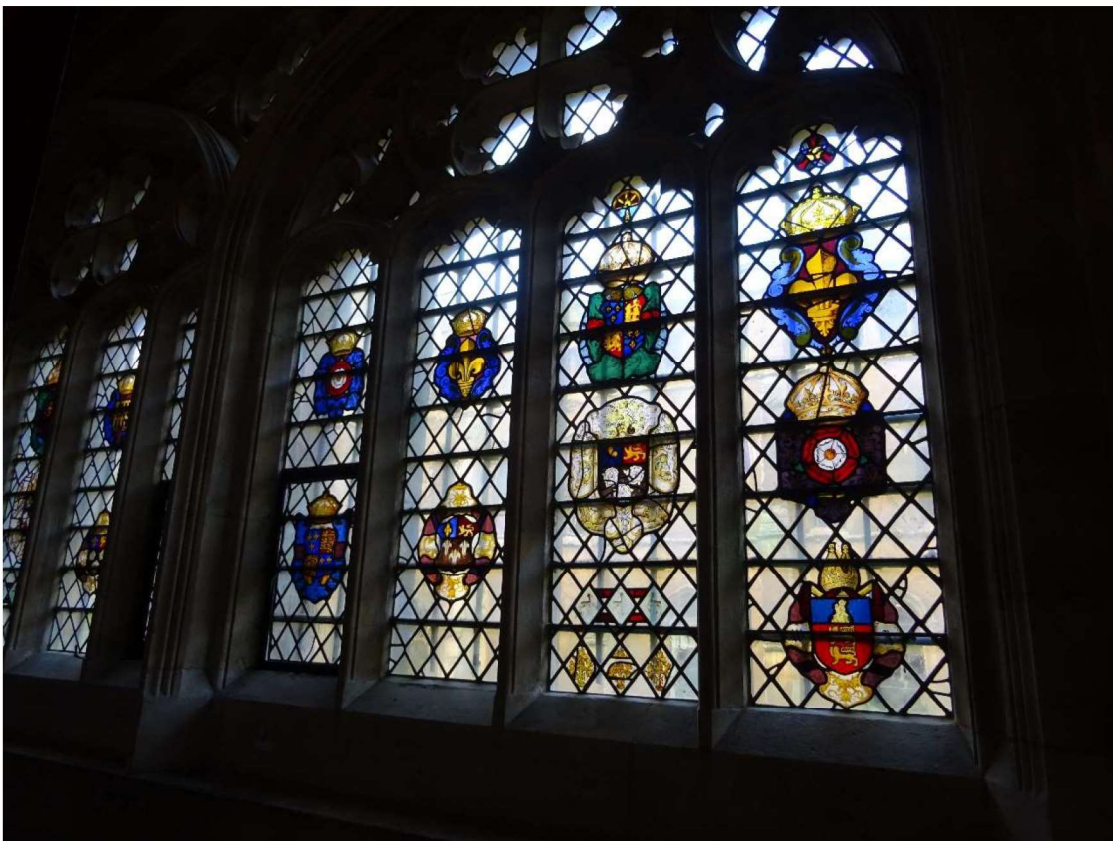
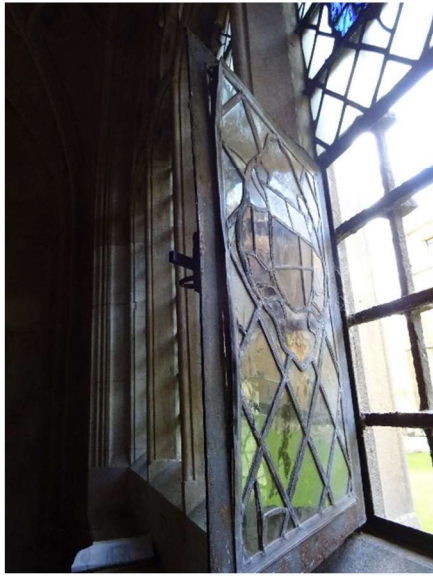
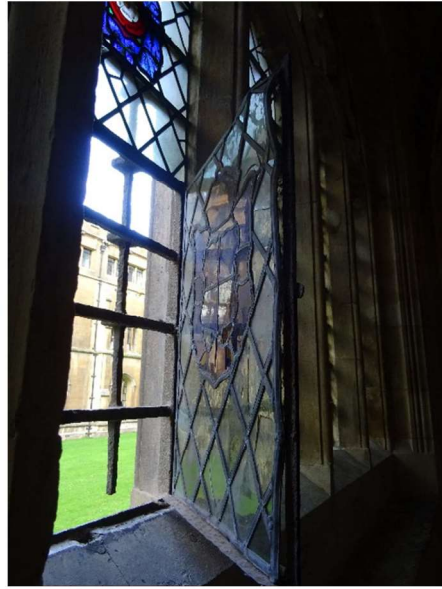
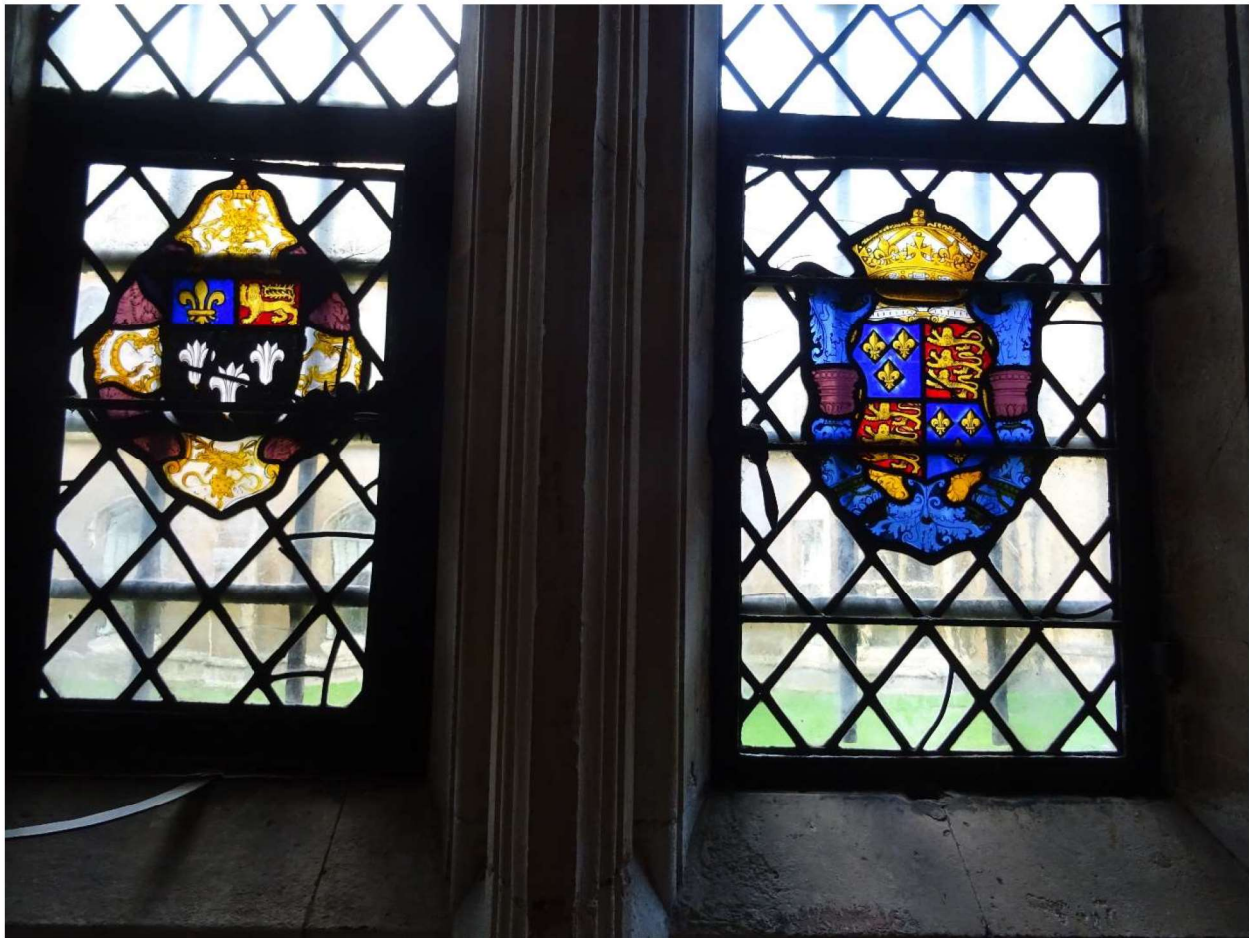
## Chapel F

The glass to this chapel is generally in good order. The exceptions are the two opening casements to lights d and e, which are in parlous condition. The casement frames are pintel type, and lift off from inside the building. Removal for necessary works is therefore relatively straightforward. The sprung opening stay, which is a rather nice feature, is missing from the casement in light e.

Condition/ Priority Code – D 4

Remove opening casements to lights d and e, temporarily glaze openings. Remove leaded panels from frames. Decorate frames to specification. Re-lead panels, fix to refurbish frames with hot rivets. Refit on site.

Manufacture and fit new curved stay.

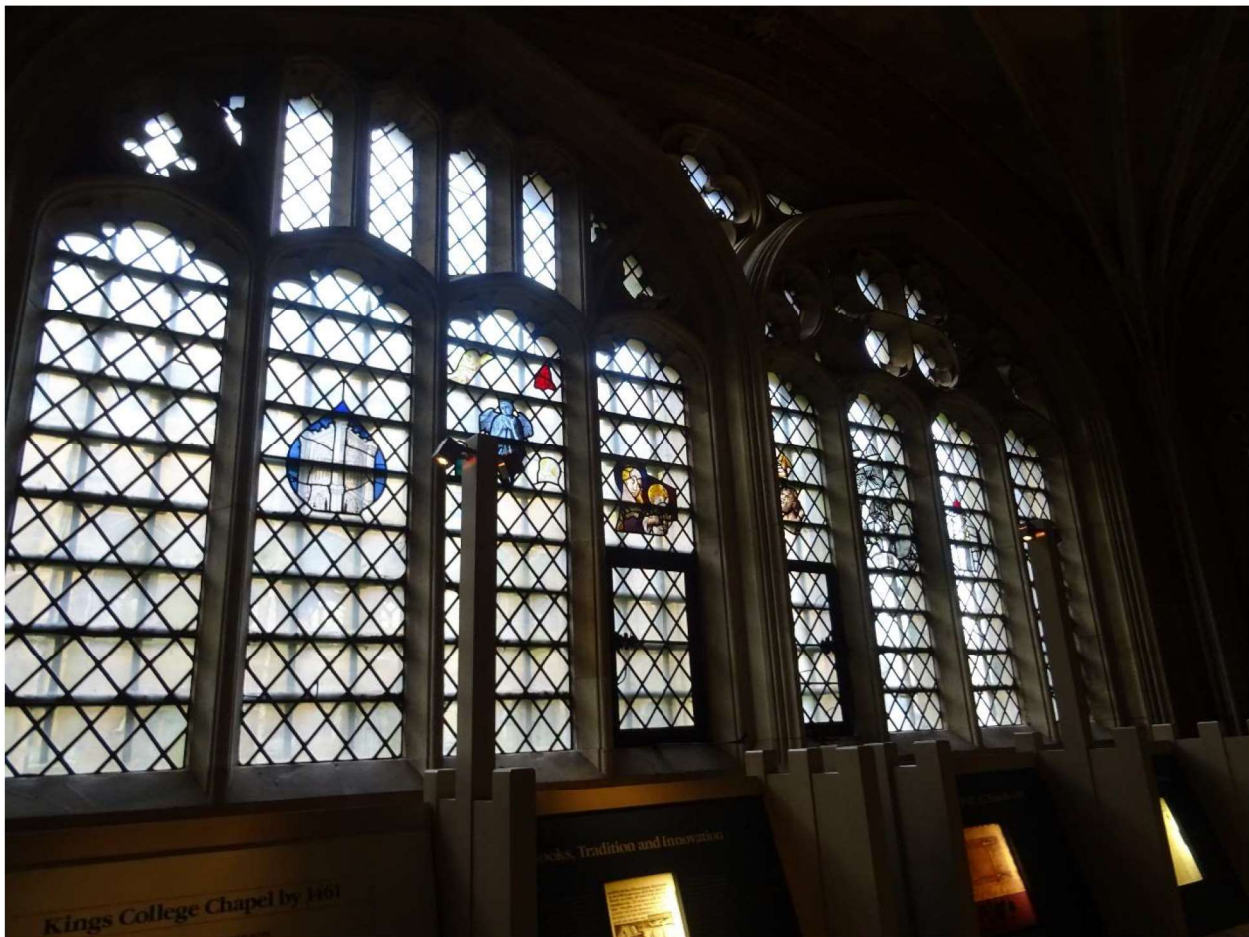
## Chapel C

The stained glass is generally in good order, however the glazed panels have come loose from the casement frames in lights d & e. This can be successfully dealt with on site by re-siting the perimeter leads, and re-puttying.

Condition/ Priority Code – C 3

Lift off casement frames to lights d & e, move to van onsite for works. Reposition perimeter lead on frames, remake pot rivets, rehang on pintels

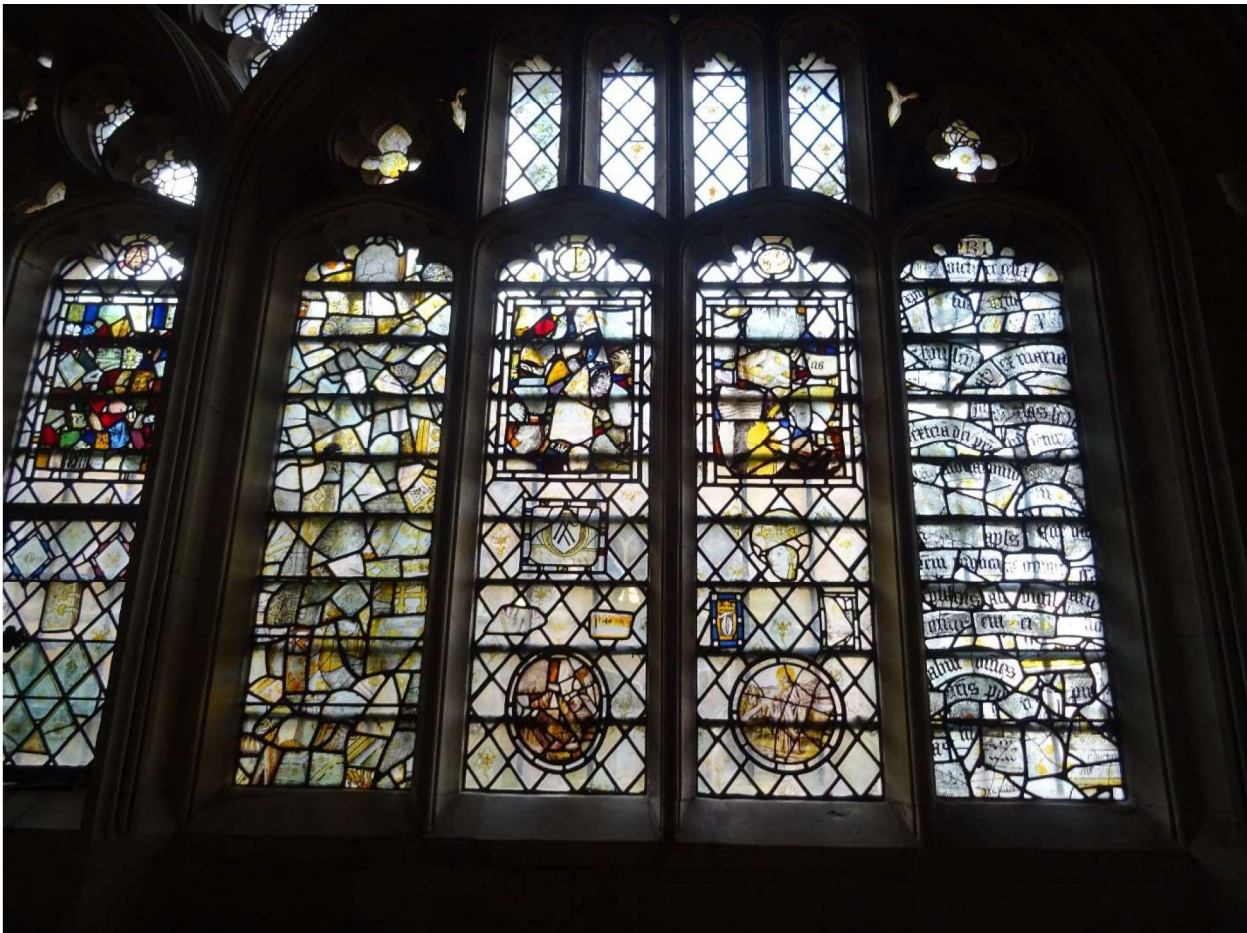
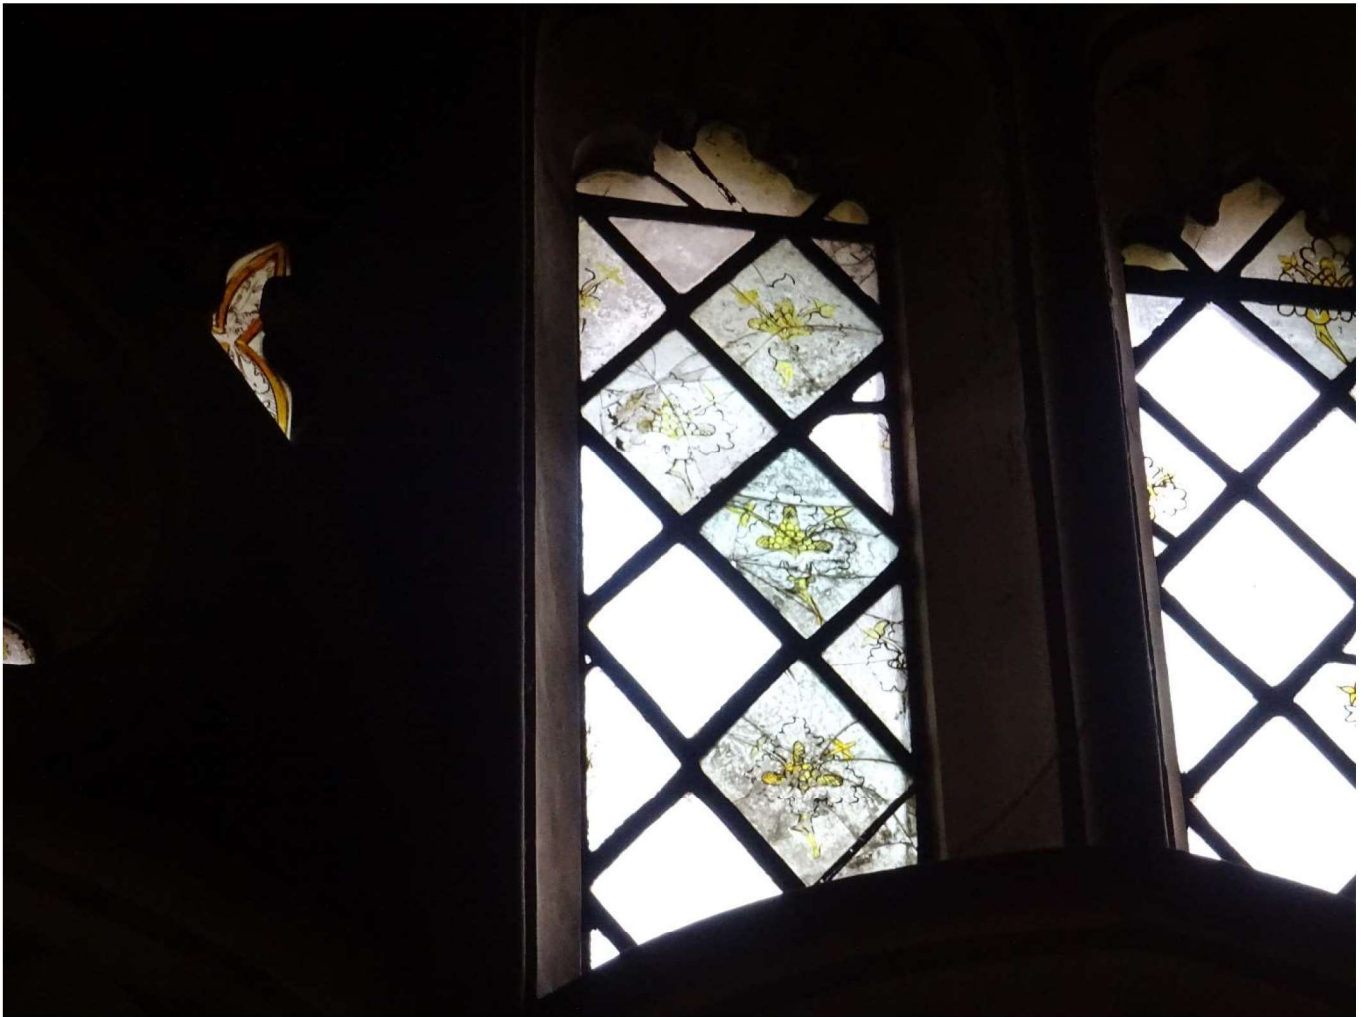
## Chapel A

The north elevation window is in reasonable condition, the exception being the tracery section illustrated, which has 15<sup>th</sup> century quarries with painted and stained floral motifs. This panel is severely bowed, with glass multi cracked and protruding from the lead.

Condition/ Priority Code – C 3

Remove tracery b by carefully chipping away perimeter mortar, install temporary glazing, transport to workshop. Dismantle and re-lead panel. Carry out resin repairs to cracked medieval quarries. Re-fix on site into lime mortar.

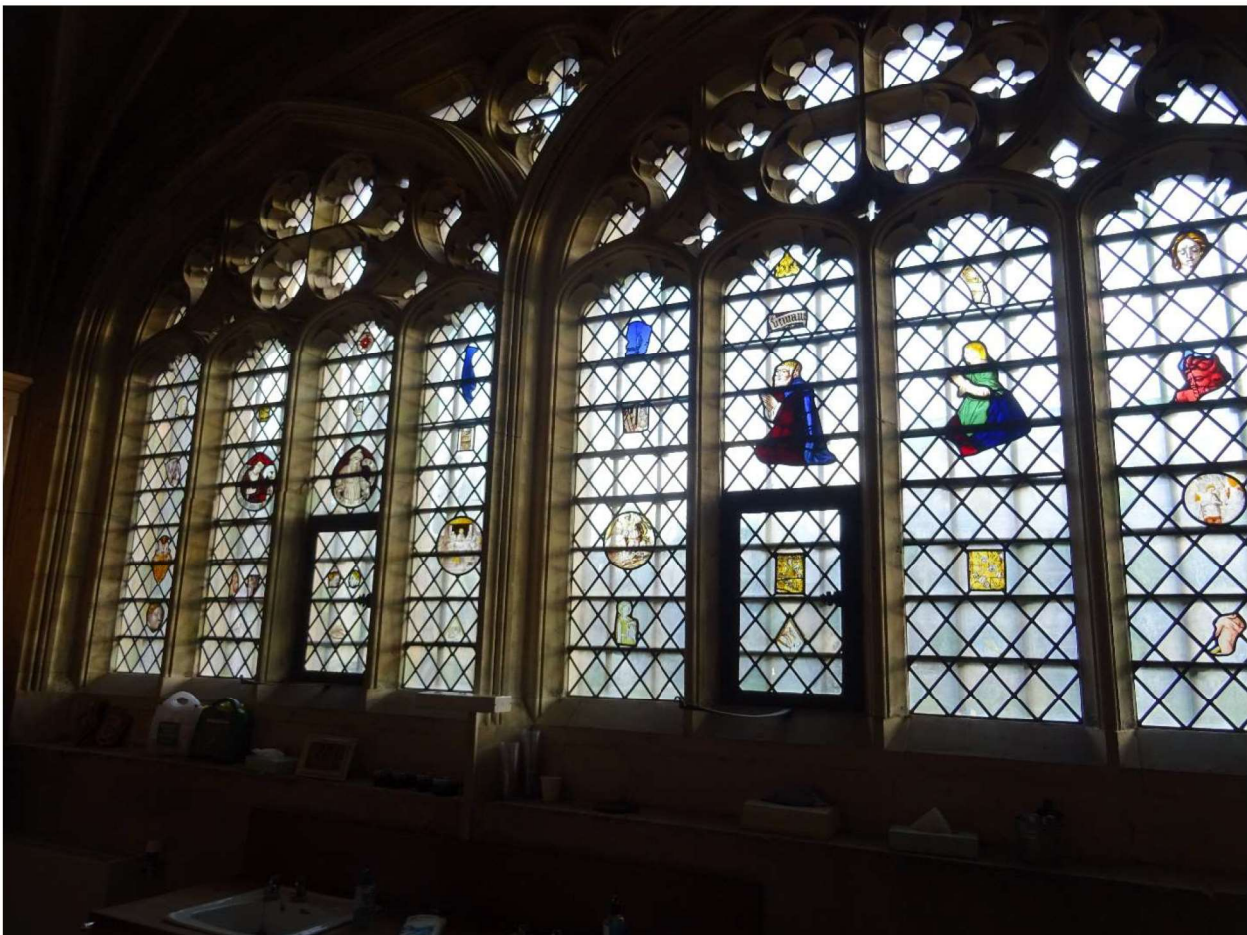
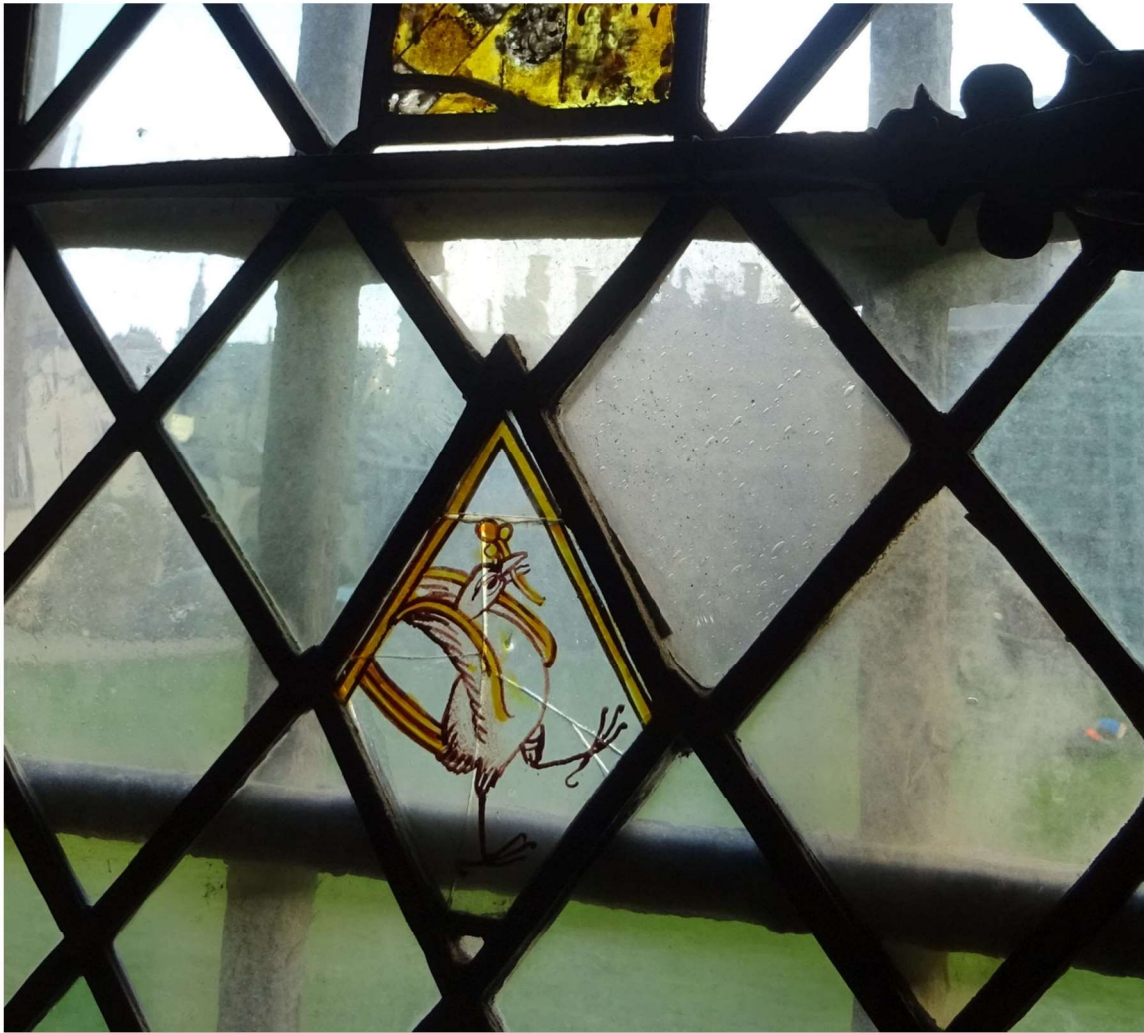
## Chapel N

The casement panels in lights c and f are in very poor structural condition, with failed lead work, cracked solder joints, and failure of perimeter leads adjacent to the iron frame.

A fine 15<sup>th</sup> century bird in paint and silver stain, is multi cracked, and requires edge bonding with epoxy resin as apart of the conservation works.

Condition/ Priority Code – D 4

Remove opening casements to lights c and f, temporarily glaze openings. Remove leaded panels from frames. Decorate frames to specification. Re-lead panels, fix to refurbish frames with hot rivets. Refit on site. Carry out resin repairs to 15<sup>th</sup> century bird quarry

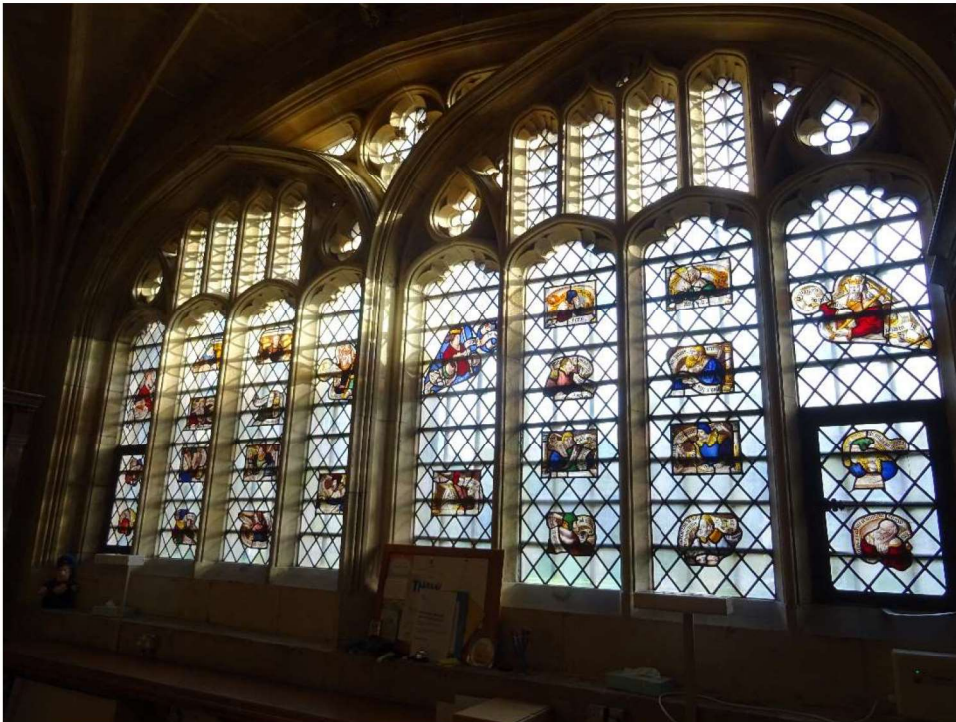
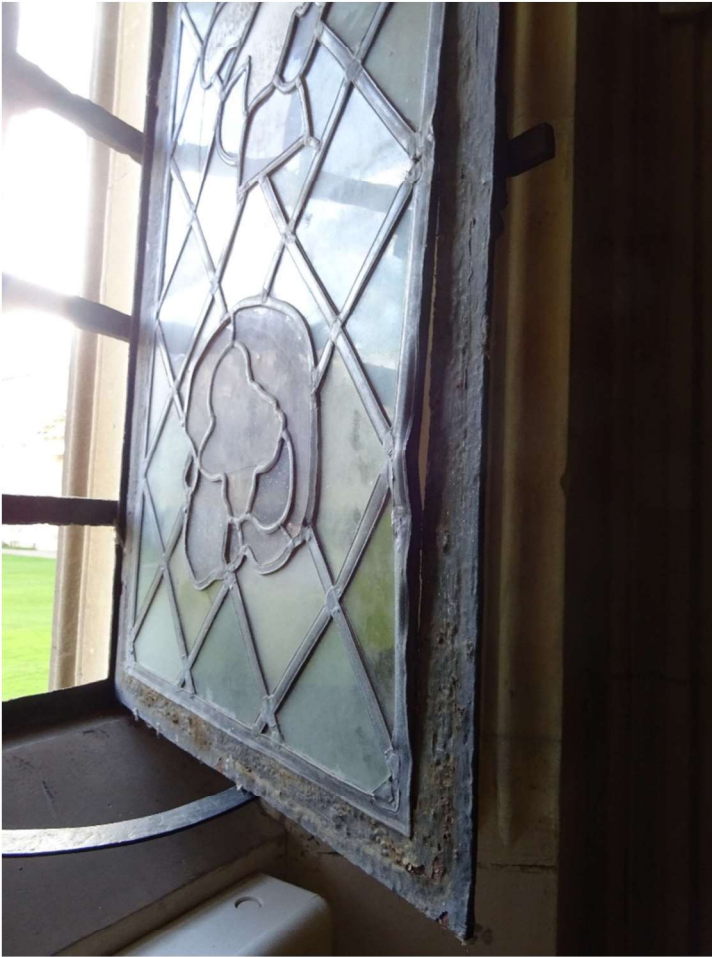
## Chapel O

The casement panels in lights a and h are in very poor structural condition, with failed lead work, cracked solder joints, and failure of perimeter leads adjacent to the iron frame.

Condition/ Priority Code – D 4

Remove opening casements to lights a and h, temporarily glaze openings. Remove leaded panels from frames. Decorate frames to specification. Re-lead panels, fix to refurbish frames with hot rivets. Refit on site.
