**099 KINGS COLLEGE CHAPEL  
REPLACEMENT OF UNSAFE HIGH-LEVEL CARVING  
COVER PAPER TO FACULTY APPLICATION**

This paper supports an application for Faculty under the 2015 RULES, for replacement of an unstable animal sculpture on the upper water table of the buttress between bays 7 and 8 for which removal of the loose parts has already been completed under an Interim Faculty, and repair of the adjacent carving on the buttress between bays 8 and 9.

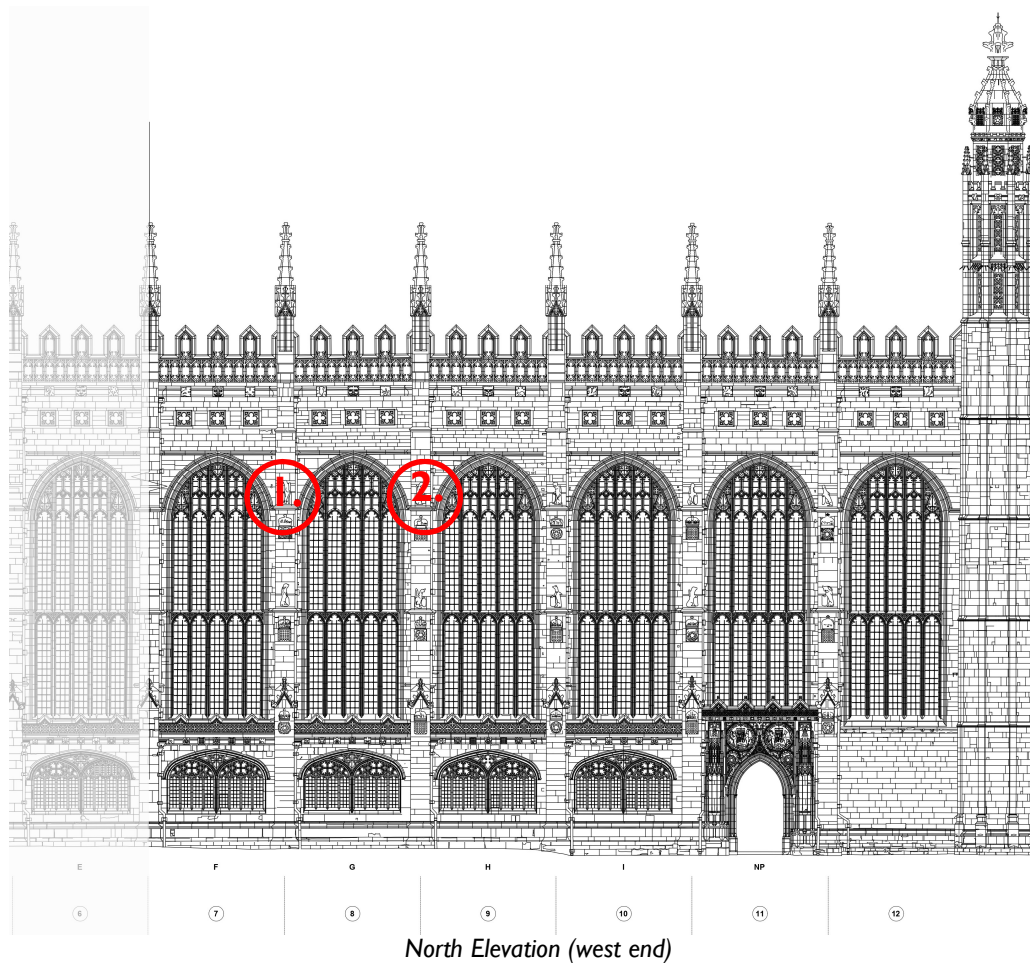
- 1.** Severely decayed and unstable carving to be carefully removed and replaced. Note stonemasons estimated weight of the replacement carving would be in the region of 400kg.
- 2.** Carving shown initial signs of similar defects although not in as poor condition as item 1. To be stabilised by insertion of stainless steel pin using the same scaffold access.

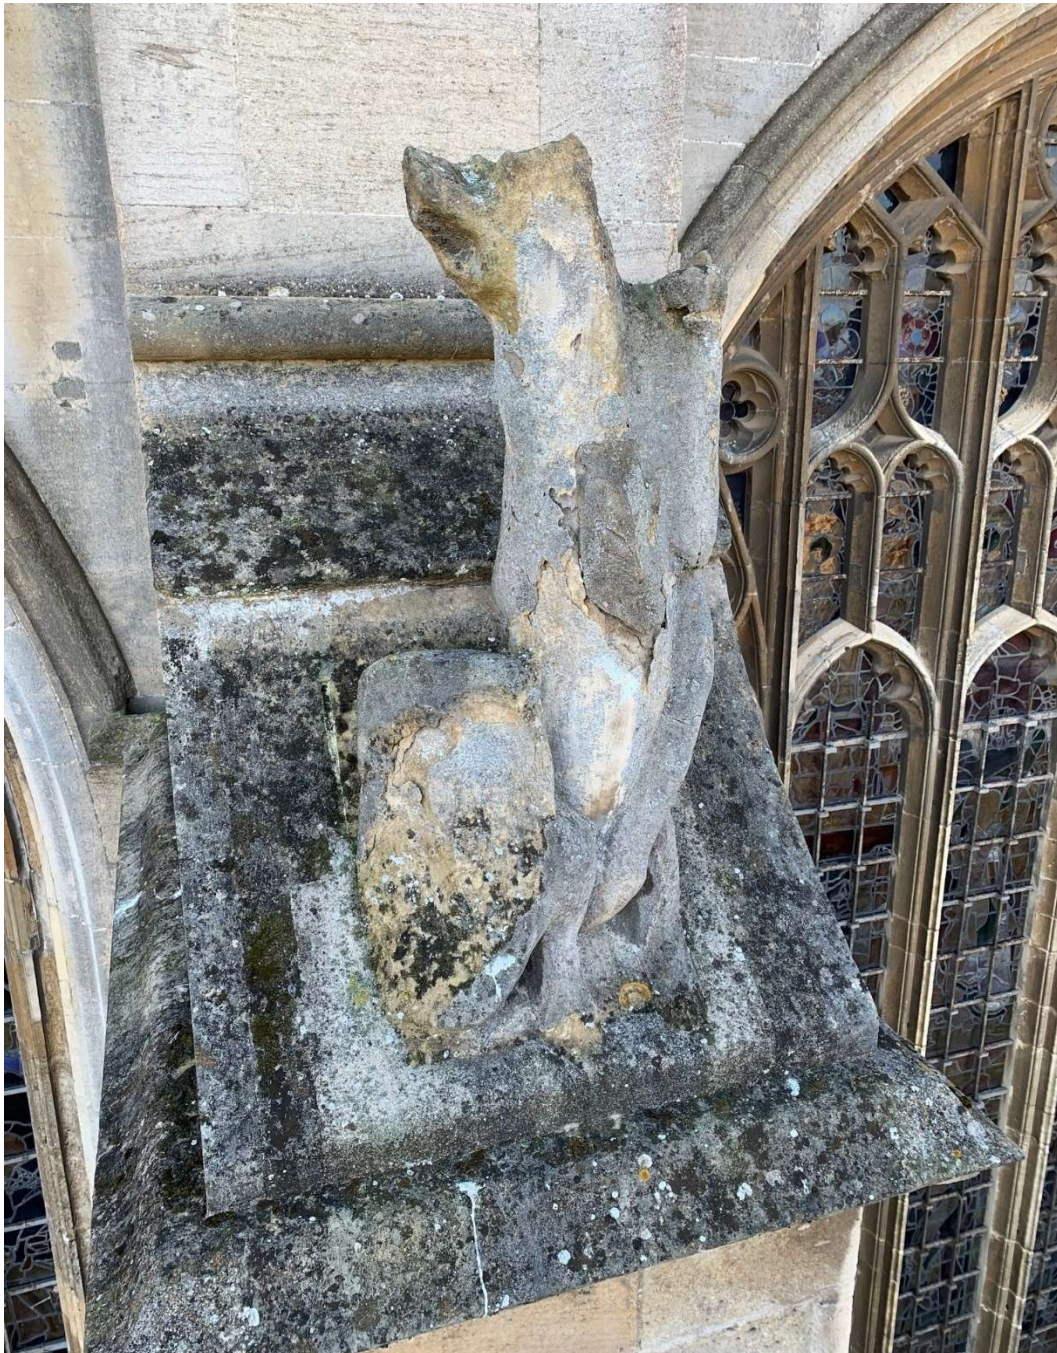
During a programme of high priority Quinquennial masonry works being completed under List B consent (dated 28/08/2021), close hand inspections to some of the high-level masonry elements on the north elevation were made possible through the associated provision of a 100ft cherry picker. The delicate animal sculpture on the upper water table of the buttress between bays 7 and 8 (from the east) was found to be in extremely poor condition as shown in the following photographs, with concerns over its stability and the risk it may not last a hard winter.

*Loose and unstable carving on the buttress between bays 7 and 8.*

### **Replacement of unstable animal sculpture (upper carving on buttress between bays 7 and 8)**

The careful removal of the existing masonry will seek to salvage the sculpture in as few fragments as possible and will be completed under the interim Faculty.

The objective is to replace the removed stone with a re-carved sculpture based on the original. We now seek agreement and consent on the proposed methodology for its replacement, as follows:

The approved maquette would then form the template for the sculptor to carve the replacement in stone. It should be noted that a number of similar carvings on the south elevation have previously been replaced in Lavoux Fin limestone, which provided a good match to the original Ketton whilst accommodating the bed height required for the sculpture (Ketton cannot be procured in the required bed heights to ensure integrity throughout the sculpture). It is proposed that this precedented use of Lavoux Fin be followed for the current replacement, subject to approval of a sample.

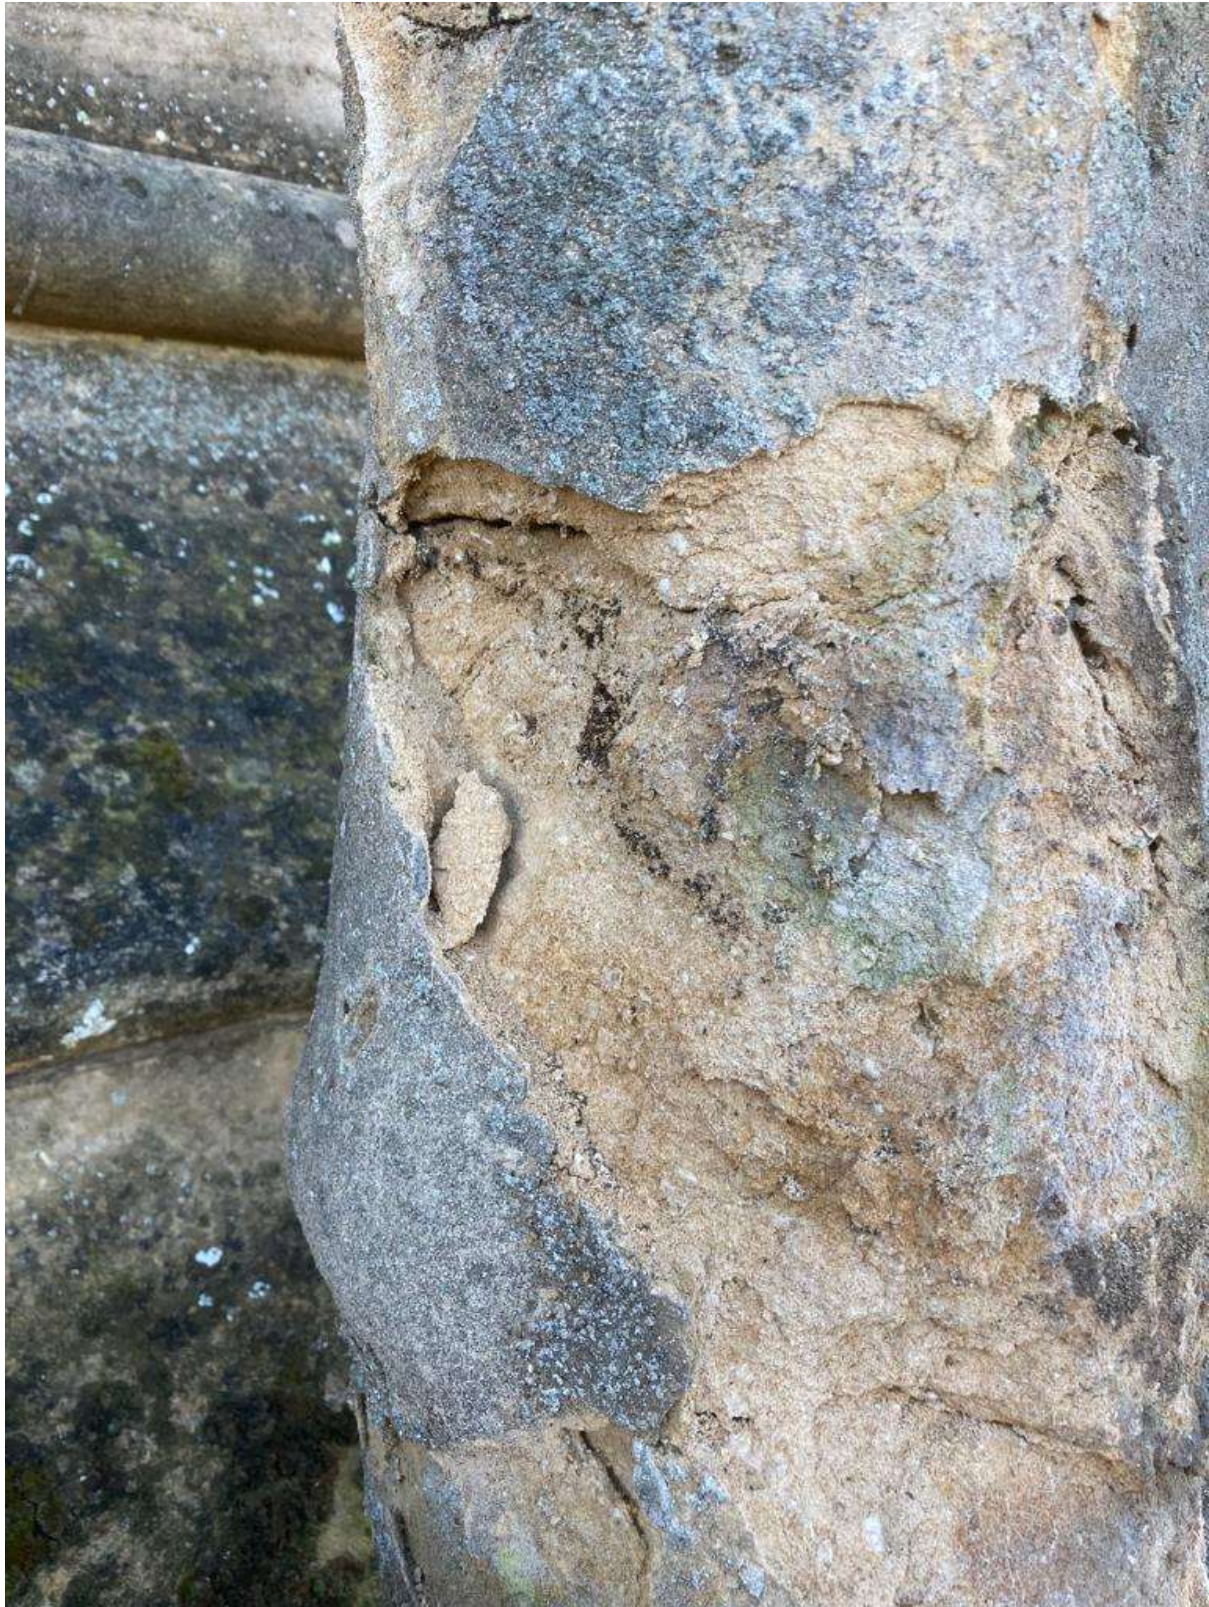
*Detail of friable and cracked carving.*
