King's College Chapel Roof Covering Renewal

Covering Paper to Faculty Application

MARCH 2022

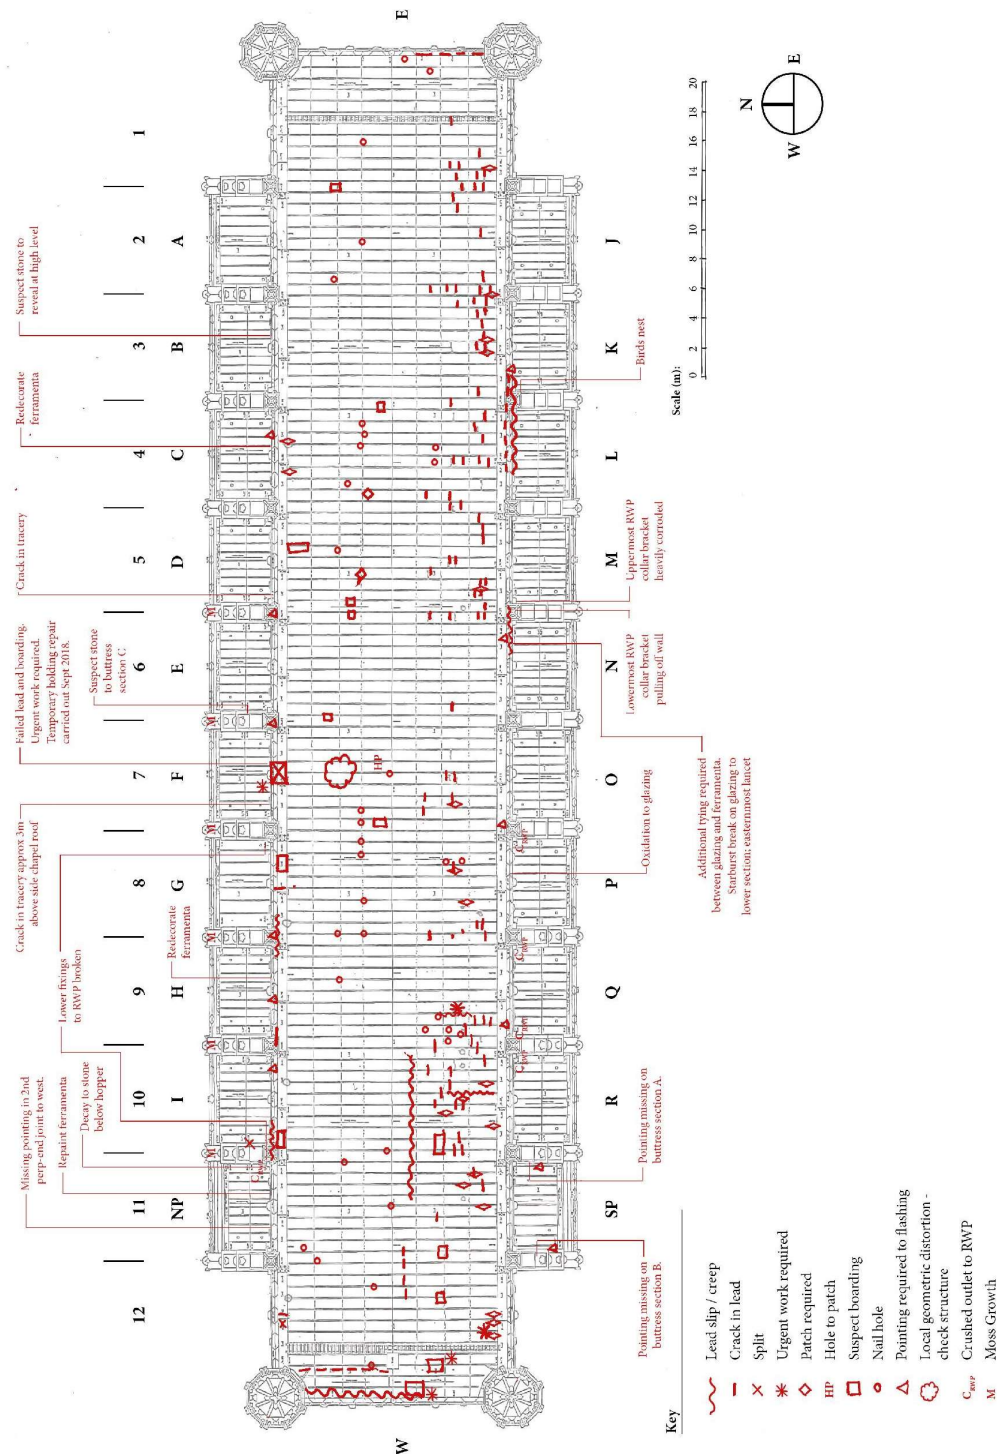
Mark up of defects identified during the 2018 Quinquennial. Note those shown in red are defects which have developed since the 2012 inspection.

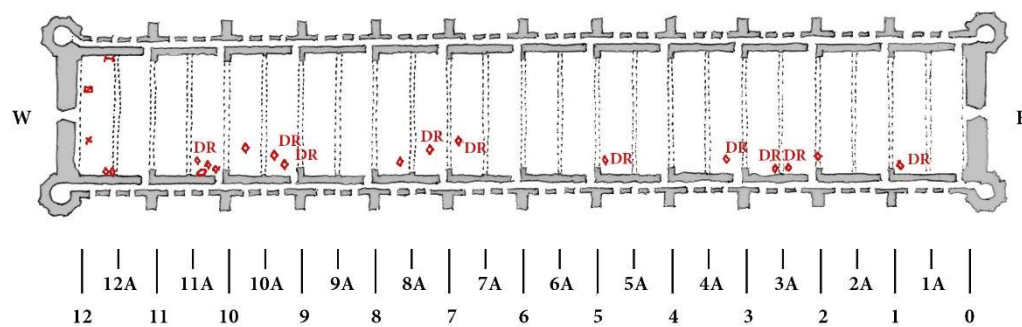
Plan of Main Chapel roof space with mark-up of internal defects identified during the 2018 Quinquennial Inspection

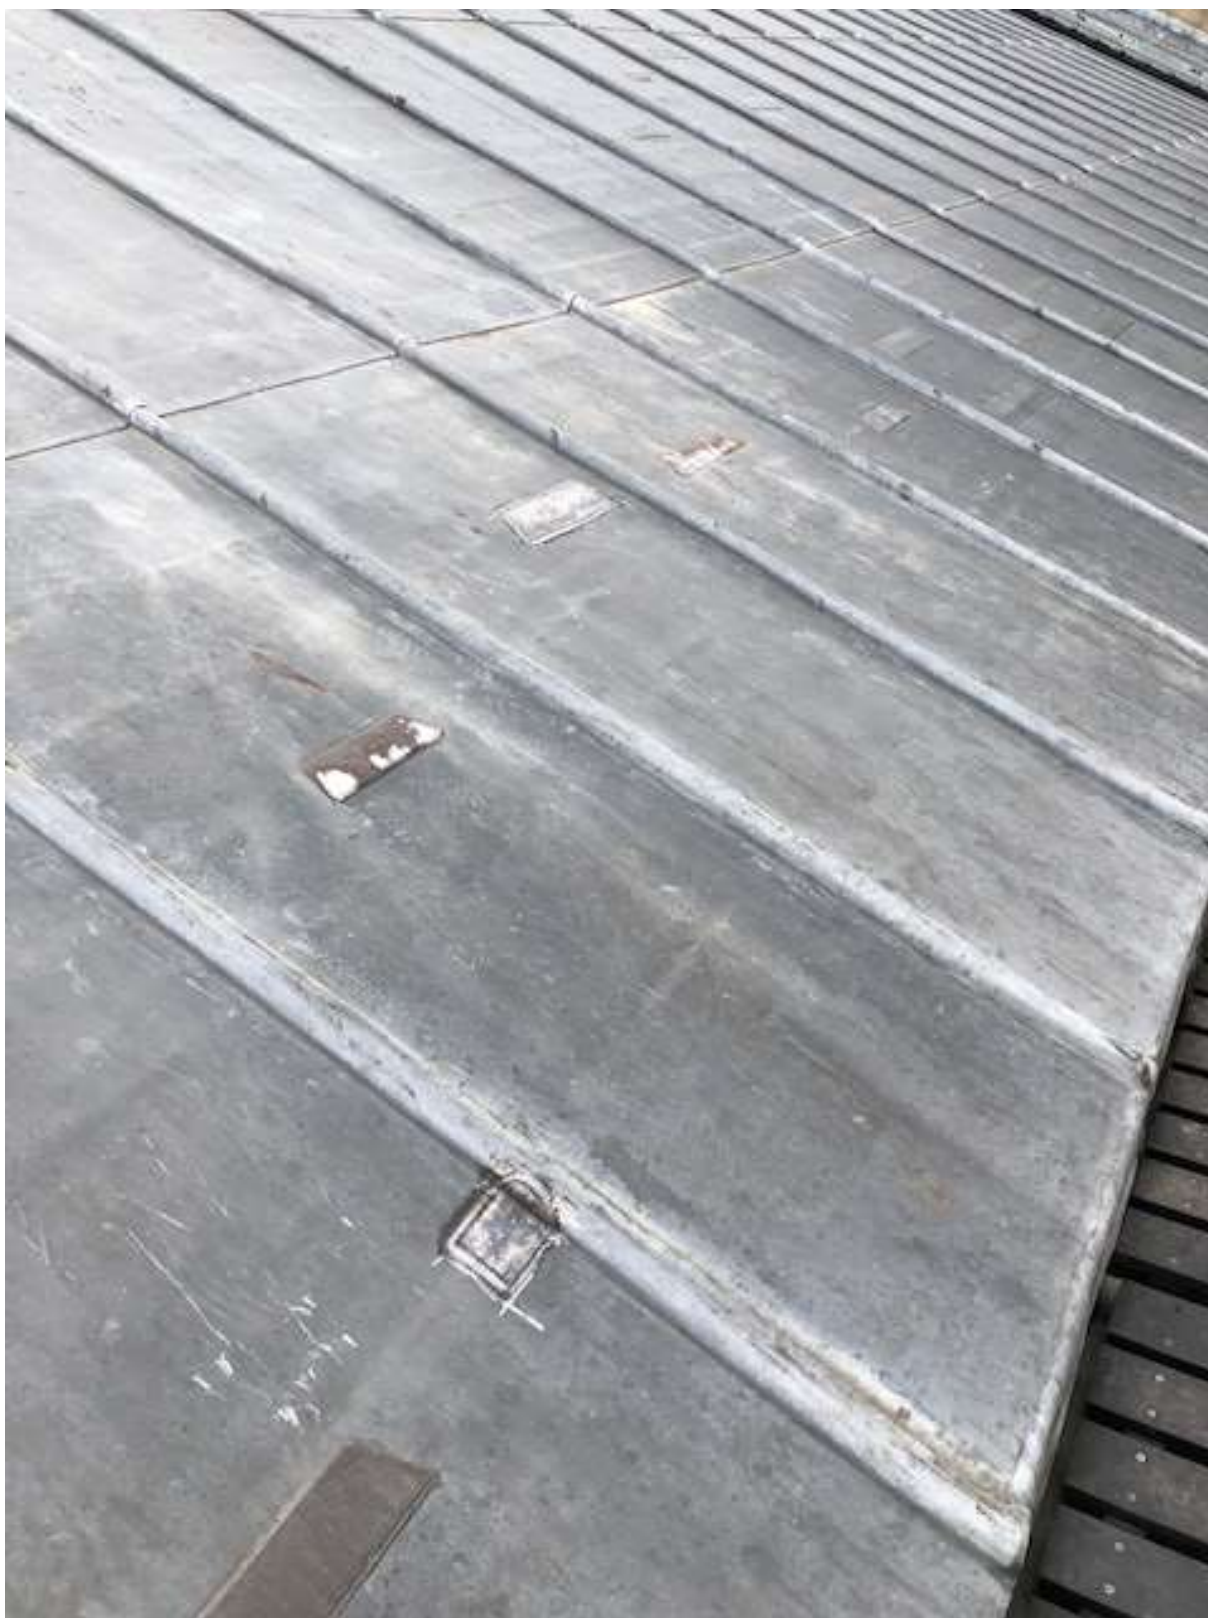
Phases of holding repairs with further buckling (precursor to tears) evident.

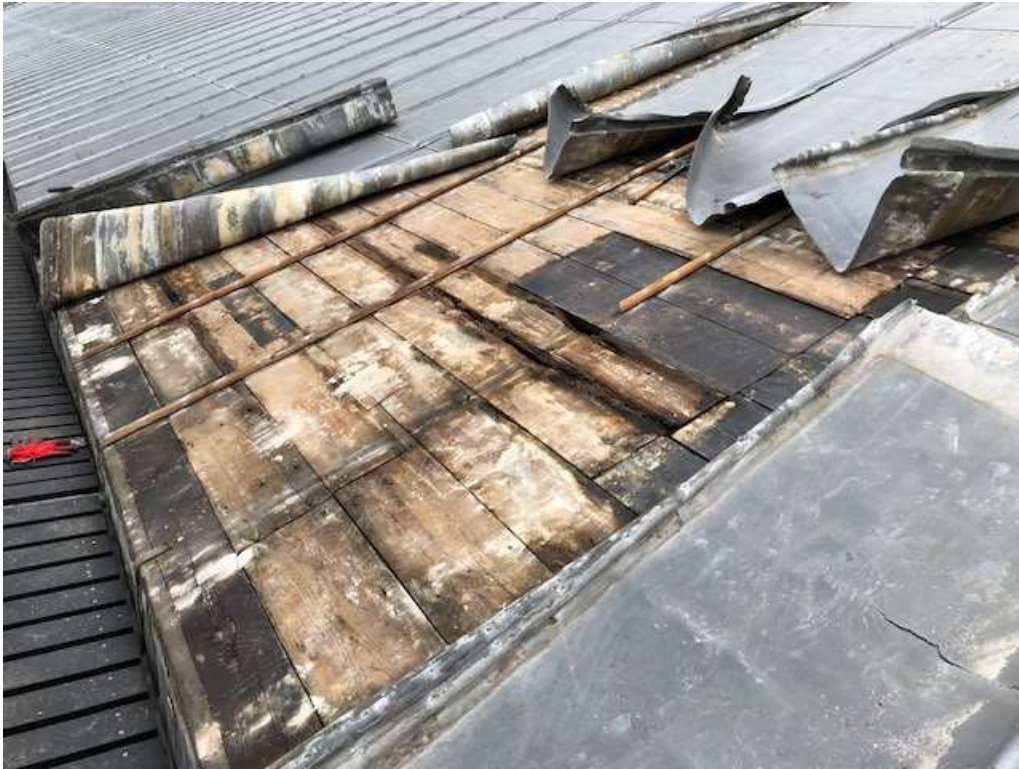
Urgent holding repairs in progress. Note rotten and decayed boarding.

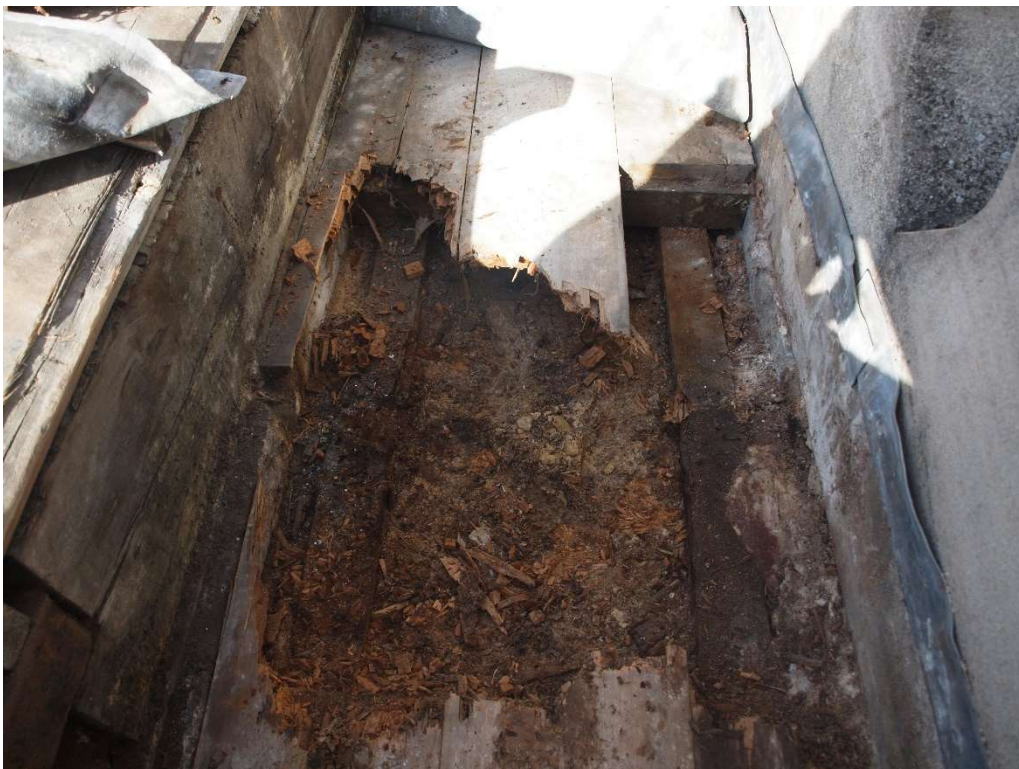
Rotten boarding and structure below defective gutter.

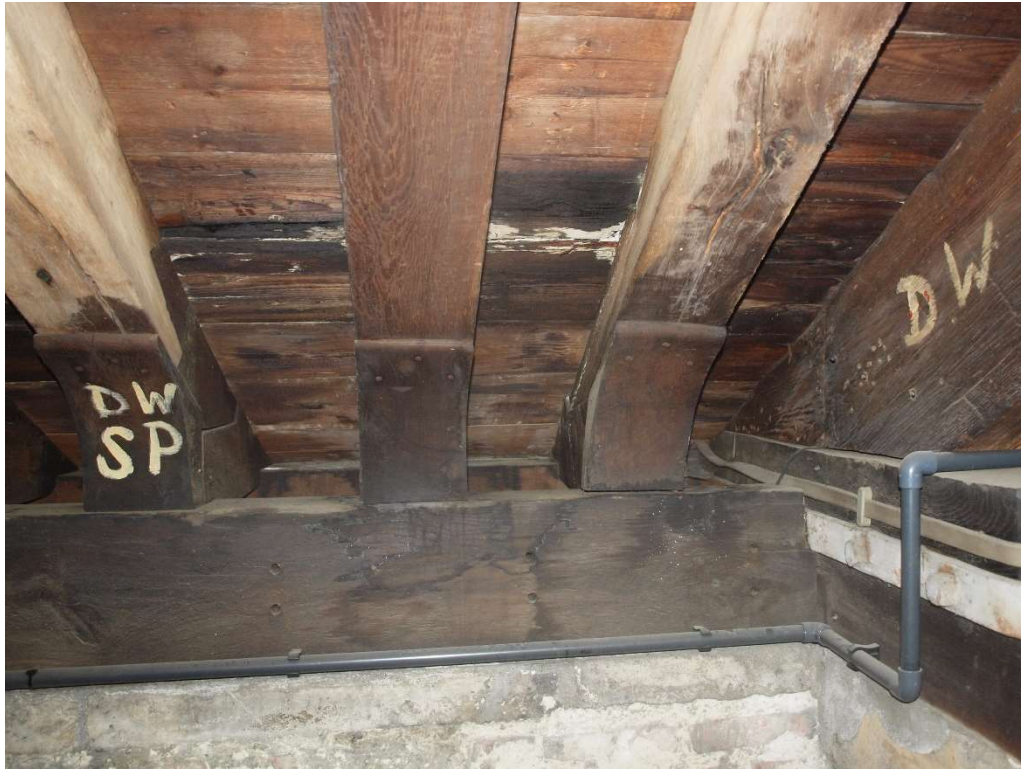
Saturated timber and rotten boarding.

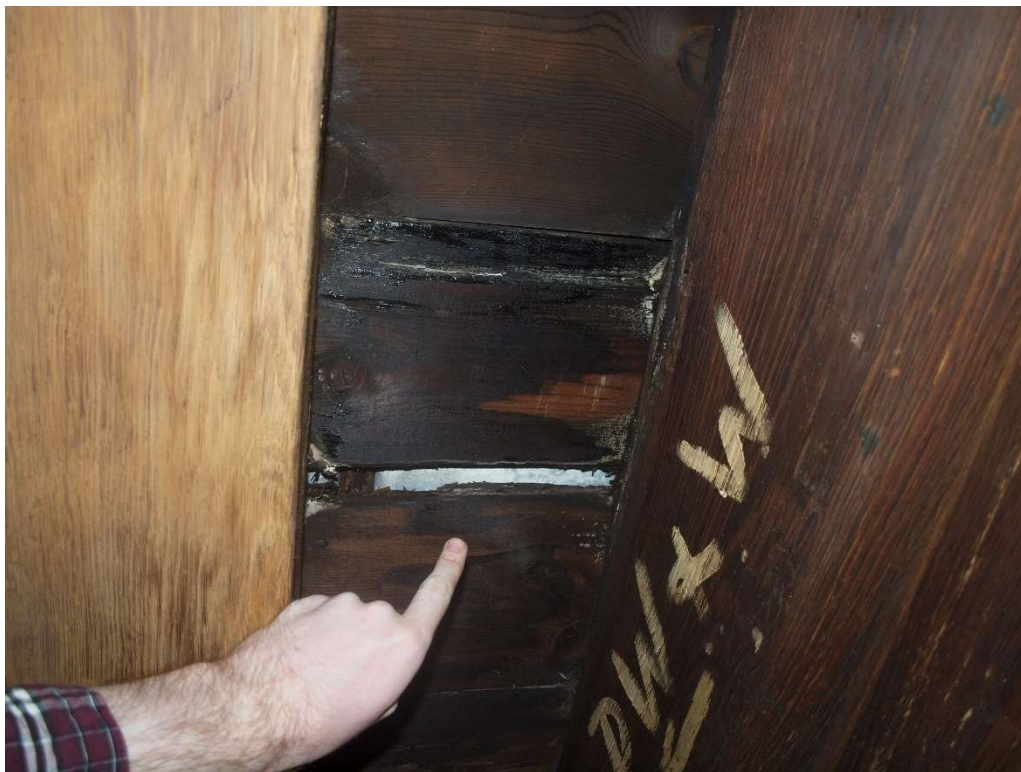
Dripping wet boarding with rot starting to establish.

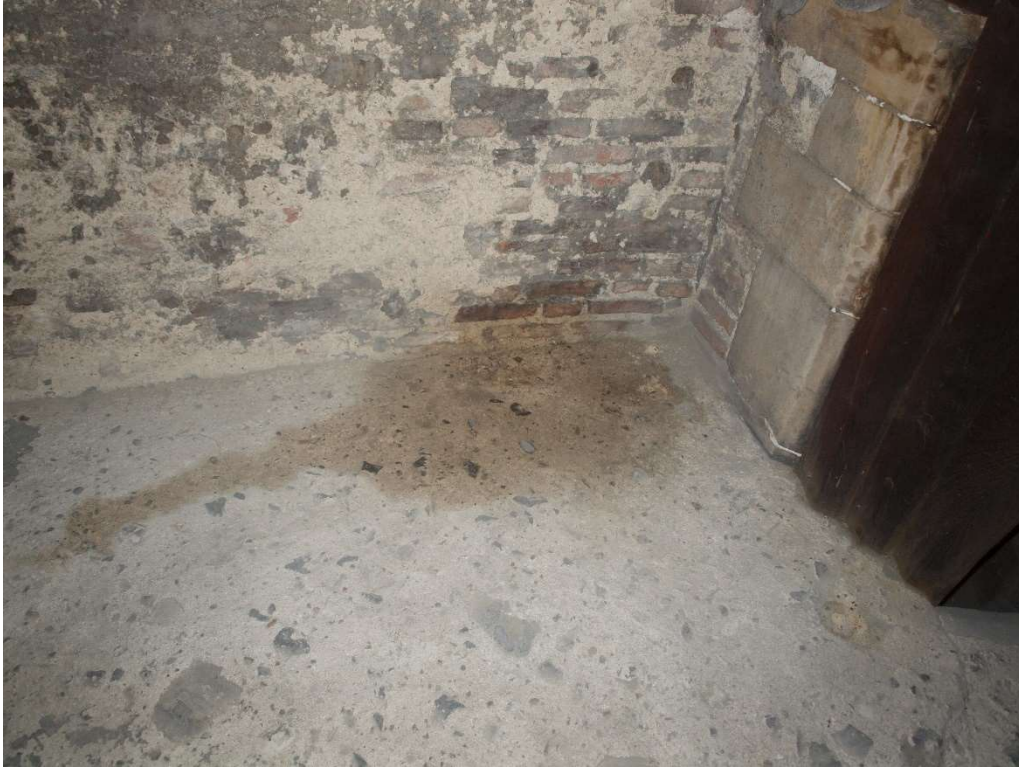
Damp staining below leaks in the roof covering. Water now pools within the roof space.
