Treatment Report King's College Chapel Joinery

Kings College Chapel
Kings Parade
Cambridge
CB2 1ST

1 June 2023

Conservator: Tristram Bainbridge ACR

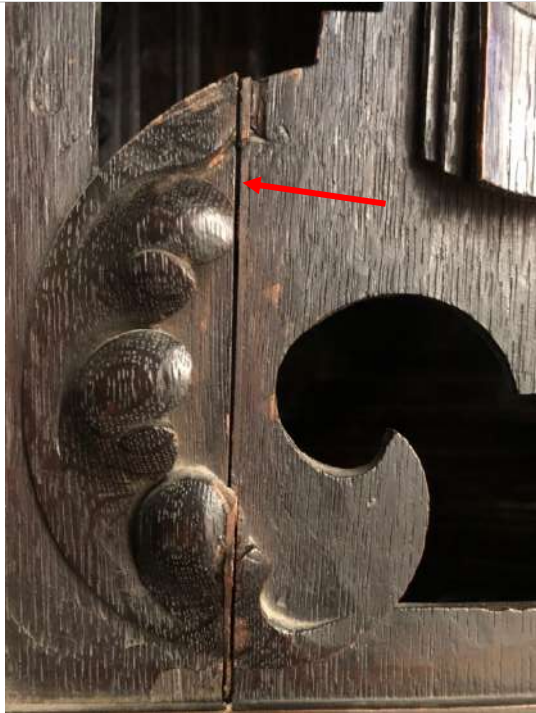
Old repair (red) and subsequent new shrinkage gap

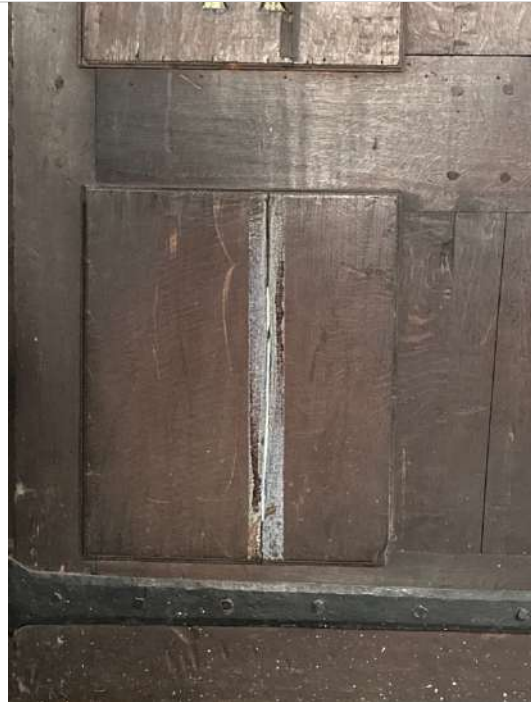
Bottom panel split – covered with gaffer tape residue

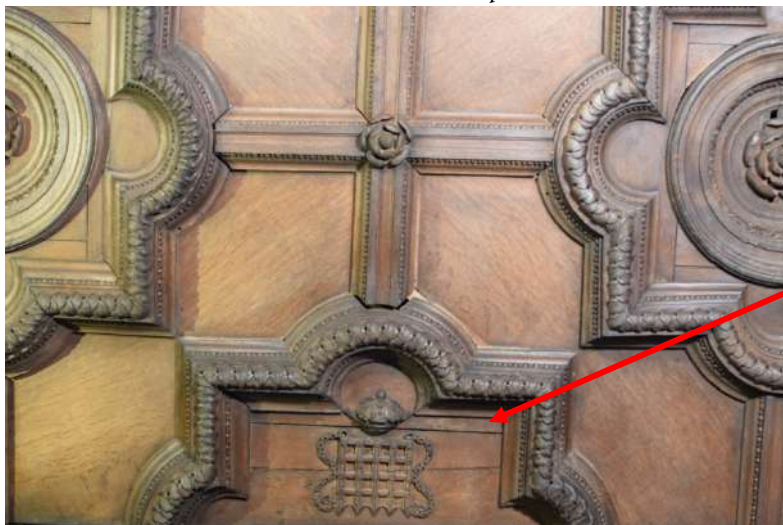
Screen Passage: Investigate movement of central panel to the east of screen passage to ascertain if whether there is a structural issue. Provide report and recommendations.

The splits in the portcullis panel on the centre East end of the screen passage ceiling were stable. This element is a thick piece of wood (as opposed to the panels surrounding it, which appear to be relatively thin), and there was no movement detected in the board. There has been a small amount of wood movement in the thin panels, but the panel structure has allowed for this. No treatment is required.

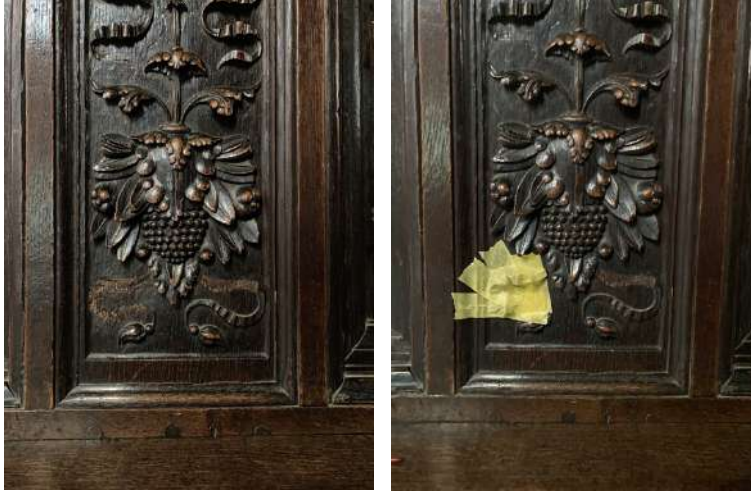
Collect 2no salvaged fragments which have previously fallen from the screen and re-fix to original locations.

These salvaged fragments were re-attached using warm hide glue.

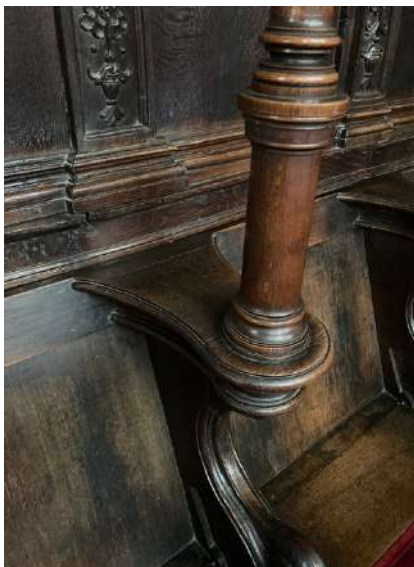
- 12
13 Bay ND, Quire Stalls: Investigate movement in the column shaft between bays six and seven. Remove string/tape from this column shaft to the column in Quire stalls sector NC.

There is a small crack in the narrowest point of the column which manifests as a wobble in the column shaft when pulled in one direction. It was not possible to remove the column from the canopy (due to the round tenon construction at the top), so it was stabilised in-situ by the addition of epoxy resin applied over an animal glue isolation layer.

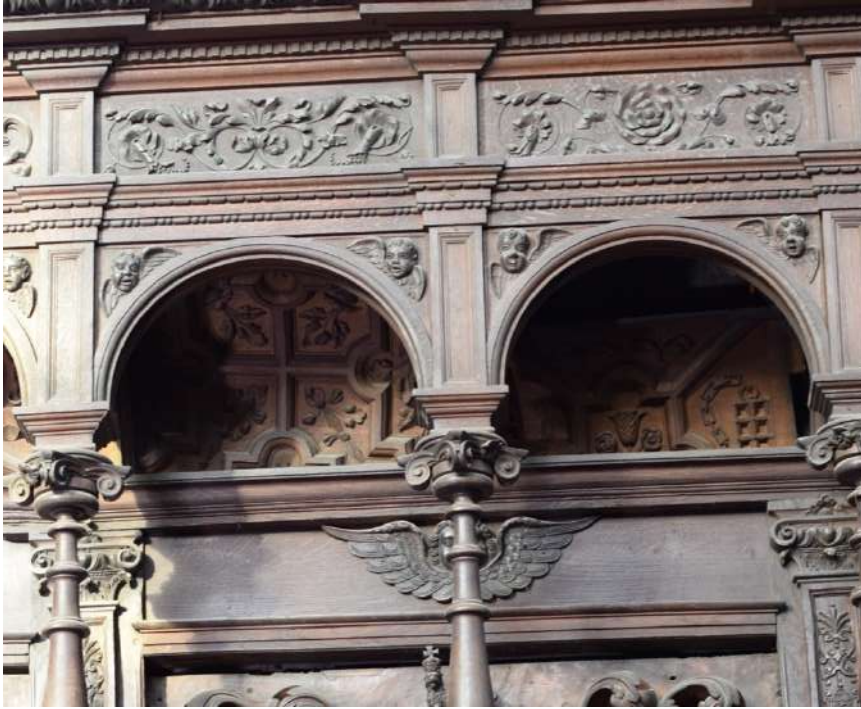
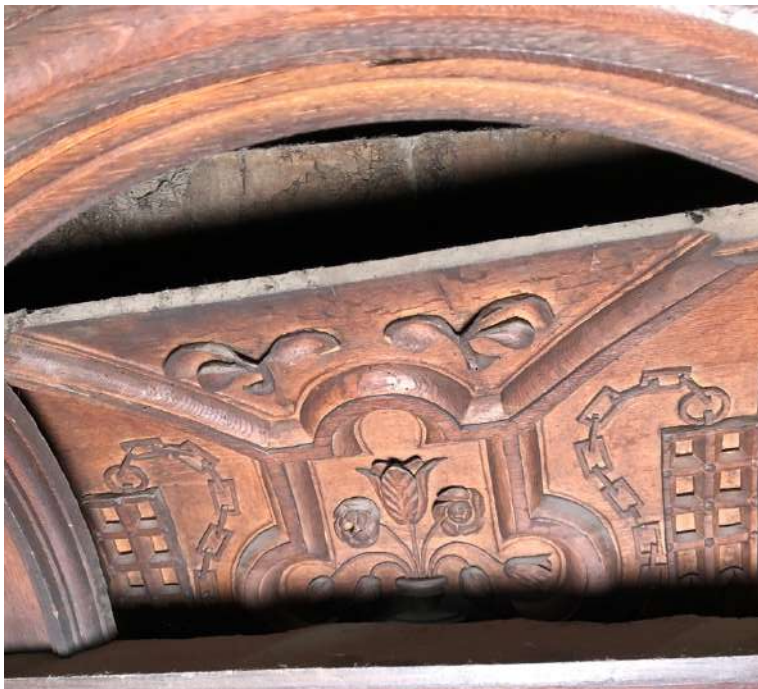
- 14 *Bay ND, Quire Stalls: Check unfixed canopy above quire stall 10 and re-secure. Investigate slipped panel above stall 9 and secure if required.*

Slipped canopy panels

The carved canopy panels are supported on the bottom by the top frieze moulding, simply resting on that and the two arched sides and secured at the top by a nail. The panels had slipped as a large area of the top frieze moulding had been eaten away by furniture beetle. The treatment of these panels was possible as scaffold gave sufficient access to this area. A minimally interventive approach saw the construction of a simple wooden frame that sits on top of the top arms panel rail and provides the correct support along the width of the canopy panel. The top of the new wood was toned out using acrylics. Both panels were supported in this way.

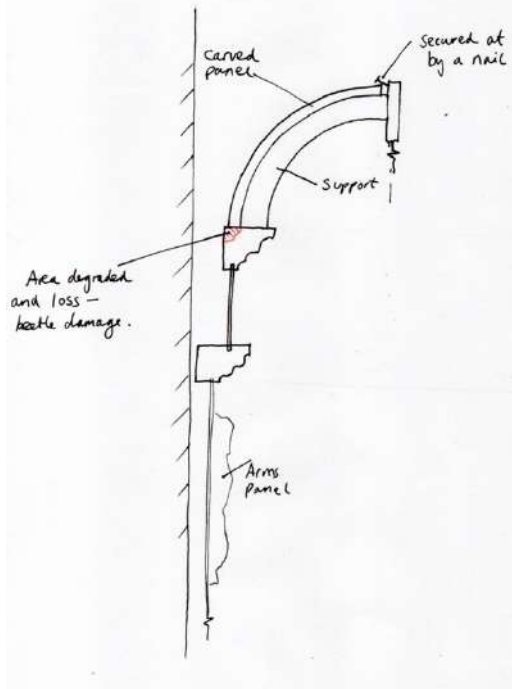
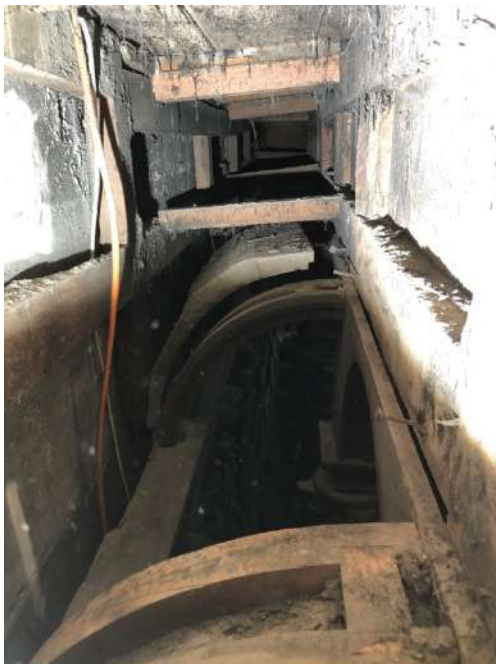
Behind the panelling, with one panel removed.

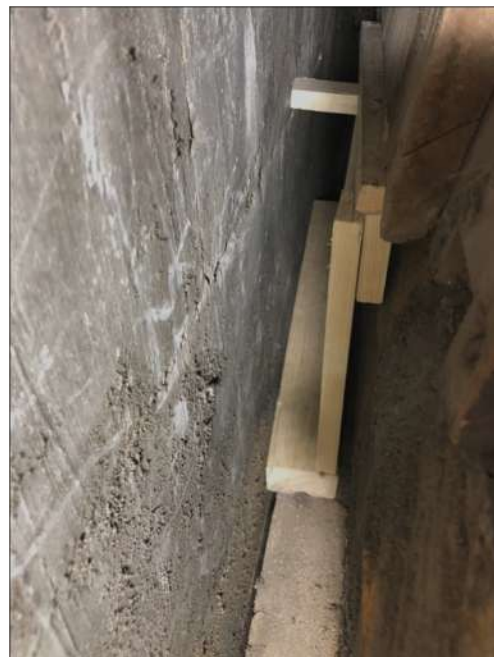
Wooden support in place

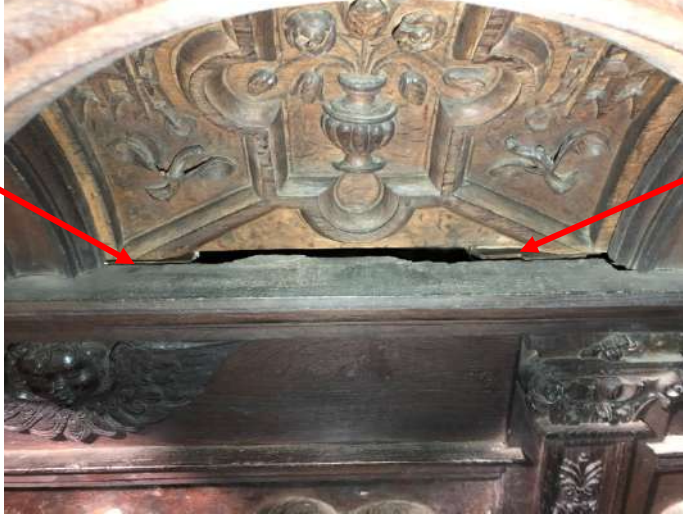
Post treatment supported panel. The loss in the frieze top moulding is evident. New support shown (red arrow)

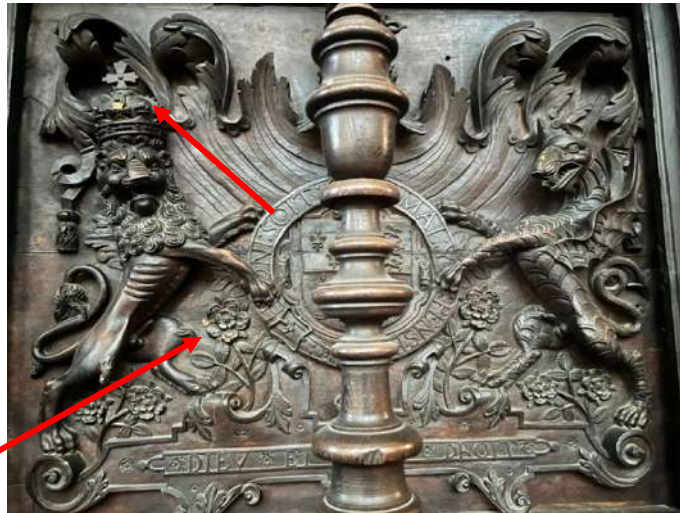
As part of this work all the armorial panels were inspected and there were 25 instances of crumbly carving, degraded by historic furniture beetle activity. These were not part of the initial schedule of work but were added as the areas were particularly vulnerable to damage in the near future (ie they were crumbling away if you touched them). These were consolidated using the same method as described above. The panels were: (Panels labelled 1-15 West to East on both sides, along with associated chapel number.)

Example from L12

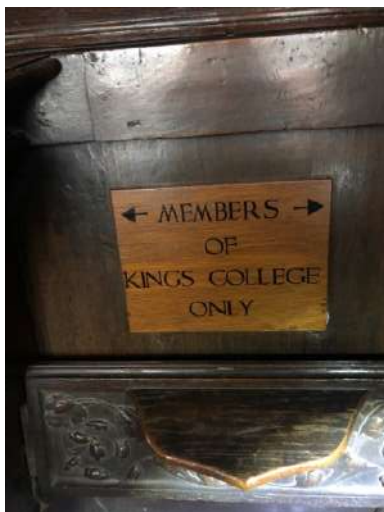
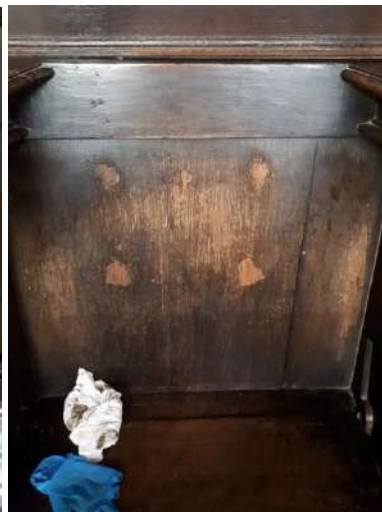
The four “Members of King’s College Only” signs, some of which are attached to the seat backs using blue tac. Successive campaigns of blue tacking has disfigured the surface, pulling of the top layer of finish and become engrained. We removed the blue tac and retouching the damaged areas using shellac and earth pigments.

Damage on stall back, North
Chapel C stall 2

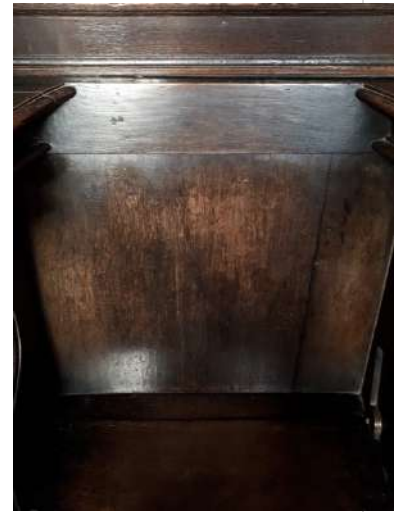
After treatment

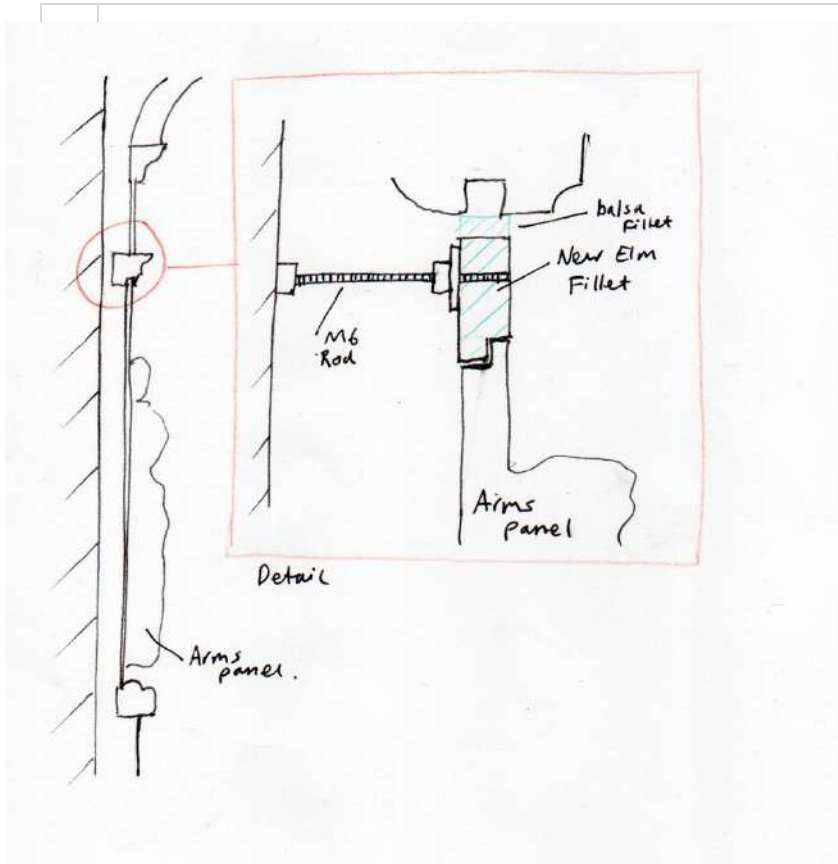
Drawing showing fillet and threaded rod support.

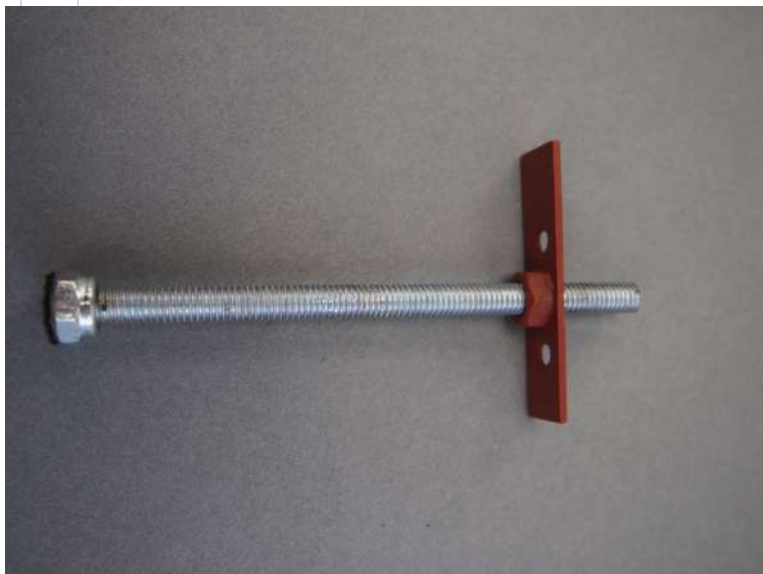
Threaded rod. The red painted element screws to the back of the new fillet. The ni-loc nut at the end makes contact with the chapel wall. It has a felt pad on the end to prevent any scratching of the surface.

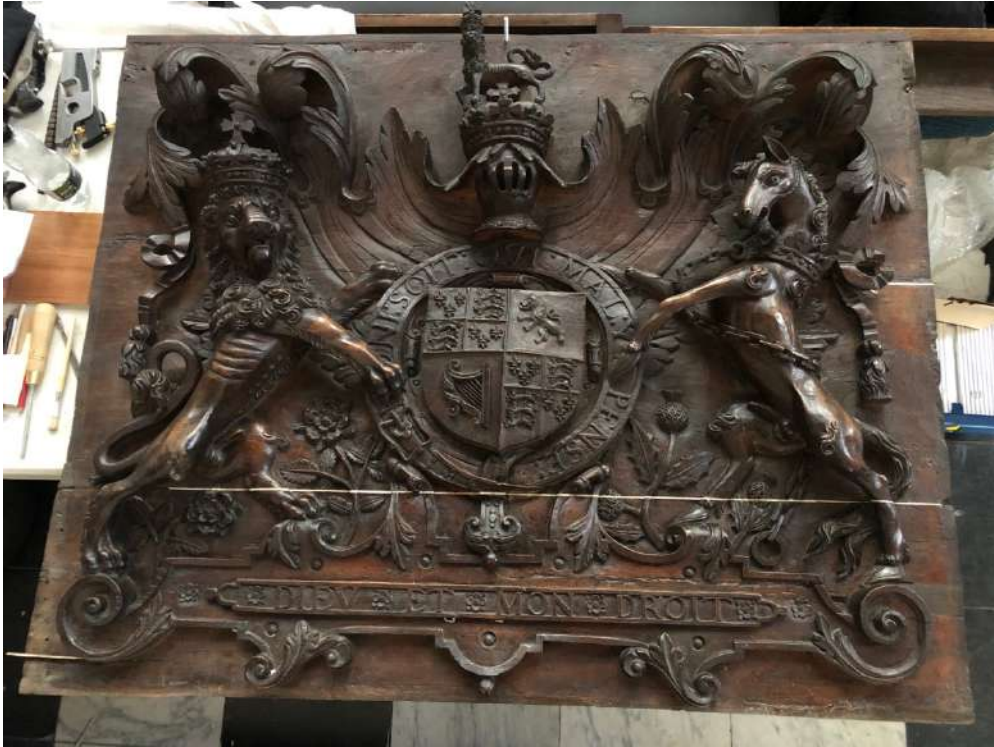
During treatment, the balsa fillet being fitted in the large shrinkage gap on the bottom board.

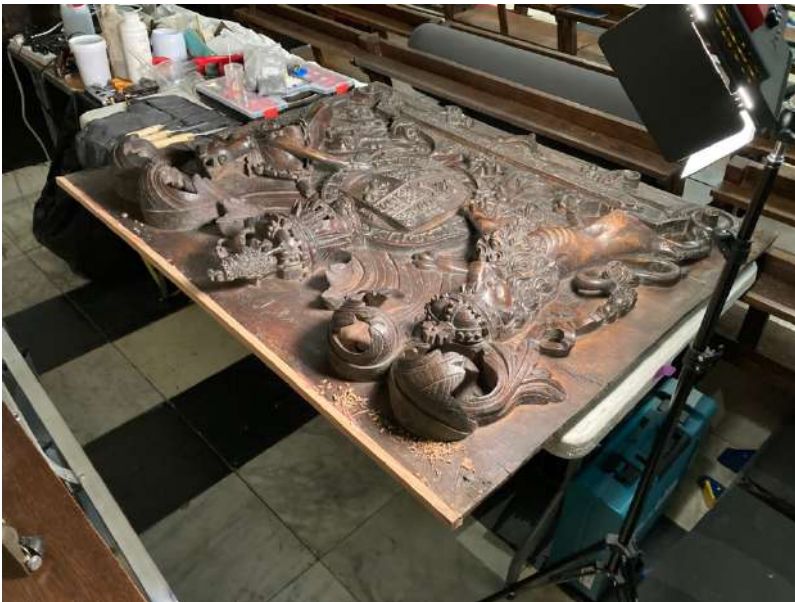
Elm fillet being fitted in position

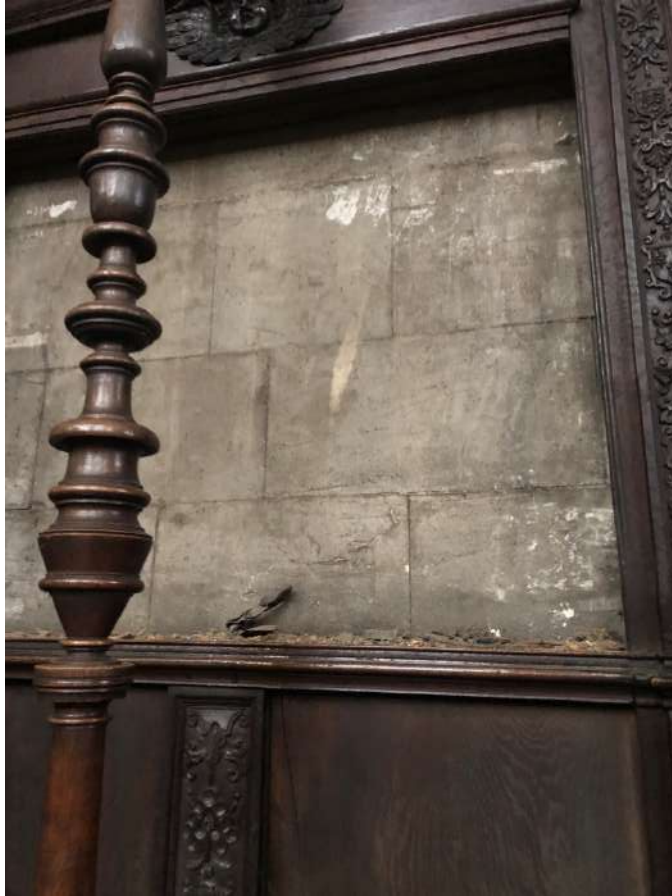
Area with the panel removed. A large quantity of dust was cleaned

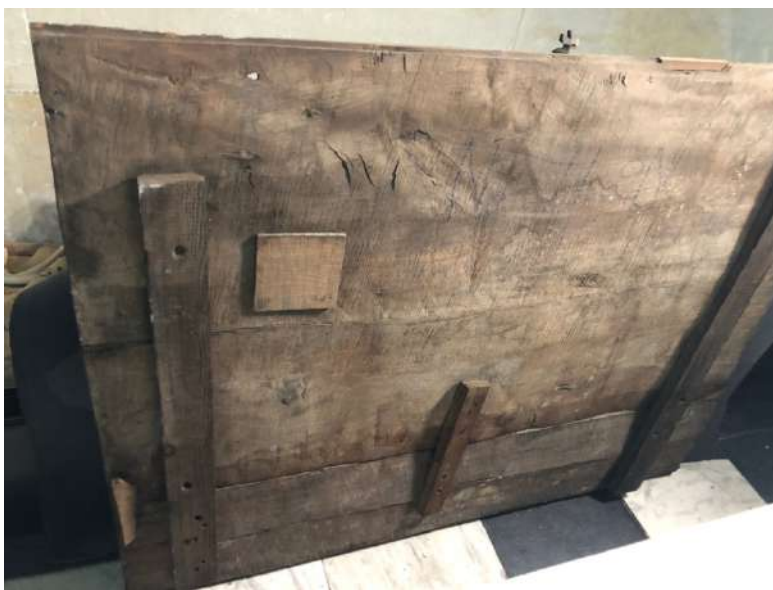
The condition of the back of the panel with various batten repairs

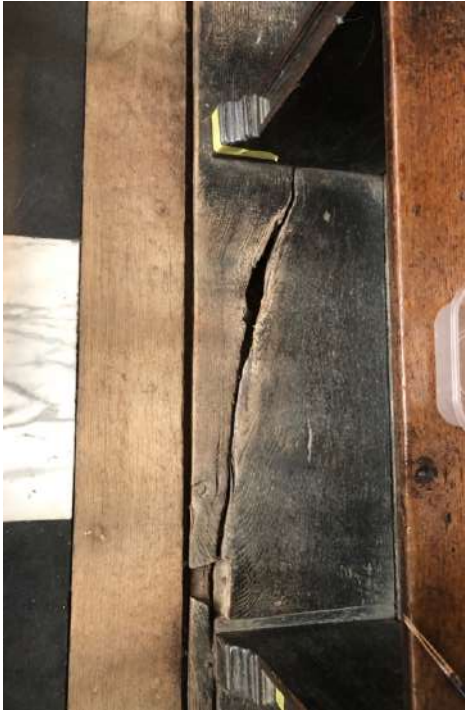
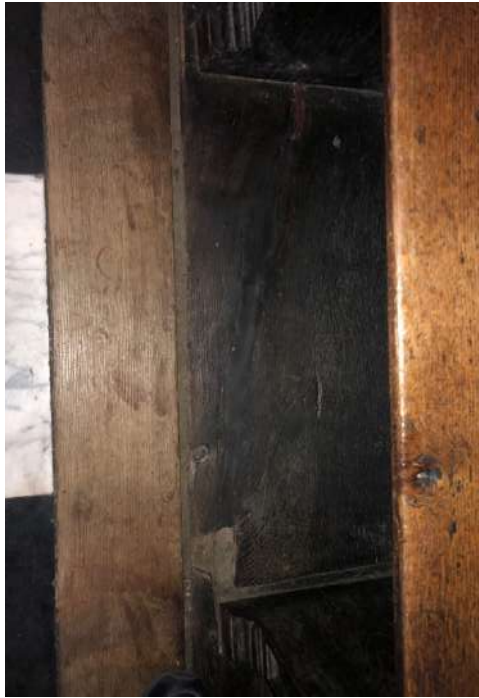
Low Stalls and Choir Benches
21	<p>Bay NE, Lower Quire Stalls: There is a large and wide split in the floor of the easternmost of the north side lower stalls underneath the misericords. Make assessment on whether split can be stabilised or repaired; submit recommendations.</p> <div>

</div> <p>This split looks dramatic but is not a structural issue, the surrounding wood is very solid with barely any movement. It's likely due to an original split or knotted area in the timber which has dropped out and worn over time. The split was filled, mostly for aesthetic reasons, but also to prevent the build-up of dust (and pest potential) and prevent further wear to the area. Rather than a matched solid wood fill, the loss was packed out with balsa wood around 10mm shy of the top surface, and the area coated with a hide glue isolation layer. The final area was filled with an epoxy bulked with microballoons and toned to match using shellac and earth pigments.</p>

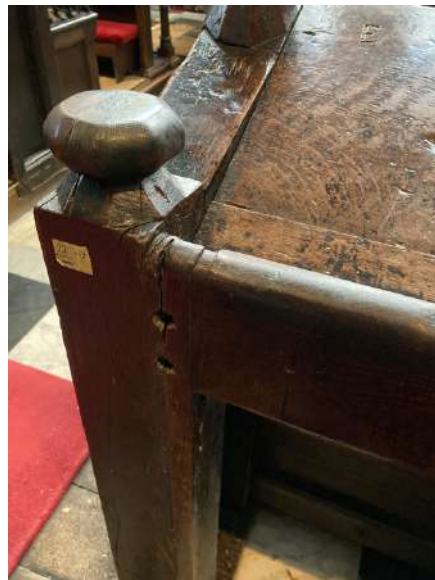
After treatment

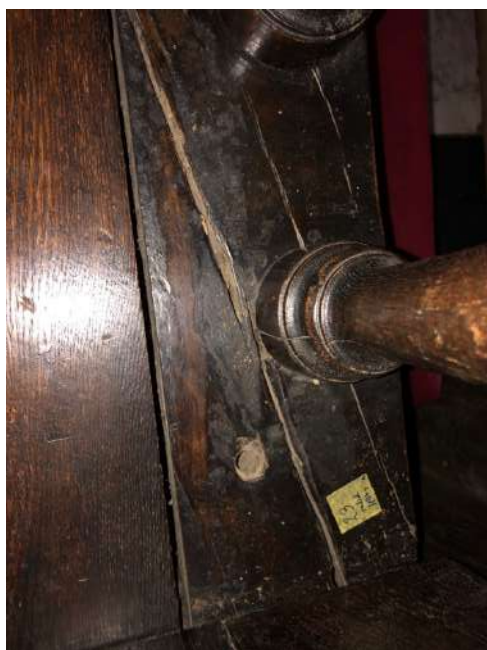
- 23 *Bays NC and ND, Choir 1, north side: Repair deep radial splits in the book board of Choir 1 at its easternmost end, and the further splitting along the length of this section. Locations as shown on the drawing.*

Before treatment

<p>The bottom triangular section of this spit had been previously repaired by way of a long screw. This was removed to facilitate the re-gluing of the loose element. The splits were stabilised using warm hide glue and filled using balsa wood. They were toned to match using shellac and earth pigments.</p>
24	<p><i>Bay NE, Choir 2: Repair split in baluster. Location shown on the drawing.</i></p> <p>The split was re-adhered using warm hide glue.</p>
25	<p><i>Generally, Lower Quire Stalls and Choir 1: Re-fix loose balusters.</i></p> <p>In all 58 balusters across the quire were loose, wobbling or rotating freely within their sockets. Small balsa and beech wooden wedges were used to fill the gaps in the round mortices and secure them. Any visible sections of new timber were toned to match using shellac and earth pigments.</p>

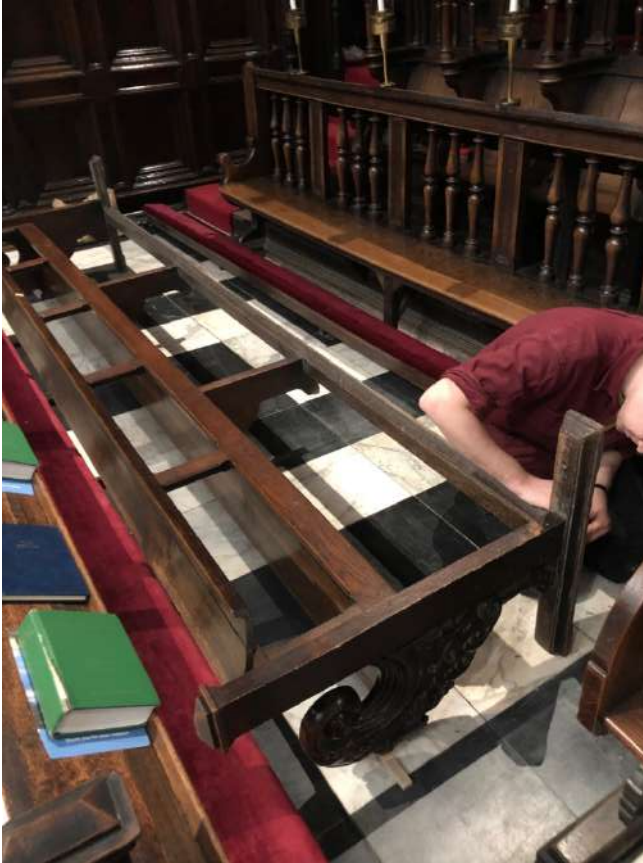
- 27 *Generally, Choir 2 front stalls: Inspect fixings to choir 2 front stalls; identify those which are loose and tighten to improve rigidity.*

The two front stalls on the whole quire were checked, with new animal glue injected into weak joints, existing metal brackets tightened, and repairs made to loose reading desks. There were a number of splits and detaching of lips in the reading desks as they are quite vulnerable and prone to being leant on. Although all loose elements were addressed, an eye should be kept on them in case of future damage.

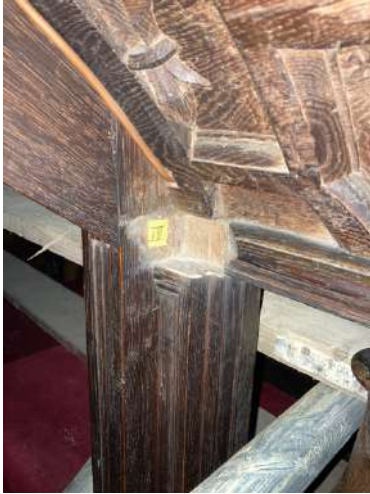
North, Chapel C bay B, loose moulding, low stall (before)
And the same on North, Chapel C bay E low stall

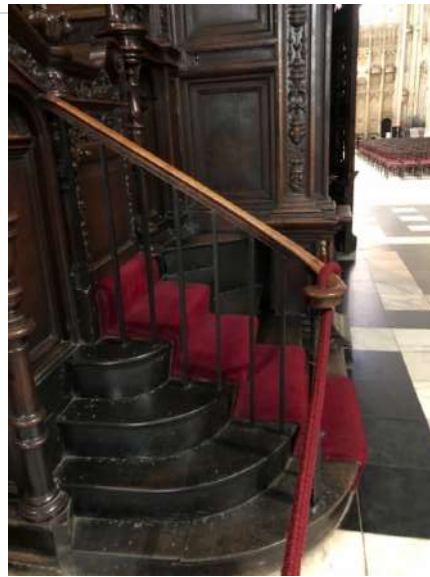
After treatment

The handrail was wobbling at the newel and at the connection to the stalls (a threaded bolt). It was also missing two spindles. One spindle was found in the stalls and re-attached using bulked epoxy resin and steel pins. The missing spindle was made from new quarter sawn oak and re-attached in the same manner. It was toned to match using black light fast stain, shellac and black earth pigment. The metal newel was secured by inserting thin brass shims under the wobbling connection (due to the age and degradation of the screws, removing the plate would have been difficult and damaging). The shims were secured in place with epoxy resin after an isolation layer of Paraloid B-72 20% w/v had been applied to the areas. The nut holding the threaded bolt connecting the handrail to the stalls was tightened.

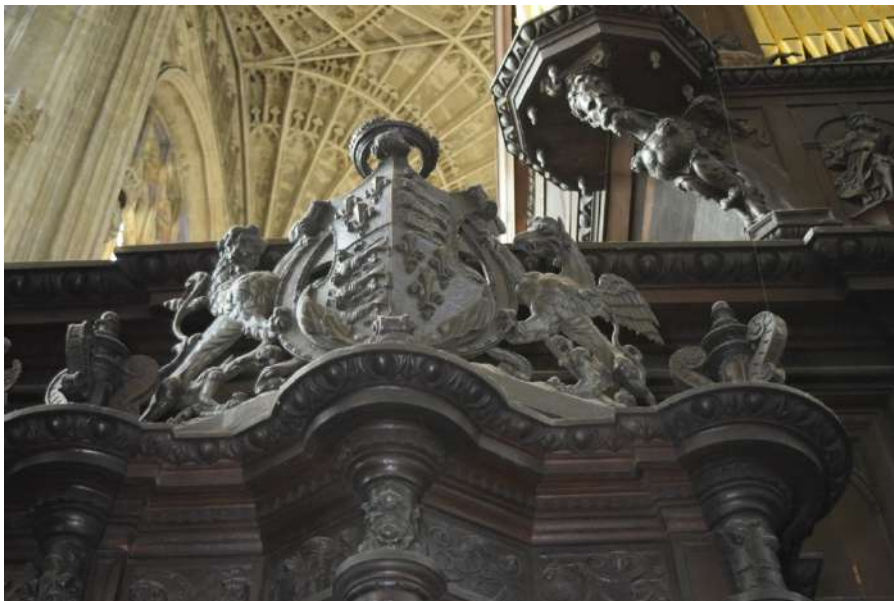
- 31 Bay WO: Record damage to crown surmounting armorial cartouche over Provost stall and consider repair

Discussion on loss replacement in report on future work

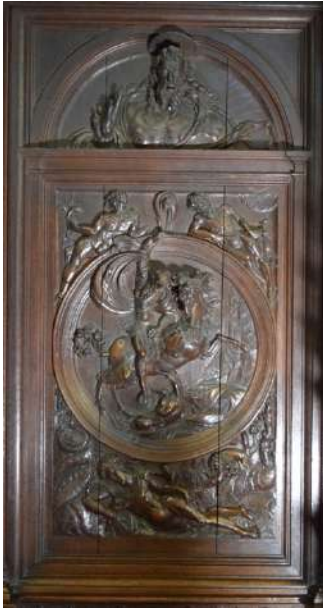
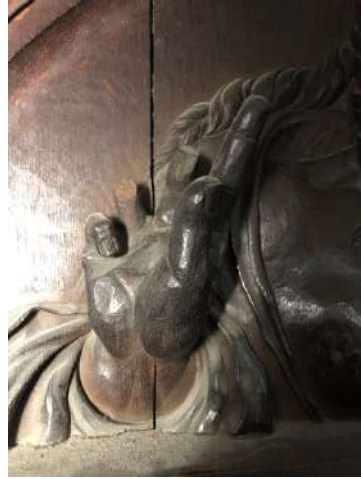
- 32 Bay WO: Consider reinstating the missing elements from the spandrel carving behind the Provost stall.

Discussion on loss replacement in report on future work

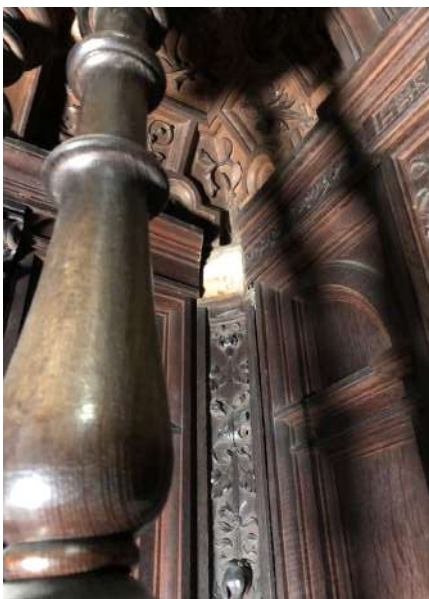
- 35 Bay WO: Reinstale loss to cornice in the corner.
A slightly complex loss as the cornice is adhered cross grain of the pilaster (which is 16th century) and bridges the gap between the 16th and 17th century elements. The cornice profiles between the two are slightly different. A compromise profile was made which is visually not intrusive and was carved out of quarter-sawn English oak. It was adhered using warm hide glue and toned using shellac and earth pigments.

Before treatment

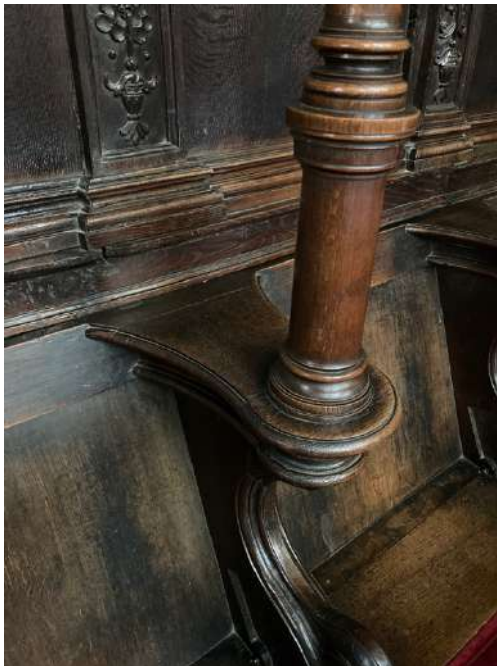
Along with movement in the column, the stall cap on which it sits is loose and has also split along the widest point. These caps are the 17th addition to accommodate the columns and canopy. They fit on top of the standard by way of a dovetail housing joint. As the board is constrained it has split. There is considerable movement in this joint. The cap was pulled out as far as it would go and warm hide glue injected into the housing joint. A balsa wood fill was added to the split, adhered with hide glue and toned using shellac and earth pigments.

Before treatment

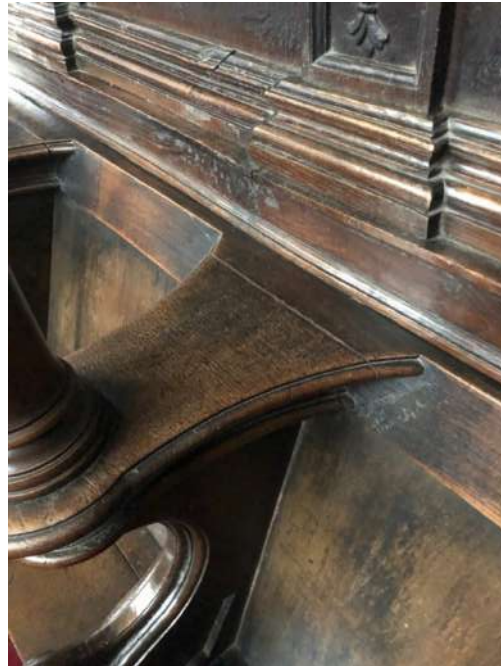
After treatment

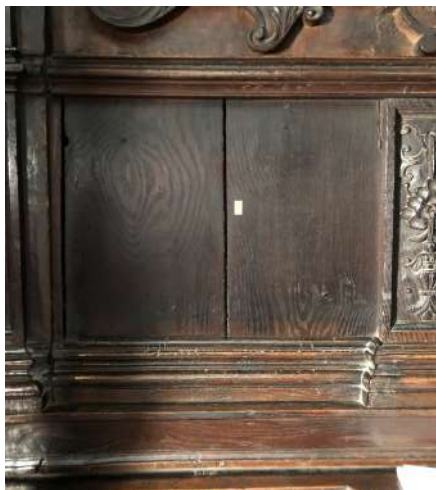
- 37 *Bay SN: Repair split in plain panel below and to the west of Panel B.*

Before treatment

The split and the following three in similar locations were filled using a balsa wood fillet. This was adhered in place using warm hide glue and colour matched using earth pigments and shellac. The use of balsa wood is to prevent future compression set shrinkage splits (see point 3). The fill is aesthetic rather than structural and may appear to open up again in the future (the appearance of the balsa wood being compressed), however this is preferable to a damaged panel which may be the outcome if a solid oak fill had been used.

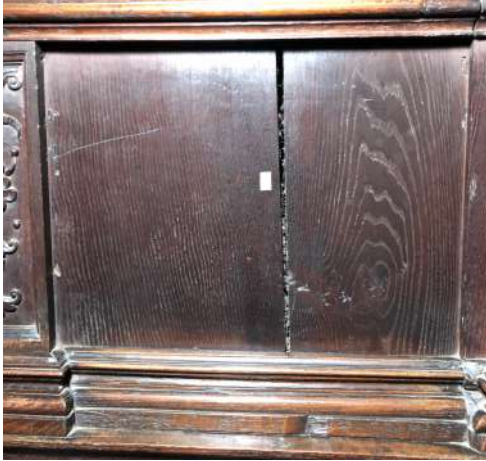
- 38 *Bay SN: Stabilise splits in plinth panels beneath panel D.
See point 37*

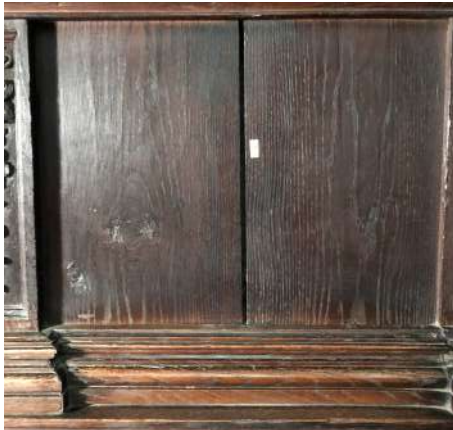
- 39 *Bay SN: Repair large wide split in the plain panel beneath carved Panel E in stall 9.
See point 37*

Before treatment

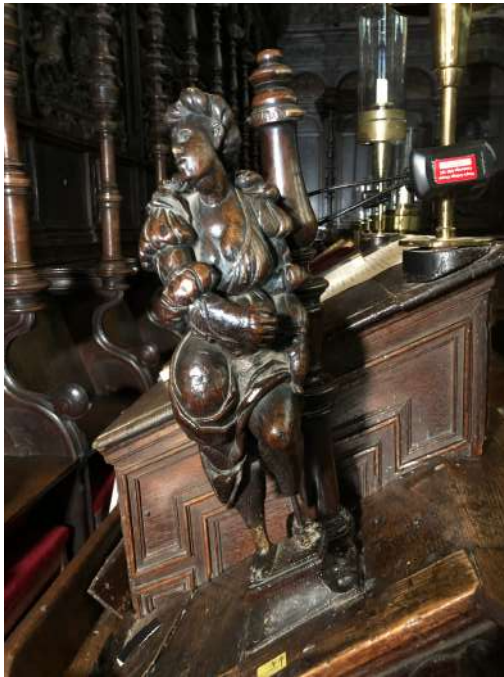
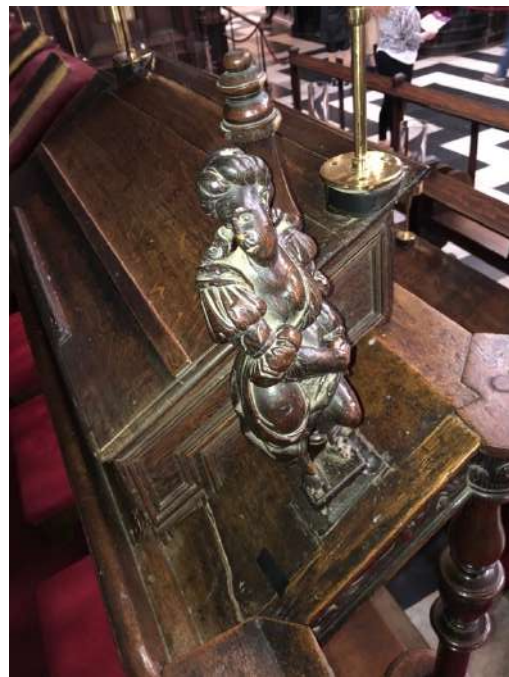
The female figure was loose and detaching from the base. The legs had been previously repaired by the addition of iron rods attaching the upper part of the legs to the base. The losses had been filled with a filler (possibly

linseed oil putty), which was degrading and had fallen out of one of the legs. The surfaces were also heavily encrusted with white dust and embedded dirt. Excessive handling and waxing had caused the surface to appear very shiny on some surfaces, which contrasts poorly with the dirt in the crevices.

Before treatment

The sculpture was removed from the stall by taking out the various screws and nails and softening the glue joint between the stand and the desk with warm water. The surfaces were cleaned using de-ionised water and a non-ionic surfactant. The wax build-up was reduced using white spirit and cotton swabs. The degrading old fill material was removed. The iron rods were effective in securing the sculpture to the base so they were retained and a new fill was applied. The fill material was epoxy resin, bulked using phenolic microballoons. The original surfaces were isolated using warm hide glue. There were breaks and old wood repairs (the back of the thighs), which encapsulated the iron rods. These were retained as evidence of historic repair and use. The new fills were designed to be visually unobtrusive and provide a structural support but given the state of the old repairs there was not enough evidence for an accurately carved fill, but the treatment here doesn't prevent that from happening if desired in the future. The new fills were toned to match using shellac and pigments, the gloss modulated with wire wool and an application of paste beeswax.

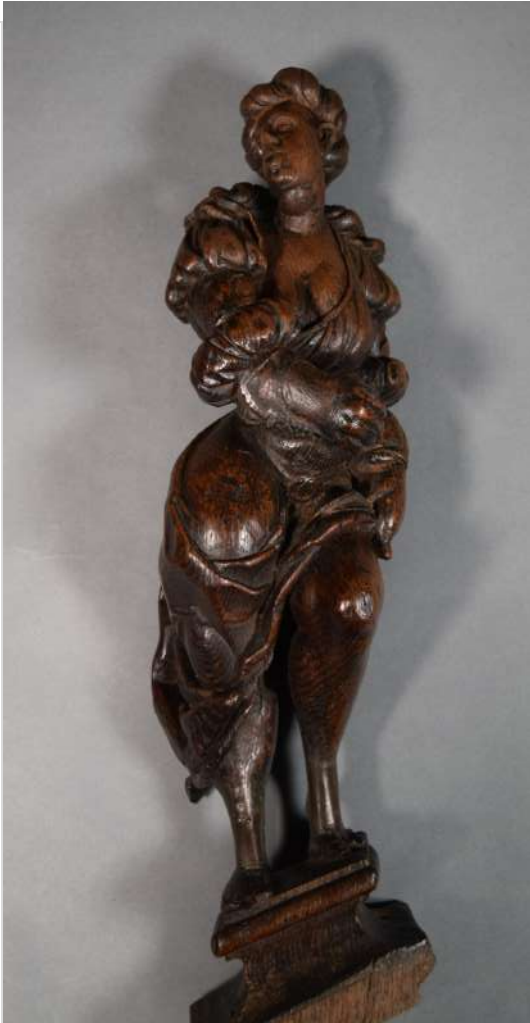
After treatment (pre re-attachment)

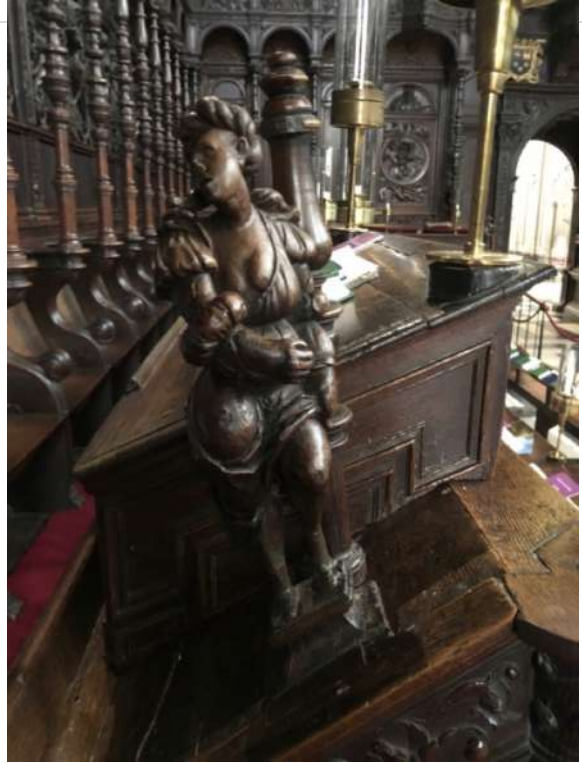
After treatment

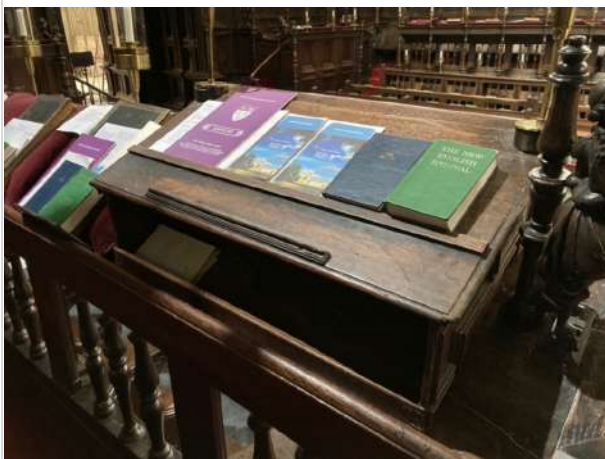
The wobbling raised riser (reading stand) in this point was repaired by the addition of two oak strips, adhered using warm hide glue to the underside short sides and toned to match using shellac and earth pigments.

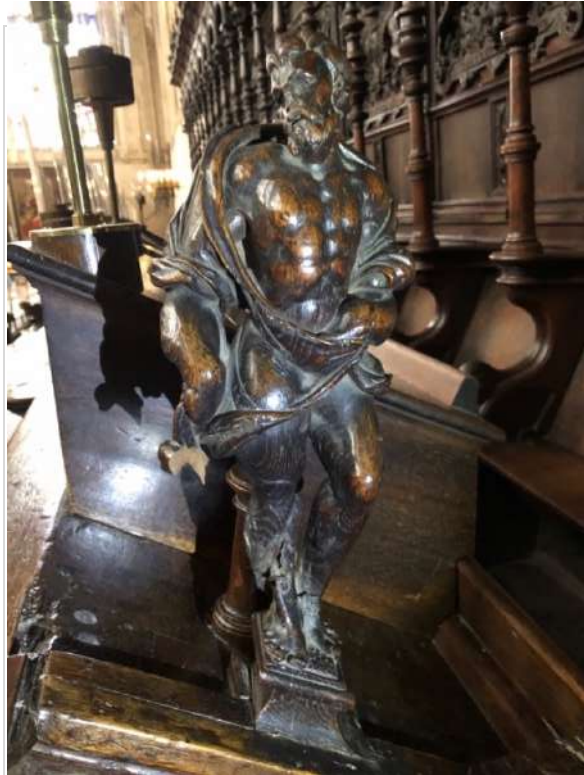
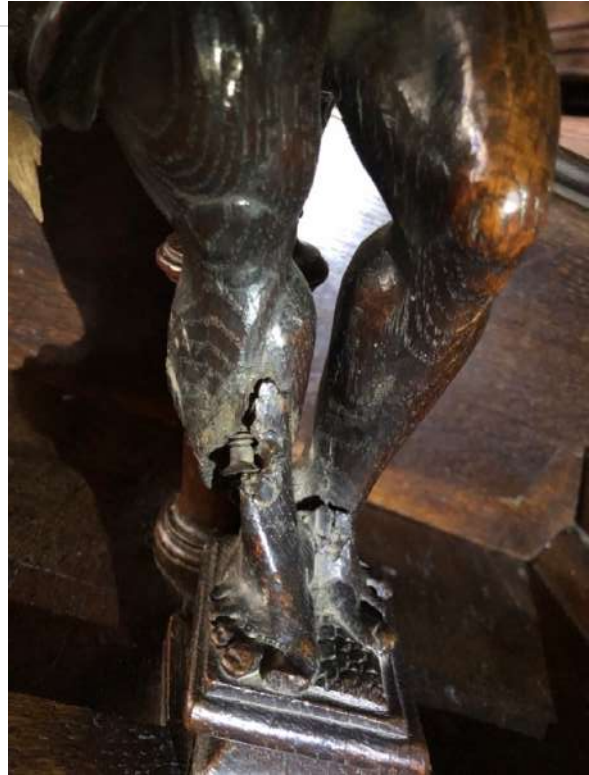
Before treatment

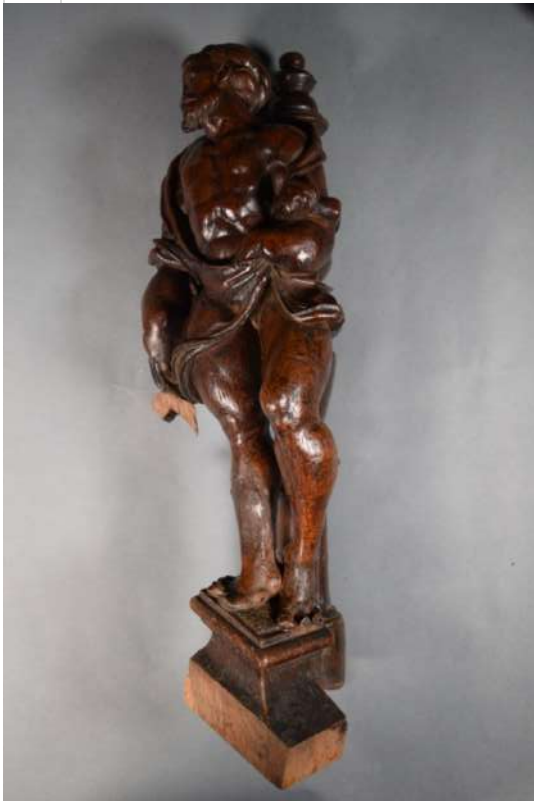
After treatment, before re-attachment

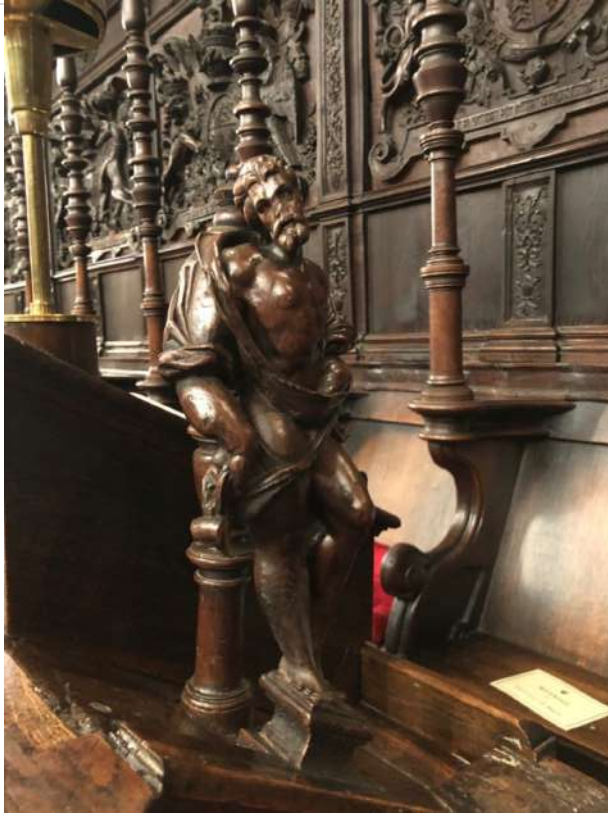
After treatment

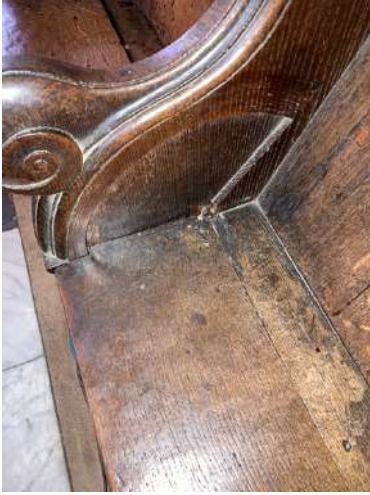
<p>In this instance the square housing had worn out of the standard and abraded the surface around it. It was moving fairly freely, but due to the geometry of the board and hinge it could not be removed. It was possible to fix the housing in place, isolating the surrounding timber with animal glue and providing a bulked epoxy fill to secure it.</p>

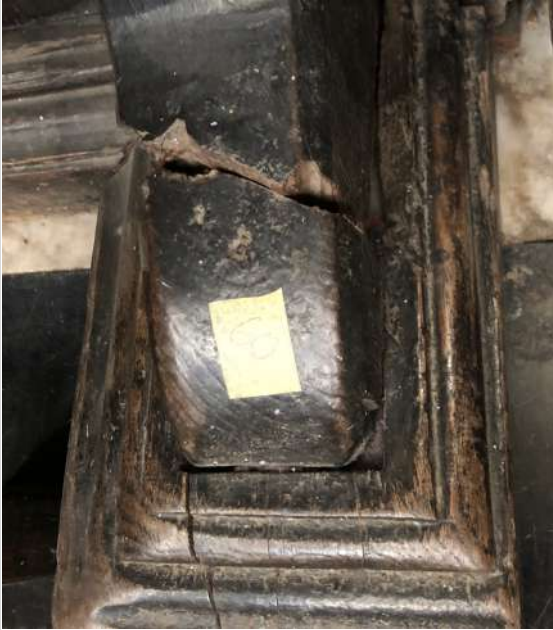
Before treatment

same level. It was re-attached using warm hide glue. The losses in the foot were filled with epoxy bulked with microballoons and toned using shellac and pigments. The original surfaces had hide glue isolation layers.

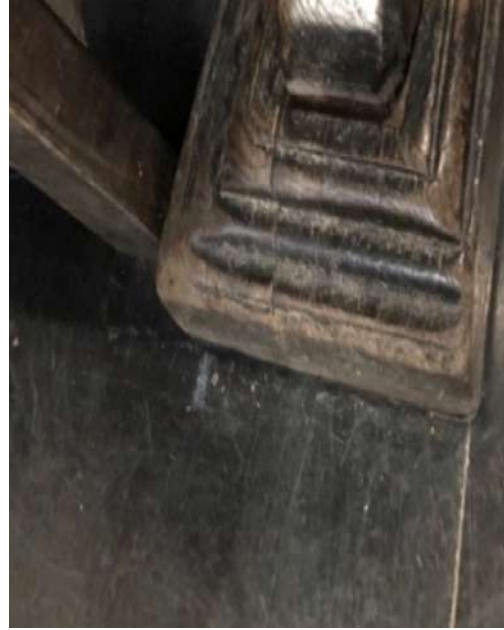
After treatment

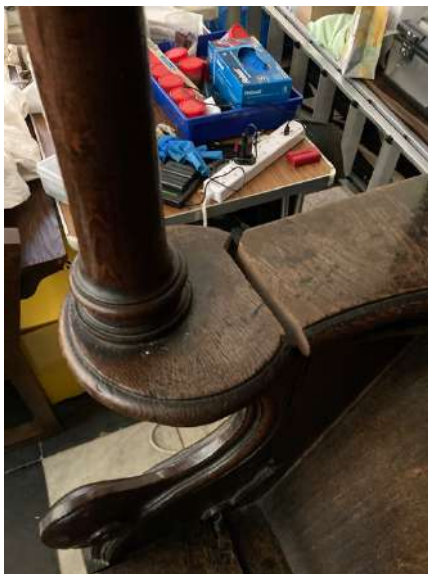
58 *S Chapel L, low stall*

Similar to the issue noted in point 36 the top of the standard with a wide split across the grain. As the cap piece is well jointed to the top of the standard it isn't a major structural issue, although the column section can be pulled out some 10mm away. The gap was extended, cleaned and re-adhered using warm hide glue and a balsa wood fillet inserted into the gap. It was toned with shellac and pigments.

During treatment

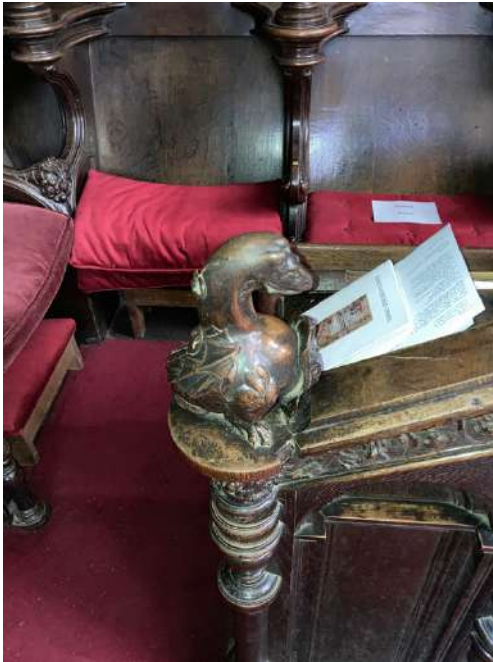
S, Chapel N West Side figure and column

All the carved figures were checked and 6 were loose and requiring securing. In most cases this was achieved by injecting warm water into any potential glue -joint areas and wiggling the sculptures to allow for penetration of adhesive. The joints or cracks were then injected with warm hide glue. The beast sculptures (S Chapel N, high stall) are a continuation of the wood of the column on which they sit (ie. They're not carved separately and attached), which not only is evidence of highly skilled carving, but makes good structural sense as there is no glue joint to fail. This is the same for the small plinths for the figure sculptures on the West stalls – the plinth and sculpture are carved from a single piece of wood.

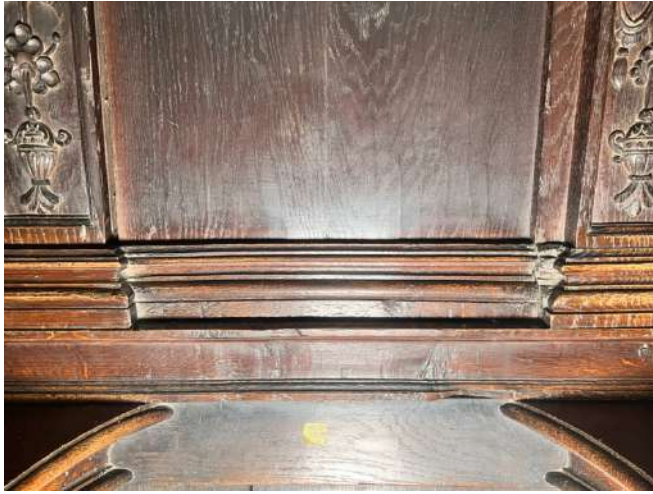
Moulding (red arrow)

These mouldings, a continuation of the attic base of the pilasters, are part of the 17th century work. They are interesting as they're not properly attached to the stalls and the corner returns on one side are mostly unfinished and cut very crudely. They're attached on the sides by way of 1 or two nails and then glued to the panel on the back. A glue joint where the grain of the two pieces go in different directions is not a happy one and consequently 36 of the mouldings are loose and detaching.
