Treatment Report King's College Chapel Joinery

Kings College Chapel
Kings Parade
Cambridge
CB2 1ST

1 June 2023

Conservator: Tristram Bainbridge ACR

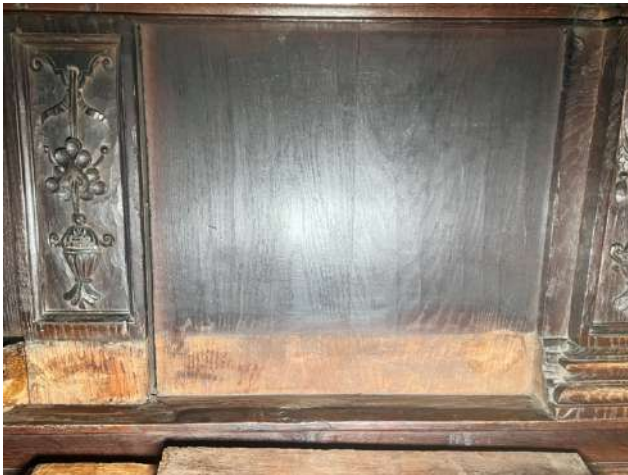
Mouldings removed and surfaces cleaned for re-adhesion.

The loose mouldings were encouraged further to come away to enable cleaning of the glue joints. Dust was vacuumed away and old animal glue softened using water thickened with Laponite (synthetic silicate). They were re-adhered along the bottom and sides using warm hide glue.
