BAINBRIDGE CONSERVATION

Report and Proposal Kings College Chapel joinery

7 June 2023

Kings College Chapel
Kings Parade
Cambridge
CB2 1ST

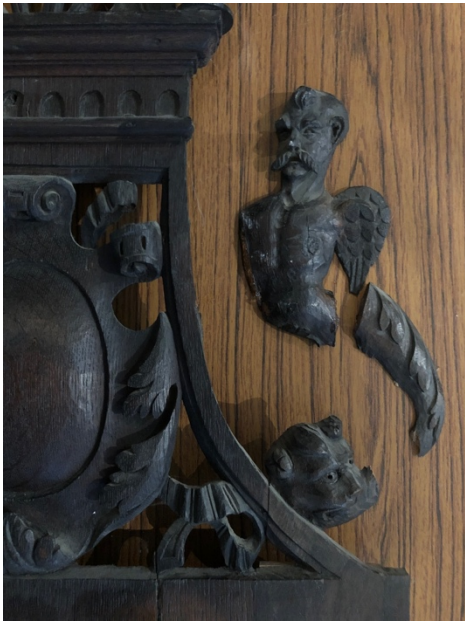
A. The urns and cartouches on the top of the canopies have various losses and detaching elements. The cartouches were last worked on in 1950, when it appears they were all re-attached to wooden battens that are screwed and glued along the bottom of the cartouche and then screwed to the top board of the canopy. The cartouche is made from a single board and the problem with the '50s gluing and screwing method is that it constrains the board across the grain. This has resulted in compression set shrinkage splits along the grain on many of them. Three cartouches were treated as part of this trial. In one example the carved figure is detached in 2 parts. This was re-adhered using warm hide glue and a bulked epoxy over hide glue isolation layer. An additional oak fillet was adhered along the back of the break using warm hide glue.

Some of the cartouches are loose, some detached altogether and some of the small turned urns on the tops are missing. Although the general propensity of the cartouche elements is to fall on to the top board, it is not impossible for them to fall down into the quire, so checking and stabilisation of all is recommended.

Before treatment detail

Detached but extant elements may be re-attached, wholly missing elements may be re-carved to the extent that the loss is noticeable from ground level. There are around 30 missing pieces – some may be extant; most are the small turned urns. There were also other loose elements in this whole high-level area – the winged angel heads on the frieze are nailed on and some appear to be detaching, and some of the applied mouldings in this area are also loose. It's not possible to tell the exact condition of every element without close inspection, but from ground level viewing combined with the trial treatment, we have a good idea of the amount of work required.

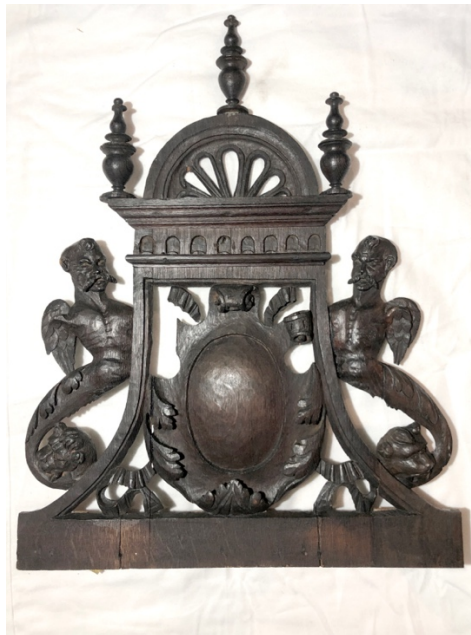
After treatment

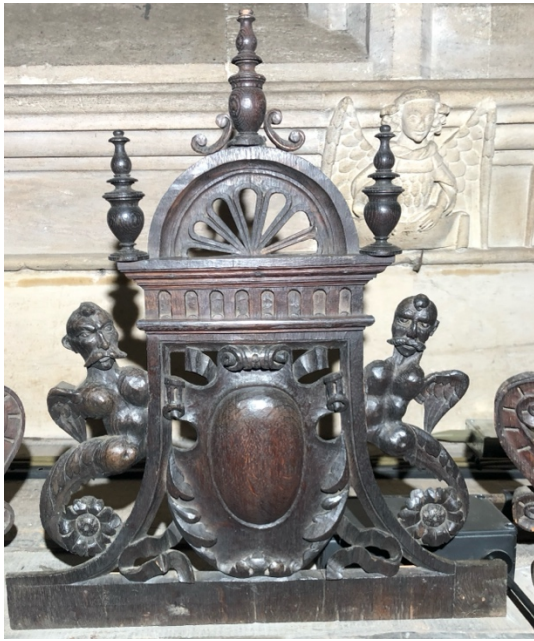
Trial bay cartouche after cleaning

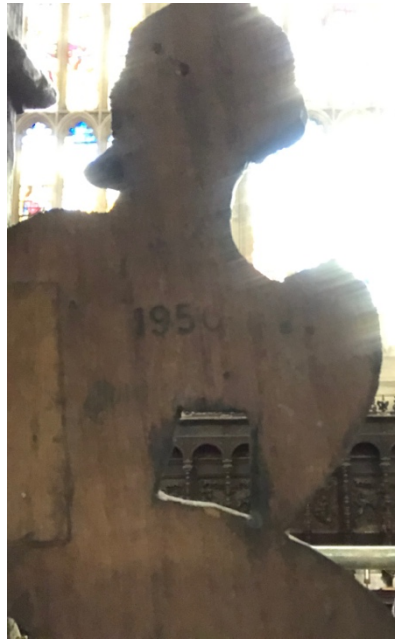
reverse of object left replacement figure, stamped '1950'

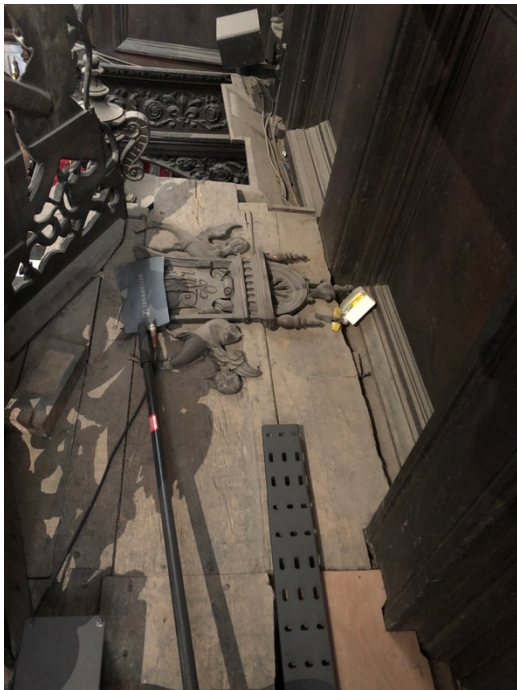
One of the fine 16th century cartouches detached on the west screen. AV equipment on top (may have been the culprit)

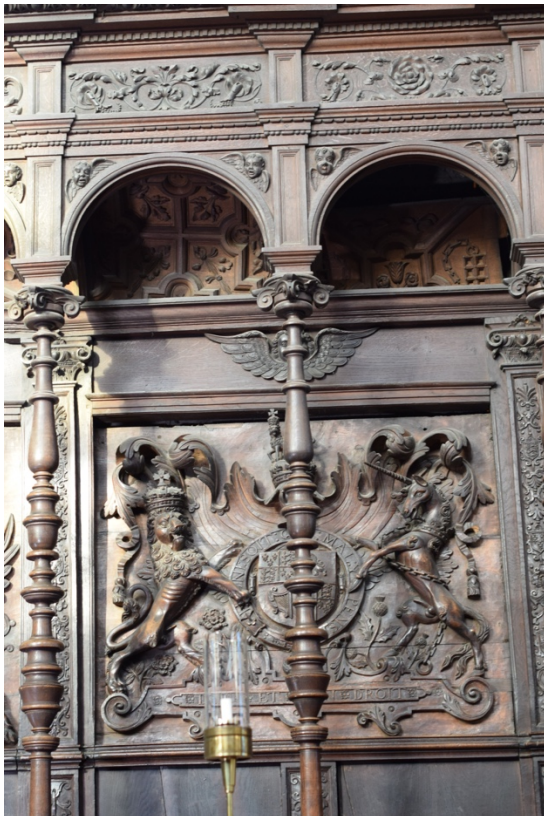
Detail before treatment

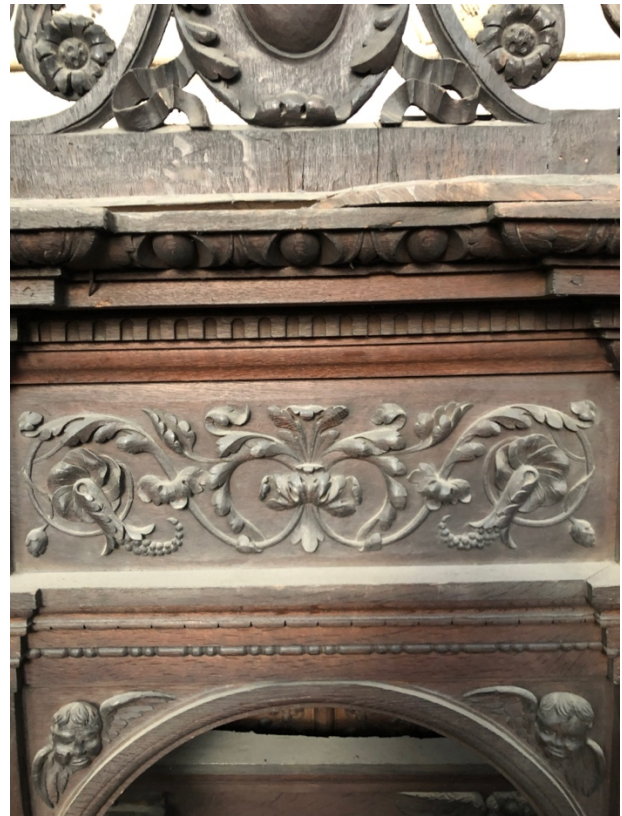
The surfaces were very dusty. There have also been various campaigns of darkening through the application of dark waxes, and possibly stains. The low-level surfaces (especially the panelling above the stalls), are very dark. This is most likely caused by the repeated application of furniture polishes and possibly a linseed oil-based reviver (which darkens with age).

Dust on surfaces before treatment

The surfaces were first vacuum cleaned and then ingrained dust was removed using deionised water and a cloth / cotton swabs. The addition of surfactants did not make any difference to the efficacy of the cleaning. There was no colour change to the surfaces, although some areas of the carving appeared brighter and glossier as old wax finishes were buffed. Careful inspection of the treated bay can show the difference – the finer areas of carving are more visible and the grey haze of the surface dust is now gone. However, the change in appearance is not dramatic. There are sound conservation reasons for the removal of dust, as over time it can become bonded to the surface and become increasingly difficult to remove. I would recommend this procedure be done to the whole quire.

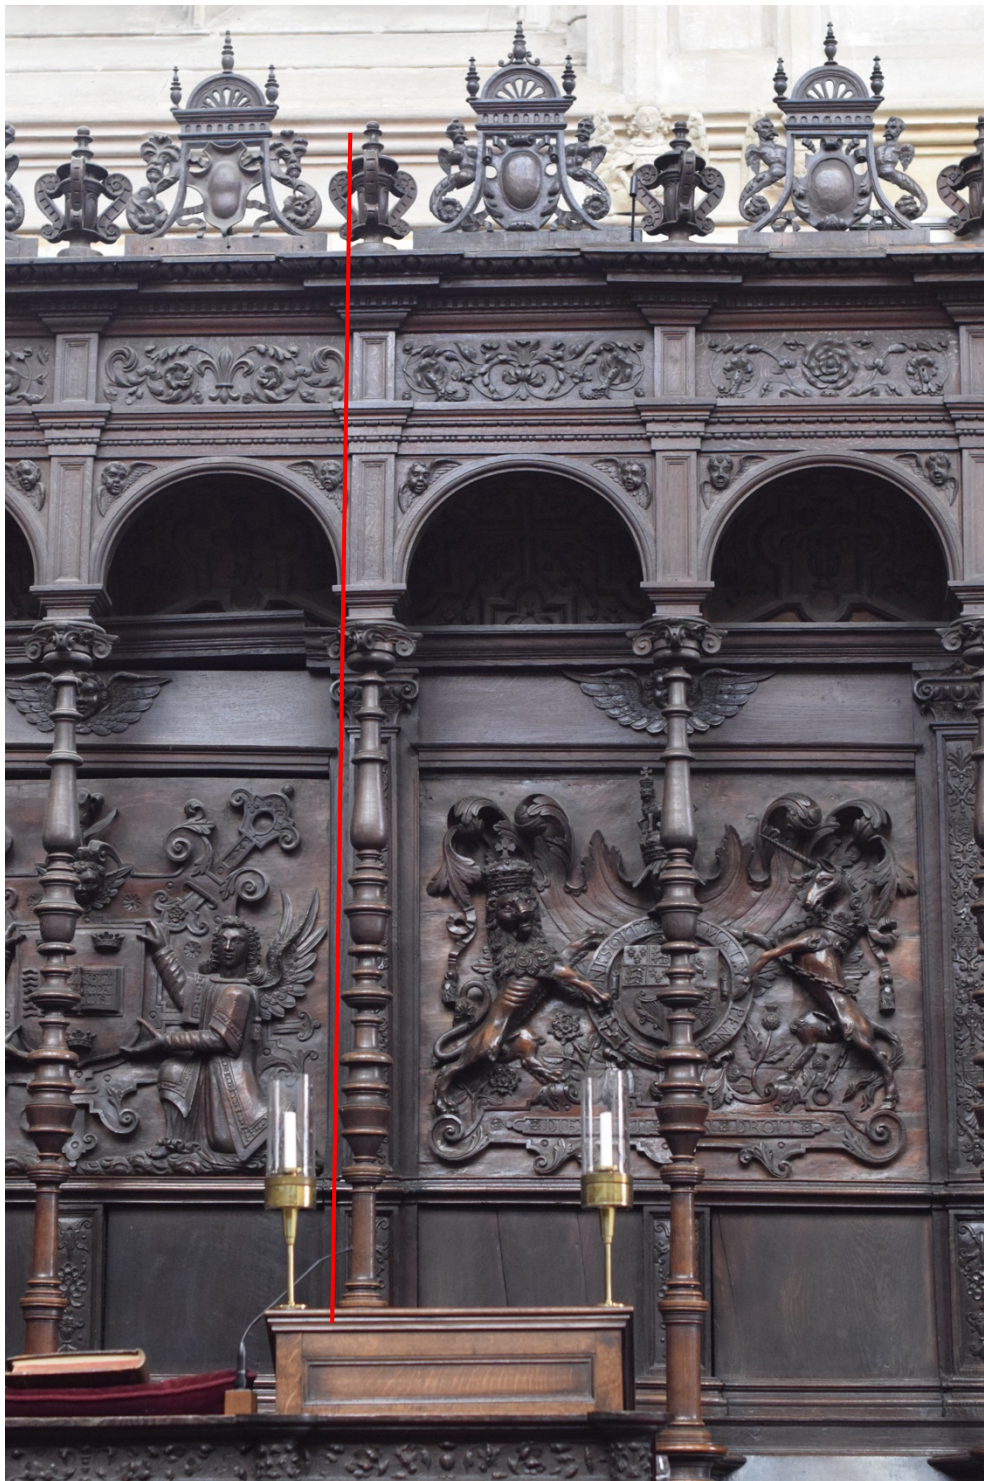
Cleaned bay after treatment (right of red line).

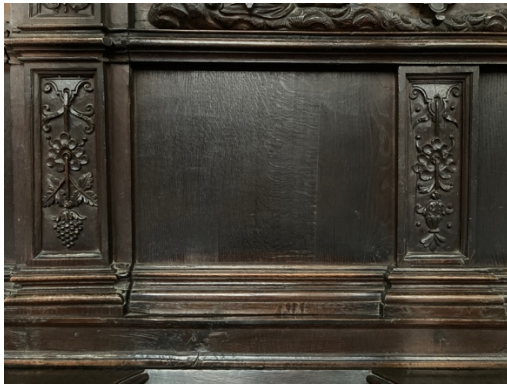
Typical dark colouring of the lower area

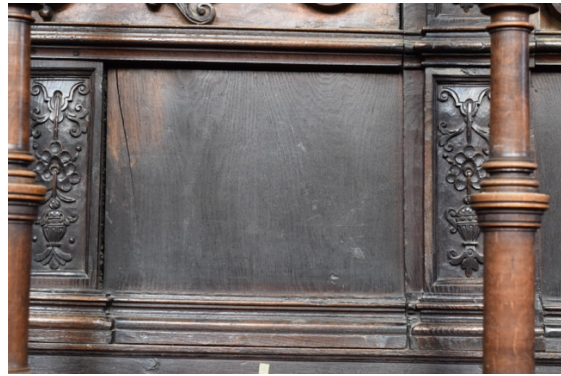
Some tests were done on the dark low-level panels and areas. Compared to the higher areas these are so dark the wood grain is almost obscured. Although some cleaning trials in the past had removed all surfaces and revealed a very pale wood surface (see Hugh Harrison report 2013) it a very dramatic change in appearance that would be hard to make a good conservation argument for doing. I used denatured alcohol and white spirit in various permutations, with cloth application and light abrasion from very fine wire wool to try and create a surface that was more closely matched to the higher areas. Although it is technically possible to create a lighter surface, it is very time consuming. Replicated in this area over the whole quire it would be prohibitively expensive to do and not justifiable given the greater conservation needs of the quire. The lightened test areas were returned to their previous state using lightfast stain and paste wax.

Trial lightening of top left corner

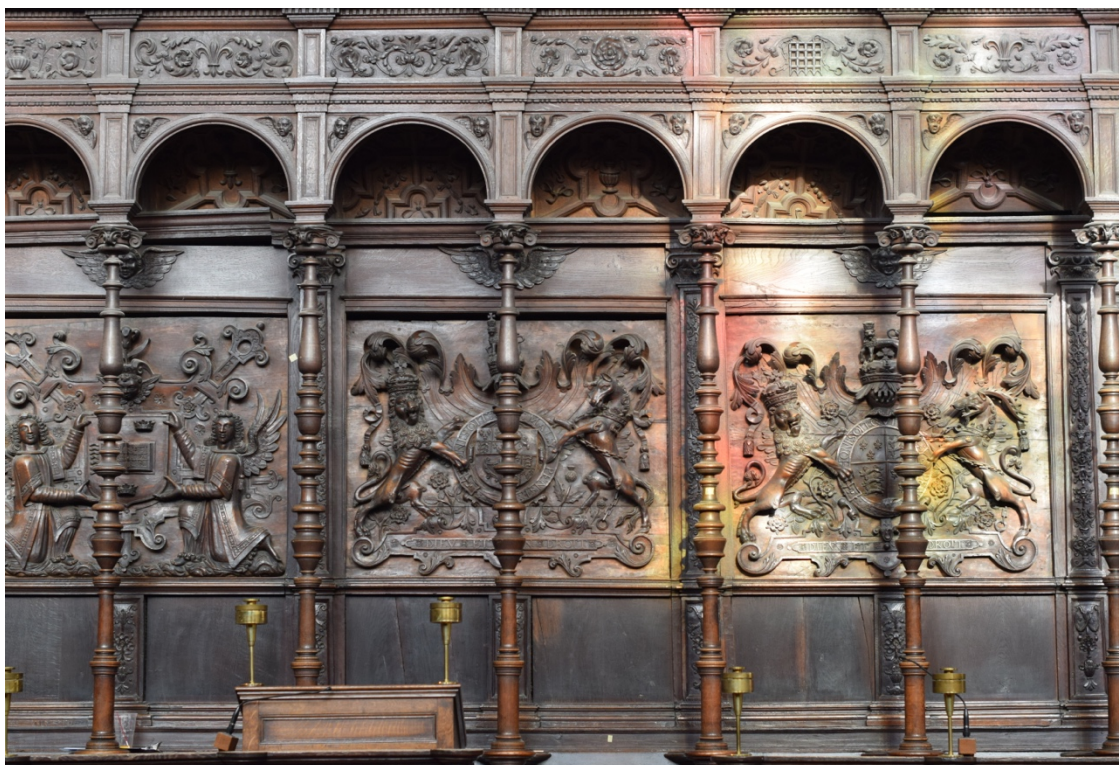
Trial lightening seen in middle panel (and opportune sunlight through the stained glass), the general darkness of the bottom panelling compared to the other areas is apparent.

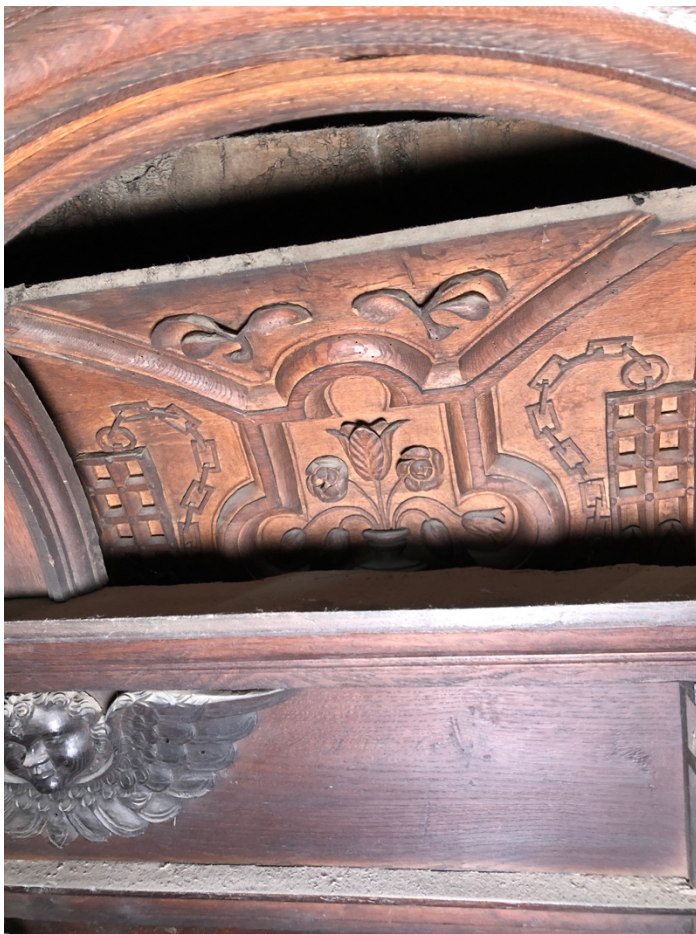
The detail of the treatment is outlined in the treatment report. As one of the canopies also slipped during cleaning (it was barely holding on), it is possible that other canopies in the quire are at risk. Although the cause of the slippage was a specific case of woodworm damage, it is possible it may occur elsewhere in the quire. At least one other canopy panel is slipping so an allowance should be made for checking and securing the others.

Slipped canopy panel in the trial bay, before treatment

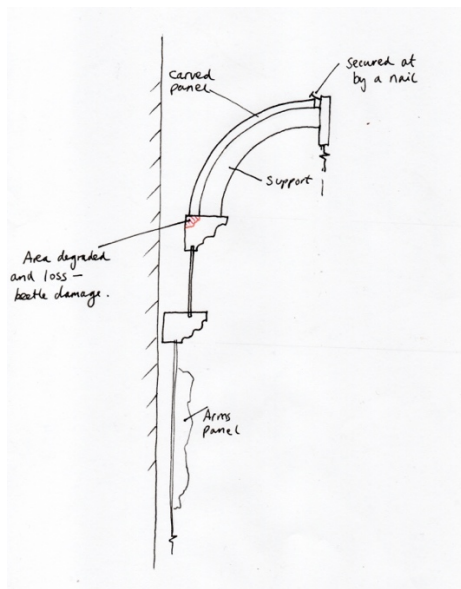
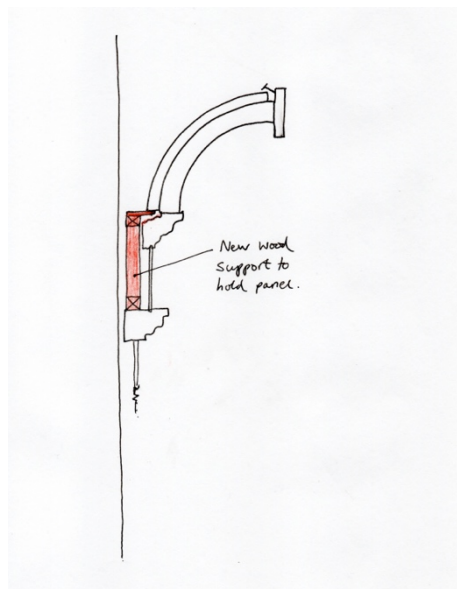
Method for supporting slipped panels

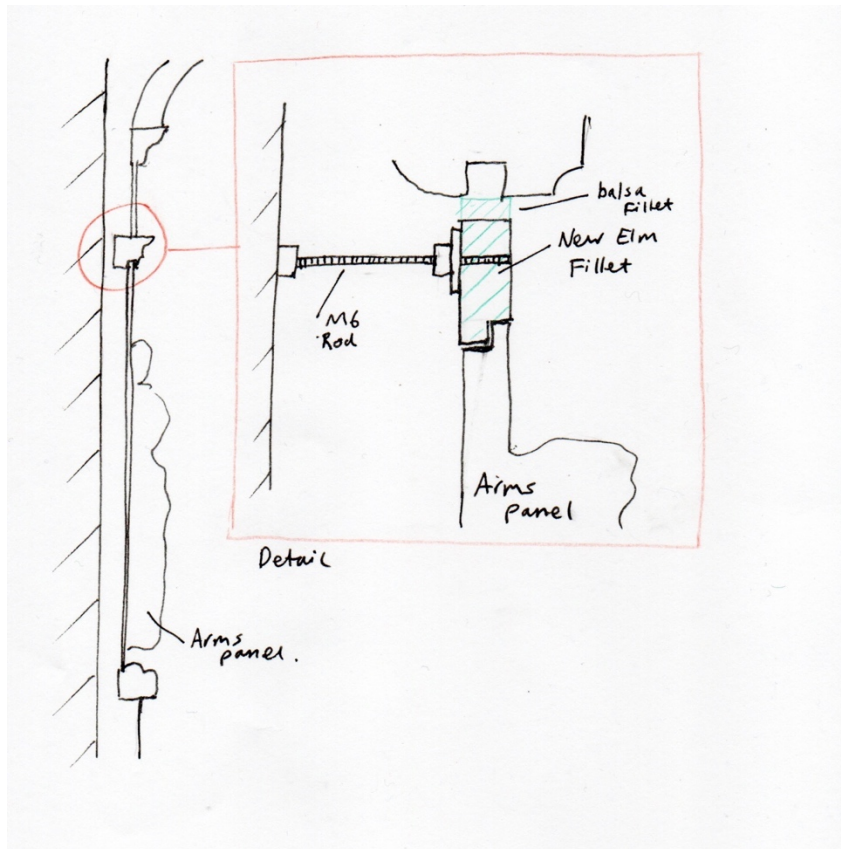
Drawing showing fillet and threaded rod support.

English elm wood was sourced and a replacement fillet cut to fit into the top rebate of the panel. The original surface was prepared with an isolation layer of warm hide glue and Japanese tissue. The elm fillet was attached using epoxy bulked with microballoons. The isolation layer means that the fillet may be easily removed in the future without damaging the original material. A 6.5mm hole was drilled in the middle of the fillet to accommodate a M6 threaded rod, brazed to a small threaded plate which was screwed to the reverse. A slot was cut into the end of the rod to allow it to be screwed against the back wall, pushing the panel into the right position and preventing further movement. Once in position the hole was filled with an elm wood plug. As a 10mm gap had to be left at the top of the panel to allow it to be moved back into position, the gap was subsequently filled with a balsa wood fillet and toned to match using shellac and earth pigments.

The technique worked well and the panel is now stable. If it is done to the other panels I would use two threaded screws rather than one central one to make it a bit more secure and easier to make adjustments.

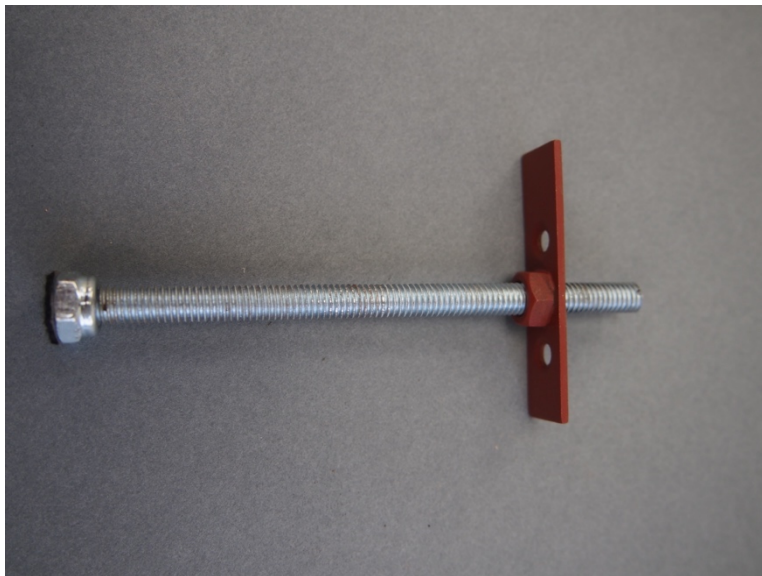
Threaded rod. The red painted element screws to the back of the new fillet. The nyloc nut at the end makes contact with the chapel wall. It has a felt pad on the end to prevent any scratching of the surface.

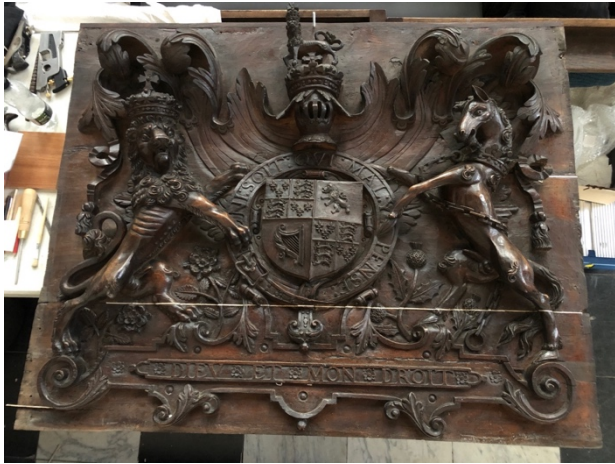
During treatment, the balsa fillet being fitted in the large shrinkage gap on the bottom board.

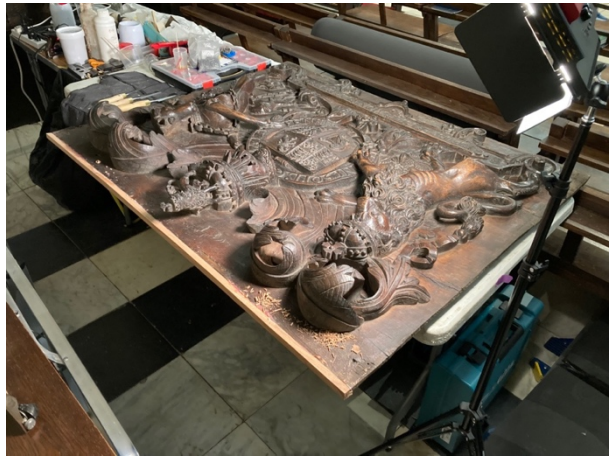
Elm fillet being fitted in position on top of the panel.

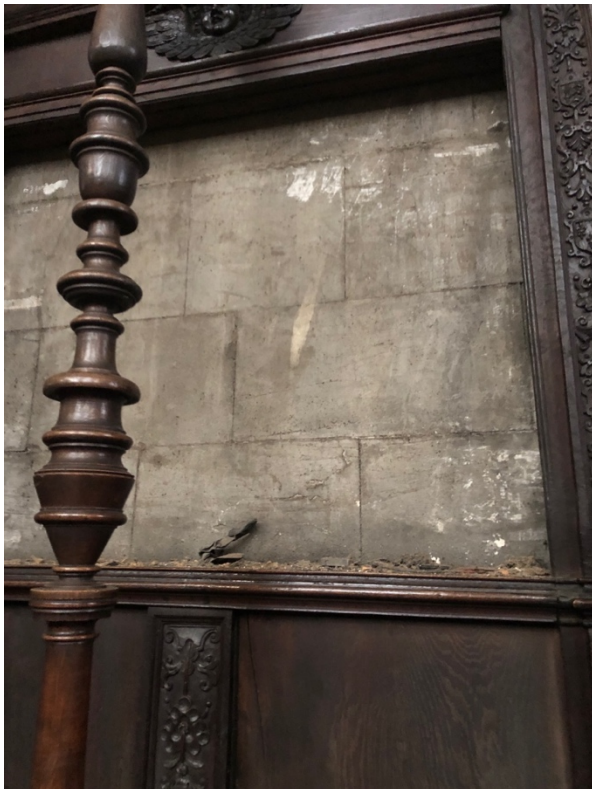
Area with the panel removed. A large quantity of dust was cleaned

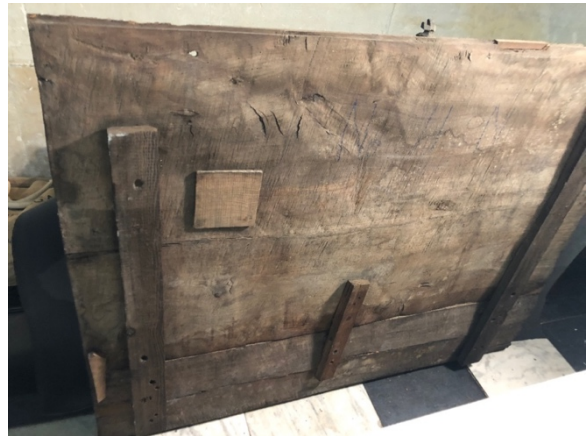
The armorial panels are of a typical frame and panel construction and would originally have been held within grooves in the rails at the top and bottom. Whilst they are still held within the grooves in the bottoms, shrinkage across the panel has caused them to come out of the top groove. All the panels have a shrinkage gap of around 10-30mm visible at the top and subsequently if they are touched they fall back against the chapel wall. As well as being unnerving and visually disruptive this movement has the potential to cause further damage. The panels are constructed from three boards glued together, and there are many splits and repairs (potentially from the 1950s campaign) which are fragile and deteriorating.

Back of the panel with various batten repairs

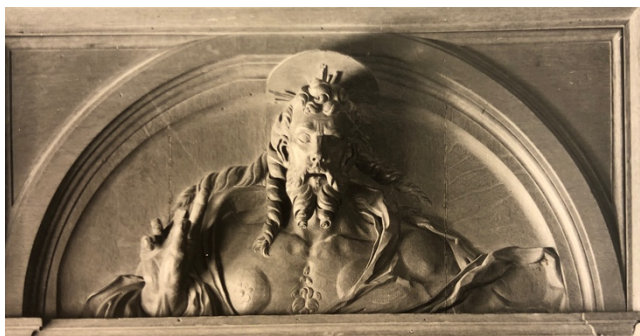
A photograph from 1985 shows the 4th finger intact and gives a good indication of the placement of this finger. The third finger placement can be deduced by the angle of the lost area. Arguably the blessing hand is one of the more important elements of the iconography of the carving. The recent nature of the loss of the 4th finger (some time post 1985, but no institutional memory of when), is another strong argument for this replacement.

1985 photograph Provost stall Christ carving (KCPH/5/7)

For the proposed loss replacements, all new carving can be first modelled in wax and the exact form agreed. They would then be carved separately in oak to fit the loss exactly. The process would be entirely reversible (so no damage or interference with the original material) and the new pieces would be identifiable on close examination, but be indistinguishable on general viewing. There are a number of methods of achieving this, from simply inscribing the date on a reverse side (as our 1950s carvers did for the replacement cartouche figure), to other indicators in the surface finishing. Clear photographic documentation would also accompany the work.

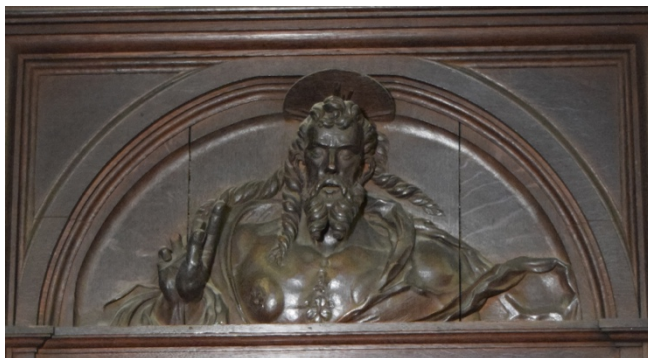
Current condition Provost stall

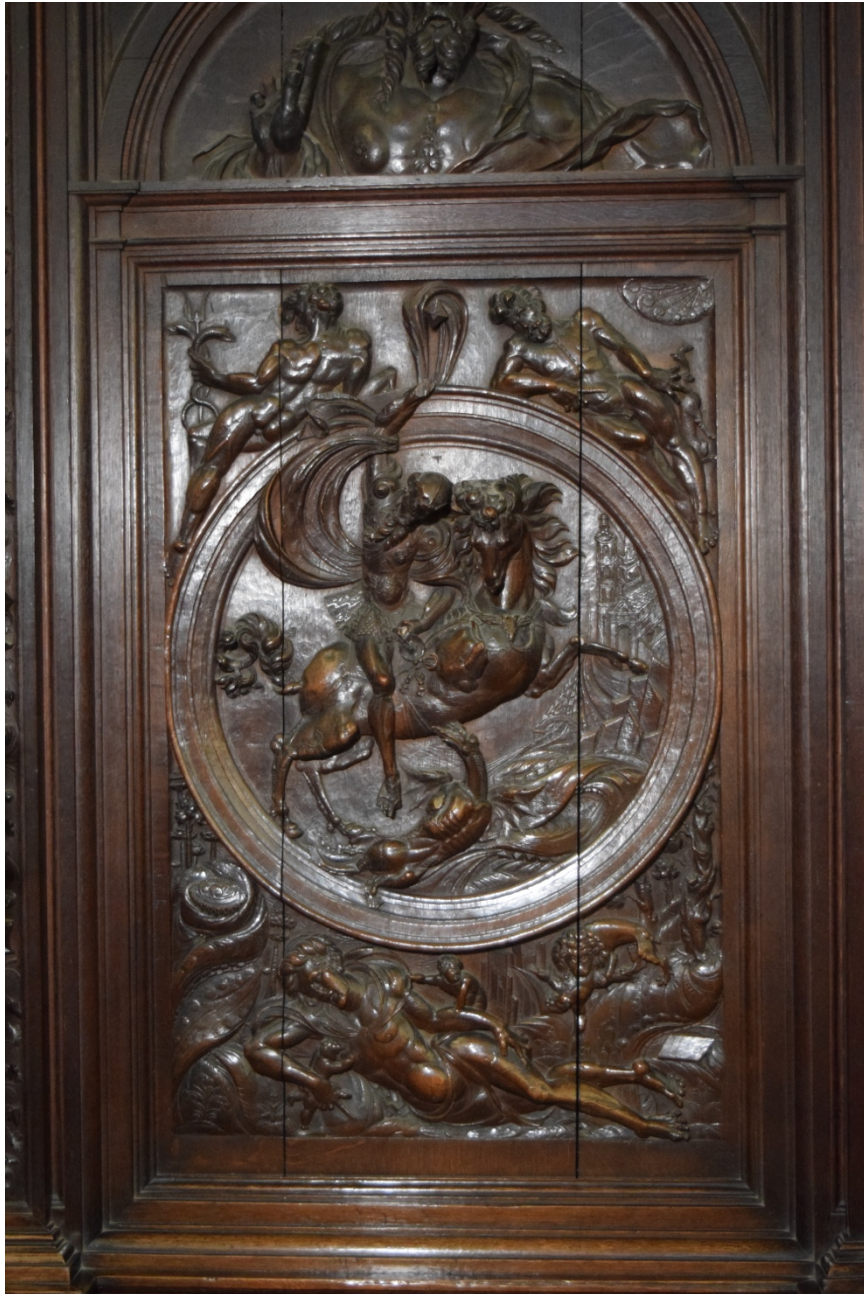
- B. Spear, arm of St George and leg of horse in Provost stall carving
Filling of shrinkage cracks in the boards

These are older losses and due to the inherent vulnerability of the limbs they may well have been lost for some centuries.

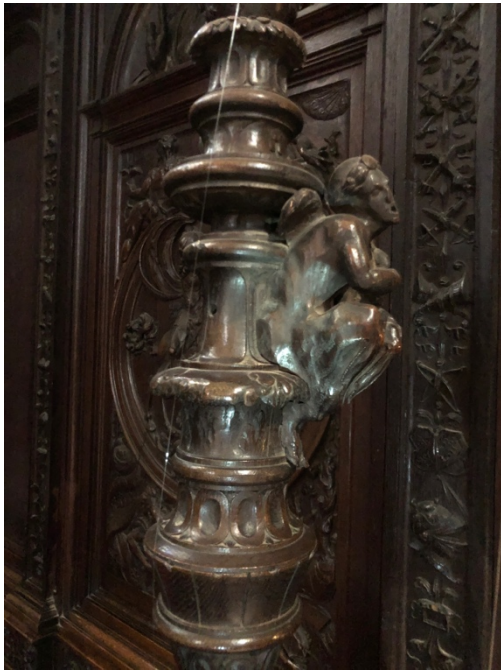
- C. Two missing angels from the Provost stall column.
Potential for replacing the heads on the angels in the corresponding north column – based on the Provost stall example.

Extant Provost stall angel (three per column)

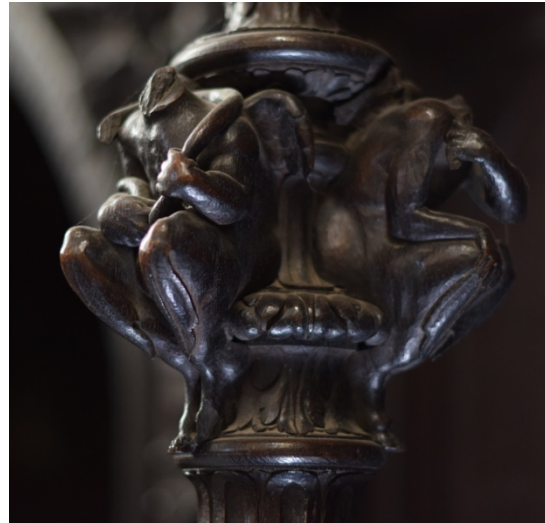
Heads missing from angels on the corresponding north column

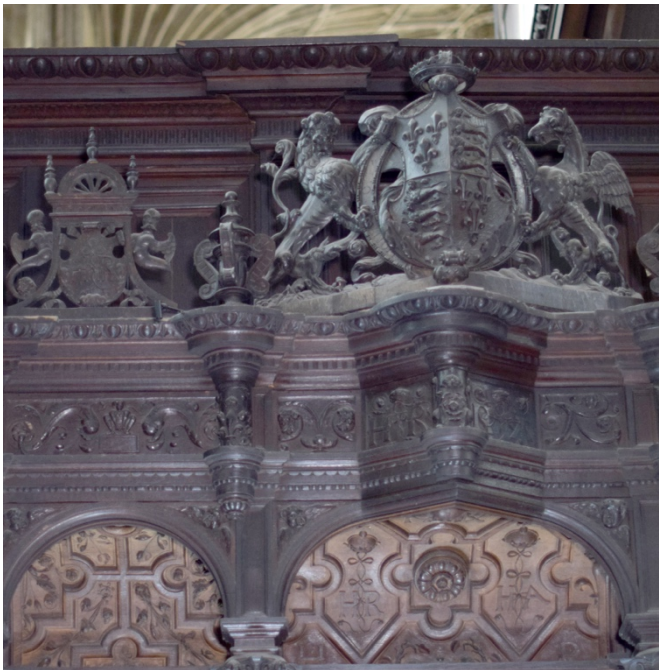
- D. Crown surmounting the coat of arms above the Provost stall

Current condition of the crown

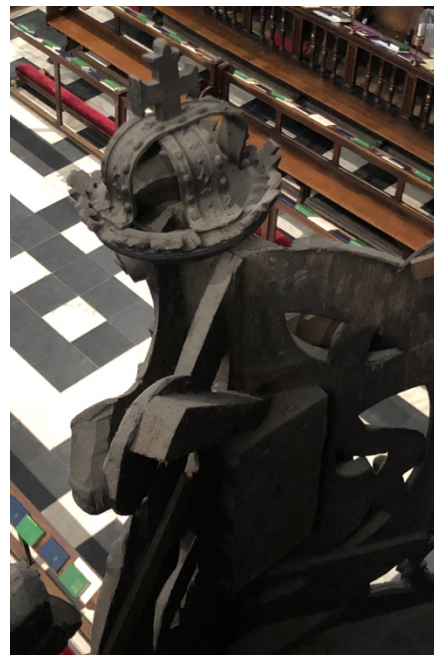
Extant detail of the North crown
