ASSESSMENT & REPORT ON THE LEAD ROOFING CONSTRUCTION

KINGS COLLEGE CHAPEL CAMBRIDGE

DATE: 19th May 2021

THE LEAD CONTRACTORS ASSOCIATION

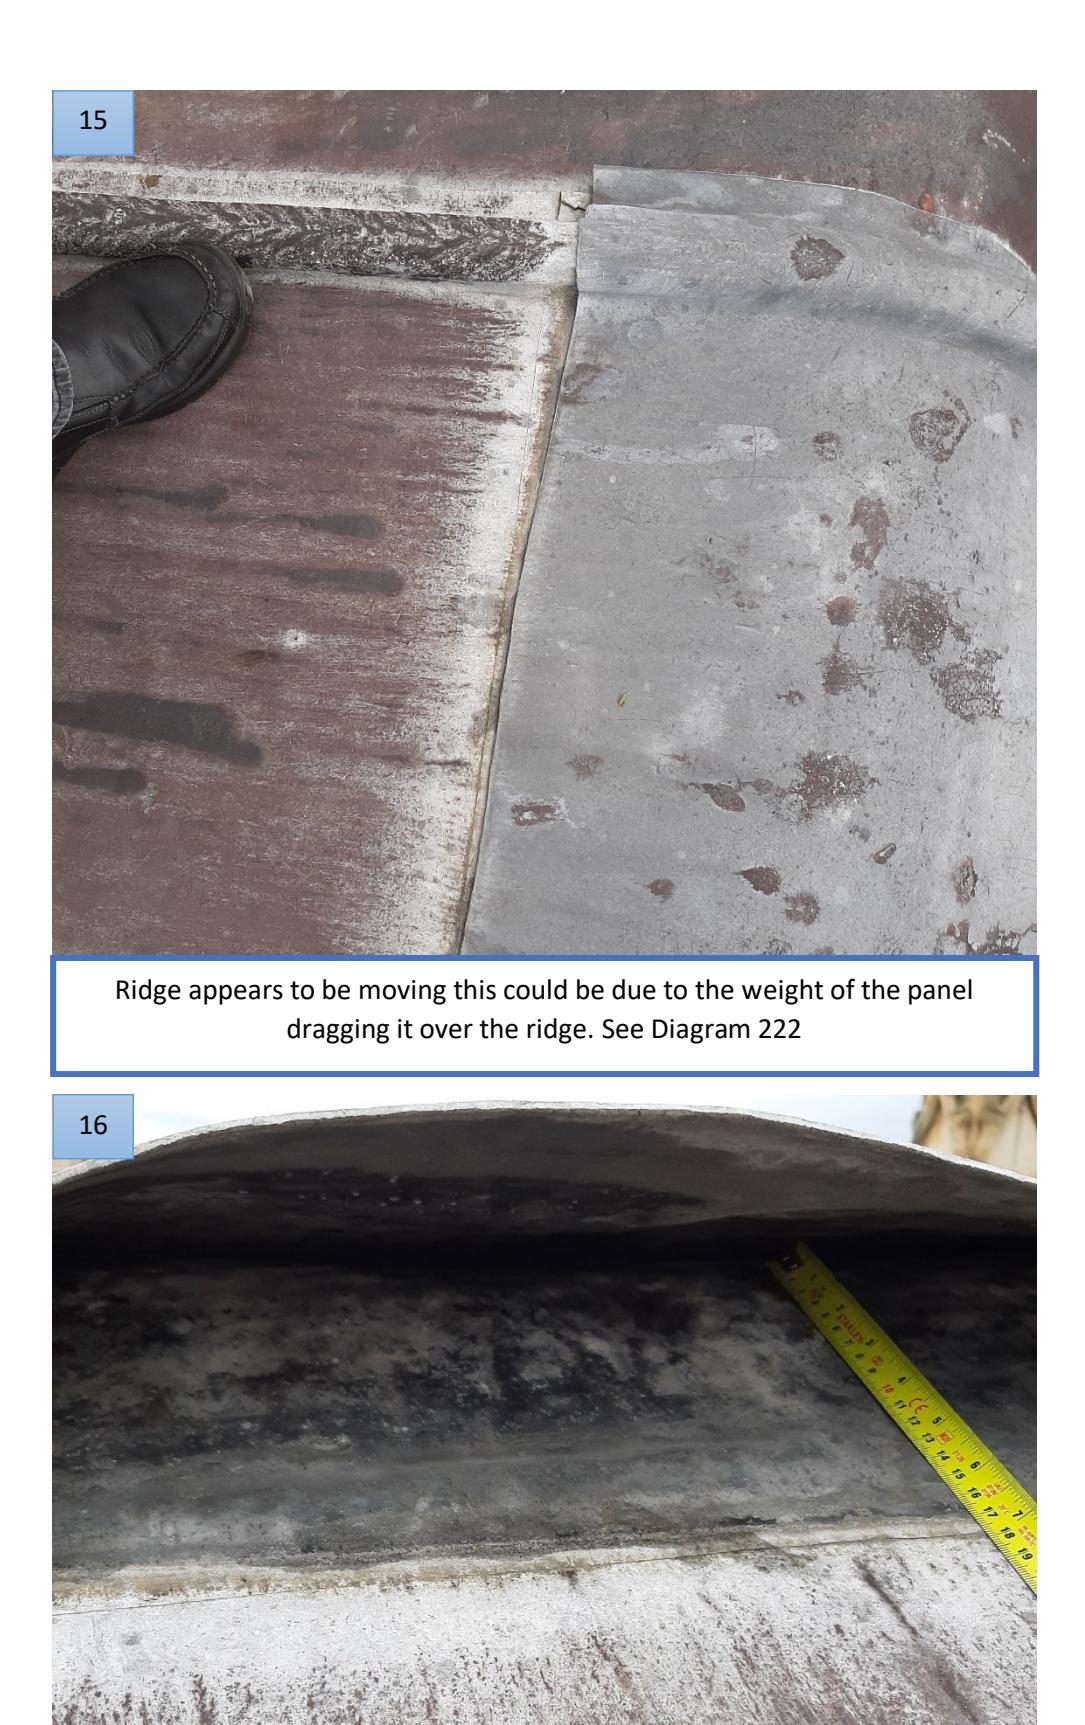
This is at the ridge and was very wet when lifted this could be condensation.

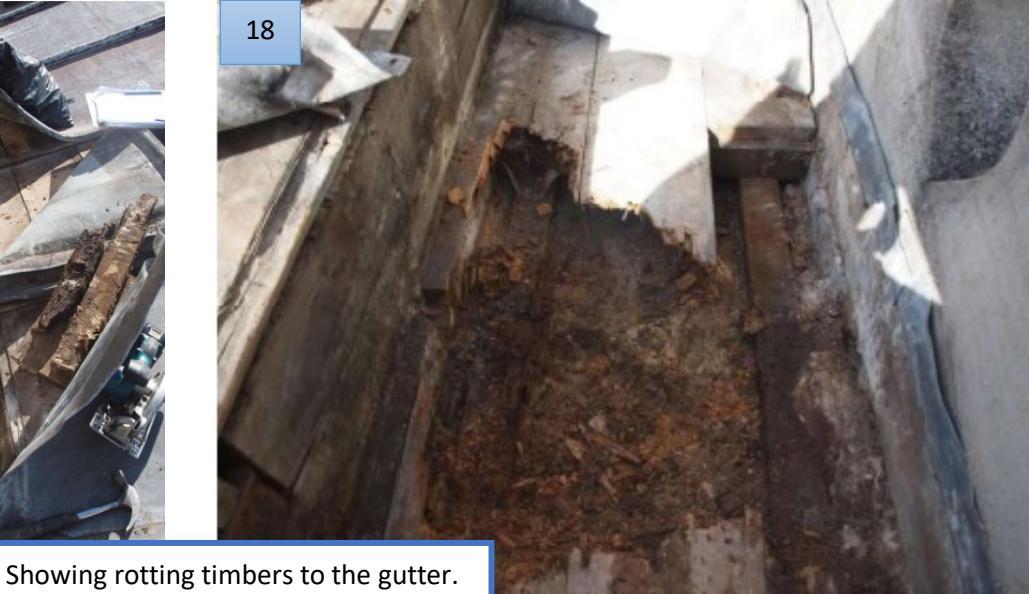
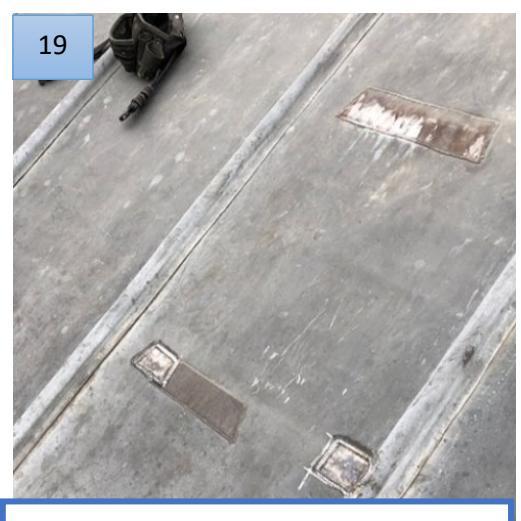
Lead welded patches.

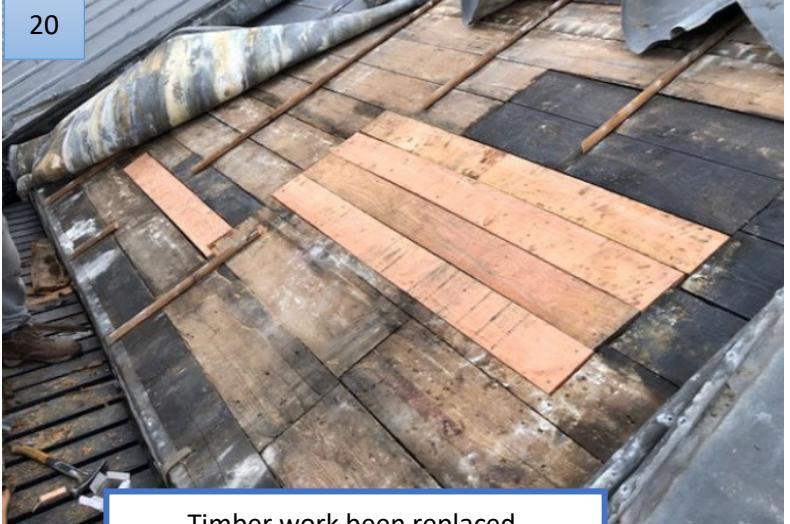
Timber work been replaced.
