King's College Chapel Roof Covering Renewal

Covering Paper to Faculty Application

MARCH 2022

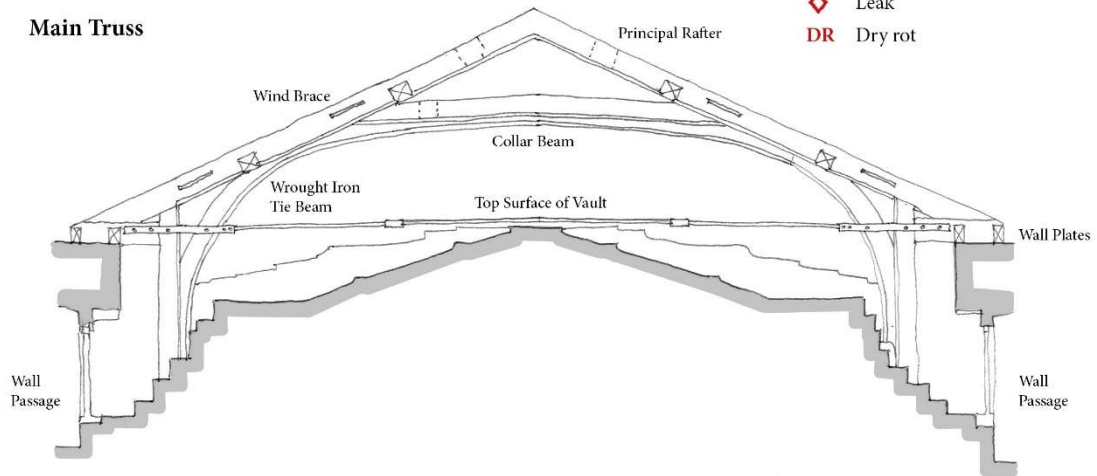
Main Truss

Plan of Main Chapel roof space with mark-up of internal defects identified during the 2018 Quinquennial Inspection
