ASSESSMENT & REPORT ON THE LEAD ROOFING CONSTRUCTION

KINGS COLLEGE CHAPEL CAMBRIDGE

DATE: 19th May 2021

THE LEAD CONTRACTORS ASSOCIATION

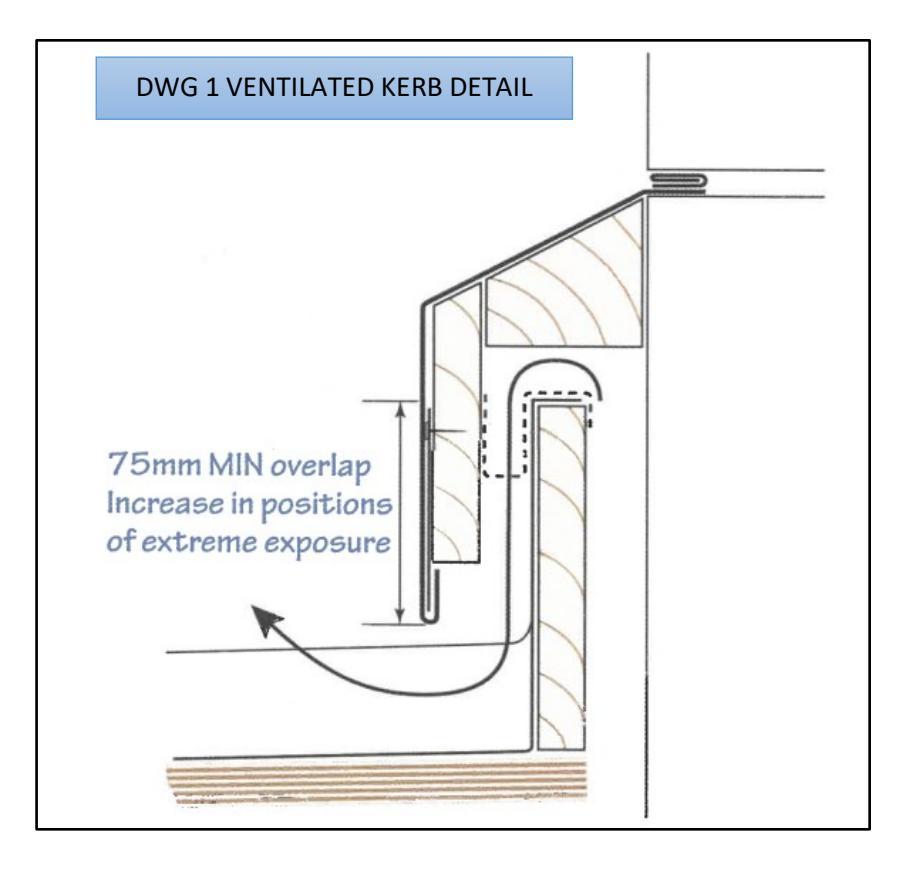
- 6. Another concern is there are no visible signs of ventilation to this area which may attribute to underside corrosion. Please see DWG 1, for standard venting detail from (LCA UGtBP).

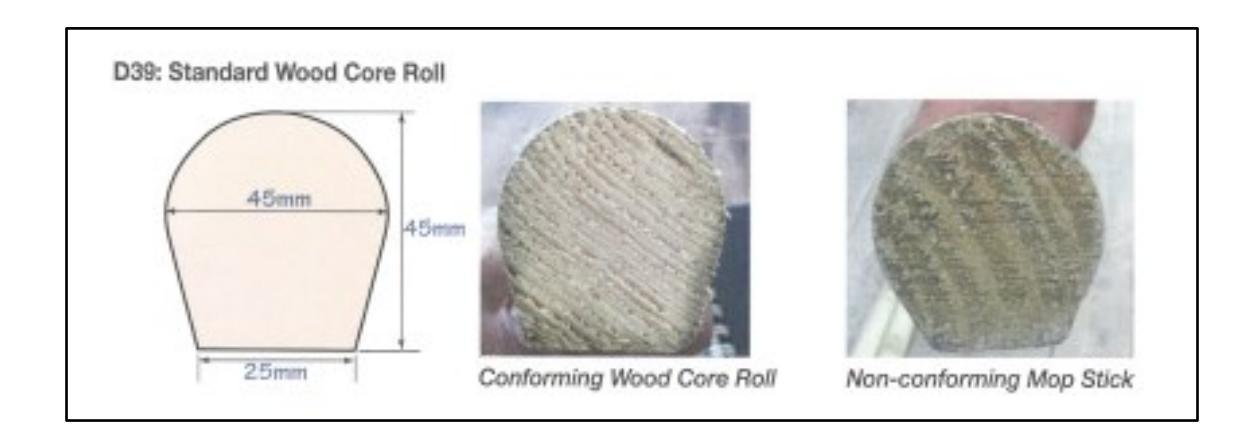
- 10. The head fixings are corroded and inadequate which is allowing the lead sheet to slip.
- 11. The bays are also fixed along the entire length of the under cloak which restricts thermal movement and is detrimental to the lead sheet. This is evidenced by the appearance of cracks and in some instances failures see Photograph 8. Bays should only be fixed for the first third.
- 12. The wood core rolls are small, approx. 30mm. Please see Photograph 9, and diagram D39 below from (LCA UGtBP).

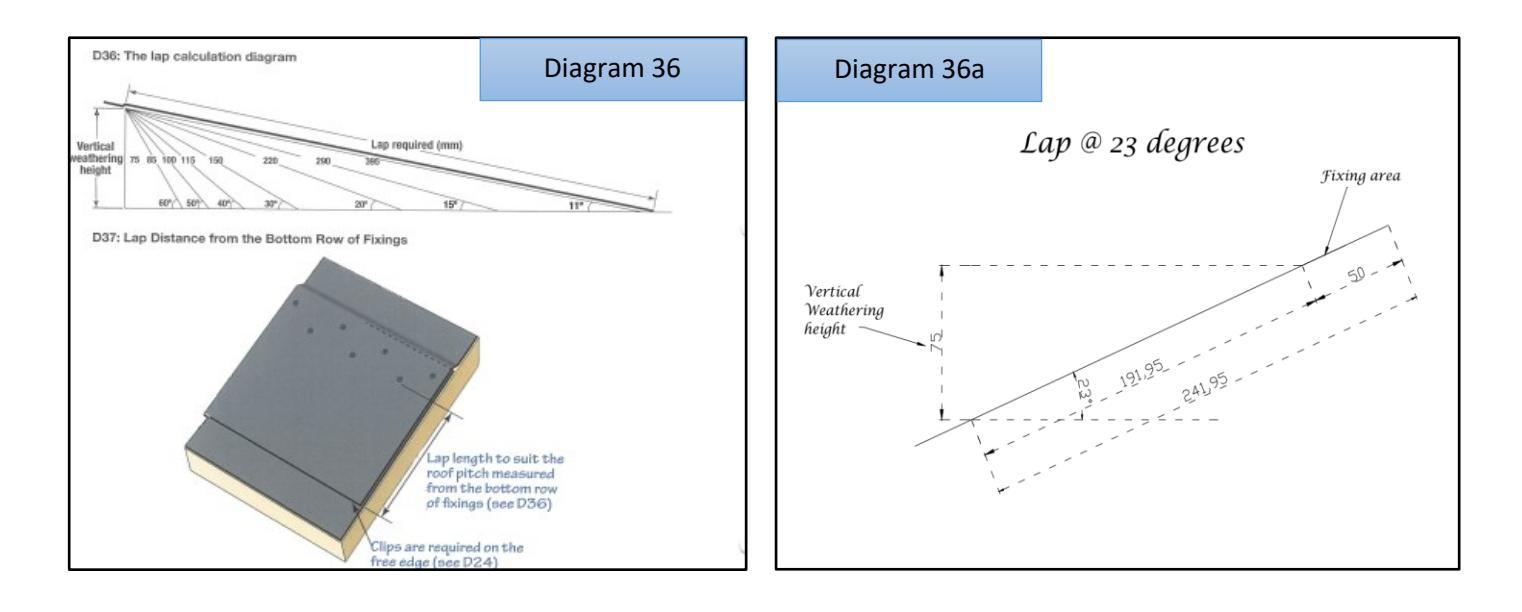
13. The laps are incorrect for the pitch of the roof - see Photograph 10, which we observed to be approximately 23 degrees. Please see Diagrams 36, 36a from the (LCA UGtBP). There would also be a benefit from the installation of clips to the free edge to avoid wind lift.

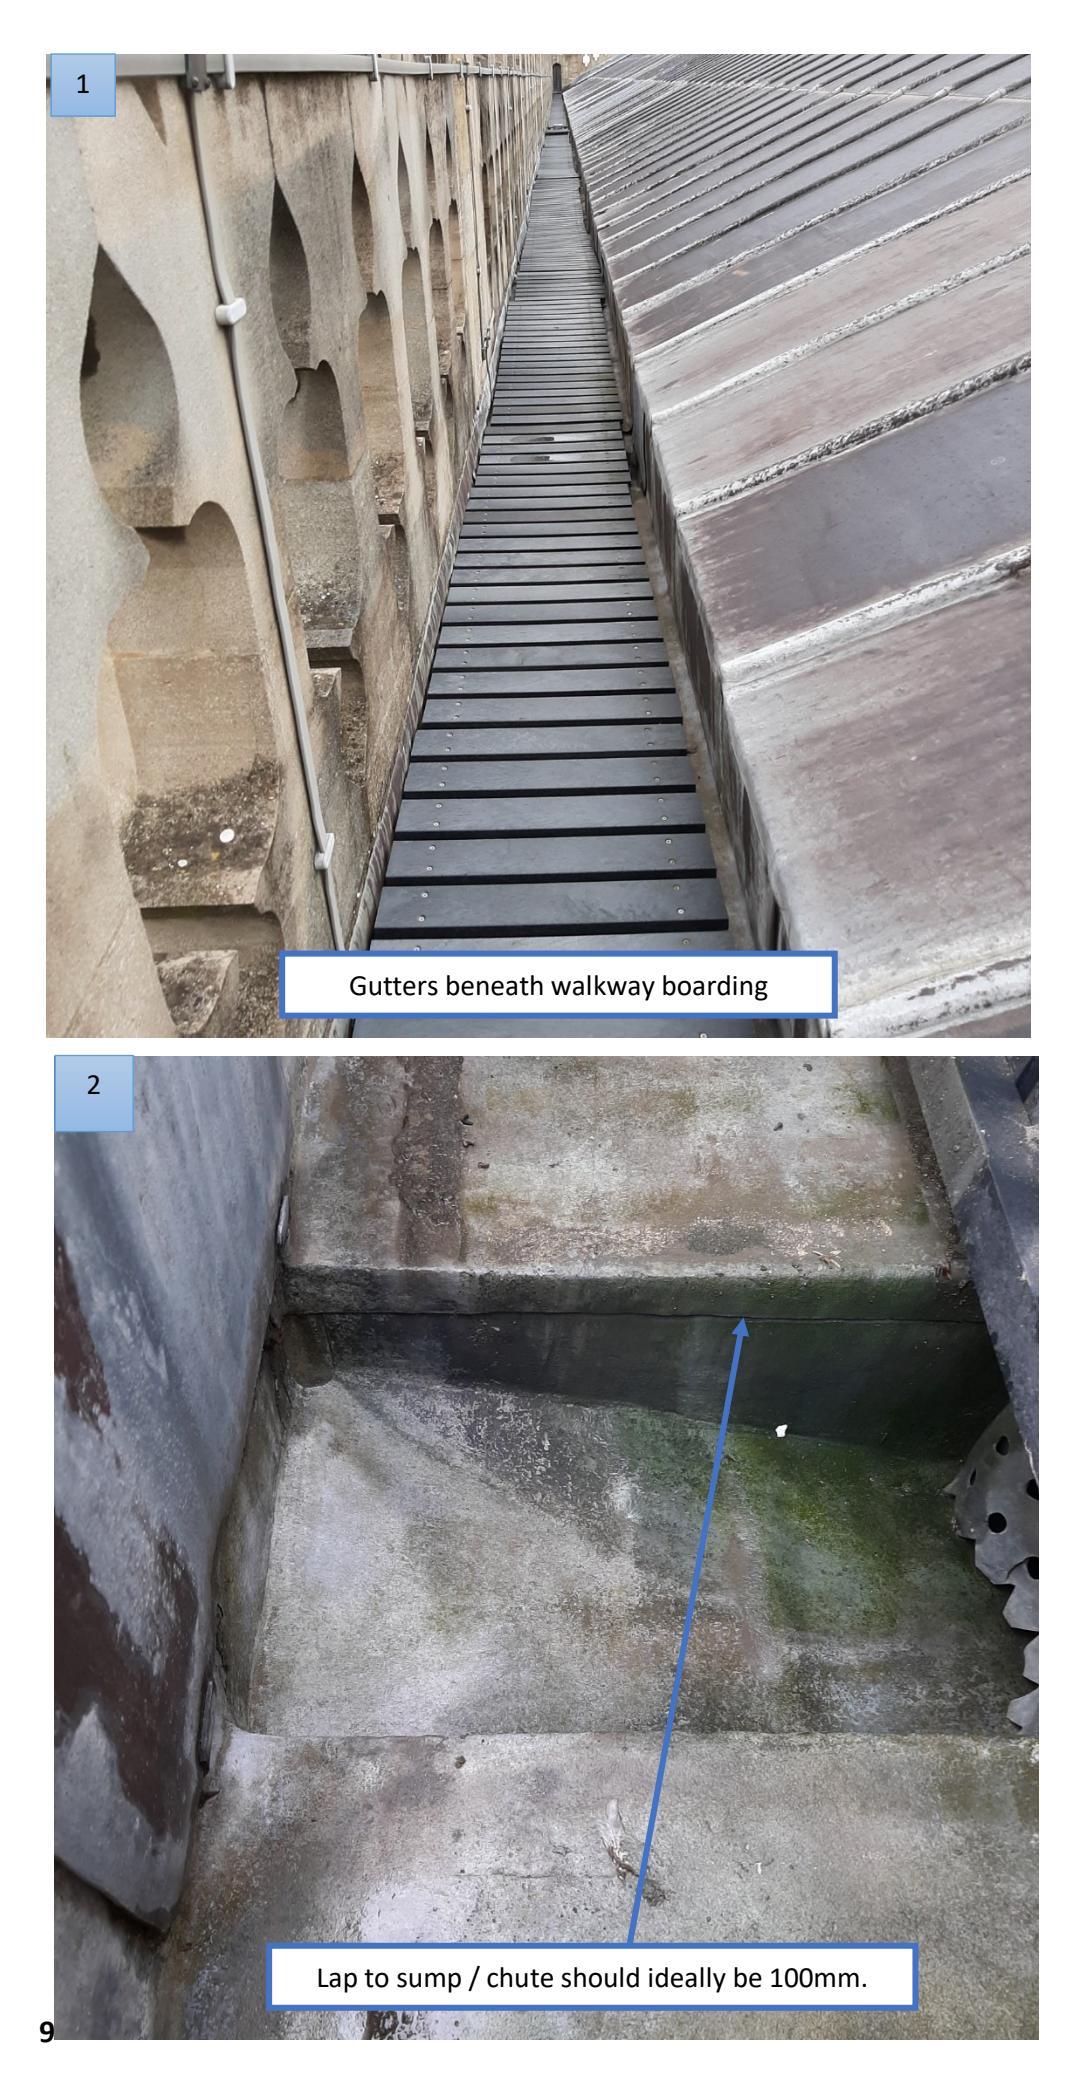
Gutters. see photos 1,2,3,4 for annotated details. Most of the lead bays to the gutters are oversized and are approximately 3.4m long and 850 – 900mm overall girth in sand cast lead. Bay sizes should be fixed with code 9 lead. The thickness appears to measure approximately code 6 lead. Please see Table 13 below taken from The Lead Contractors Association Ultimate Guide to Best Practice (LCA UGtBP) for recommended sizes to be used.

- 2. The falls appear to be good without signs of ponding and generally there are no signs of fatigue, possibly due to the boarding in Photograph 1 protecting them from the sun. Our thoughts are that these gutters have been replaced at some time but difficult to establish.

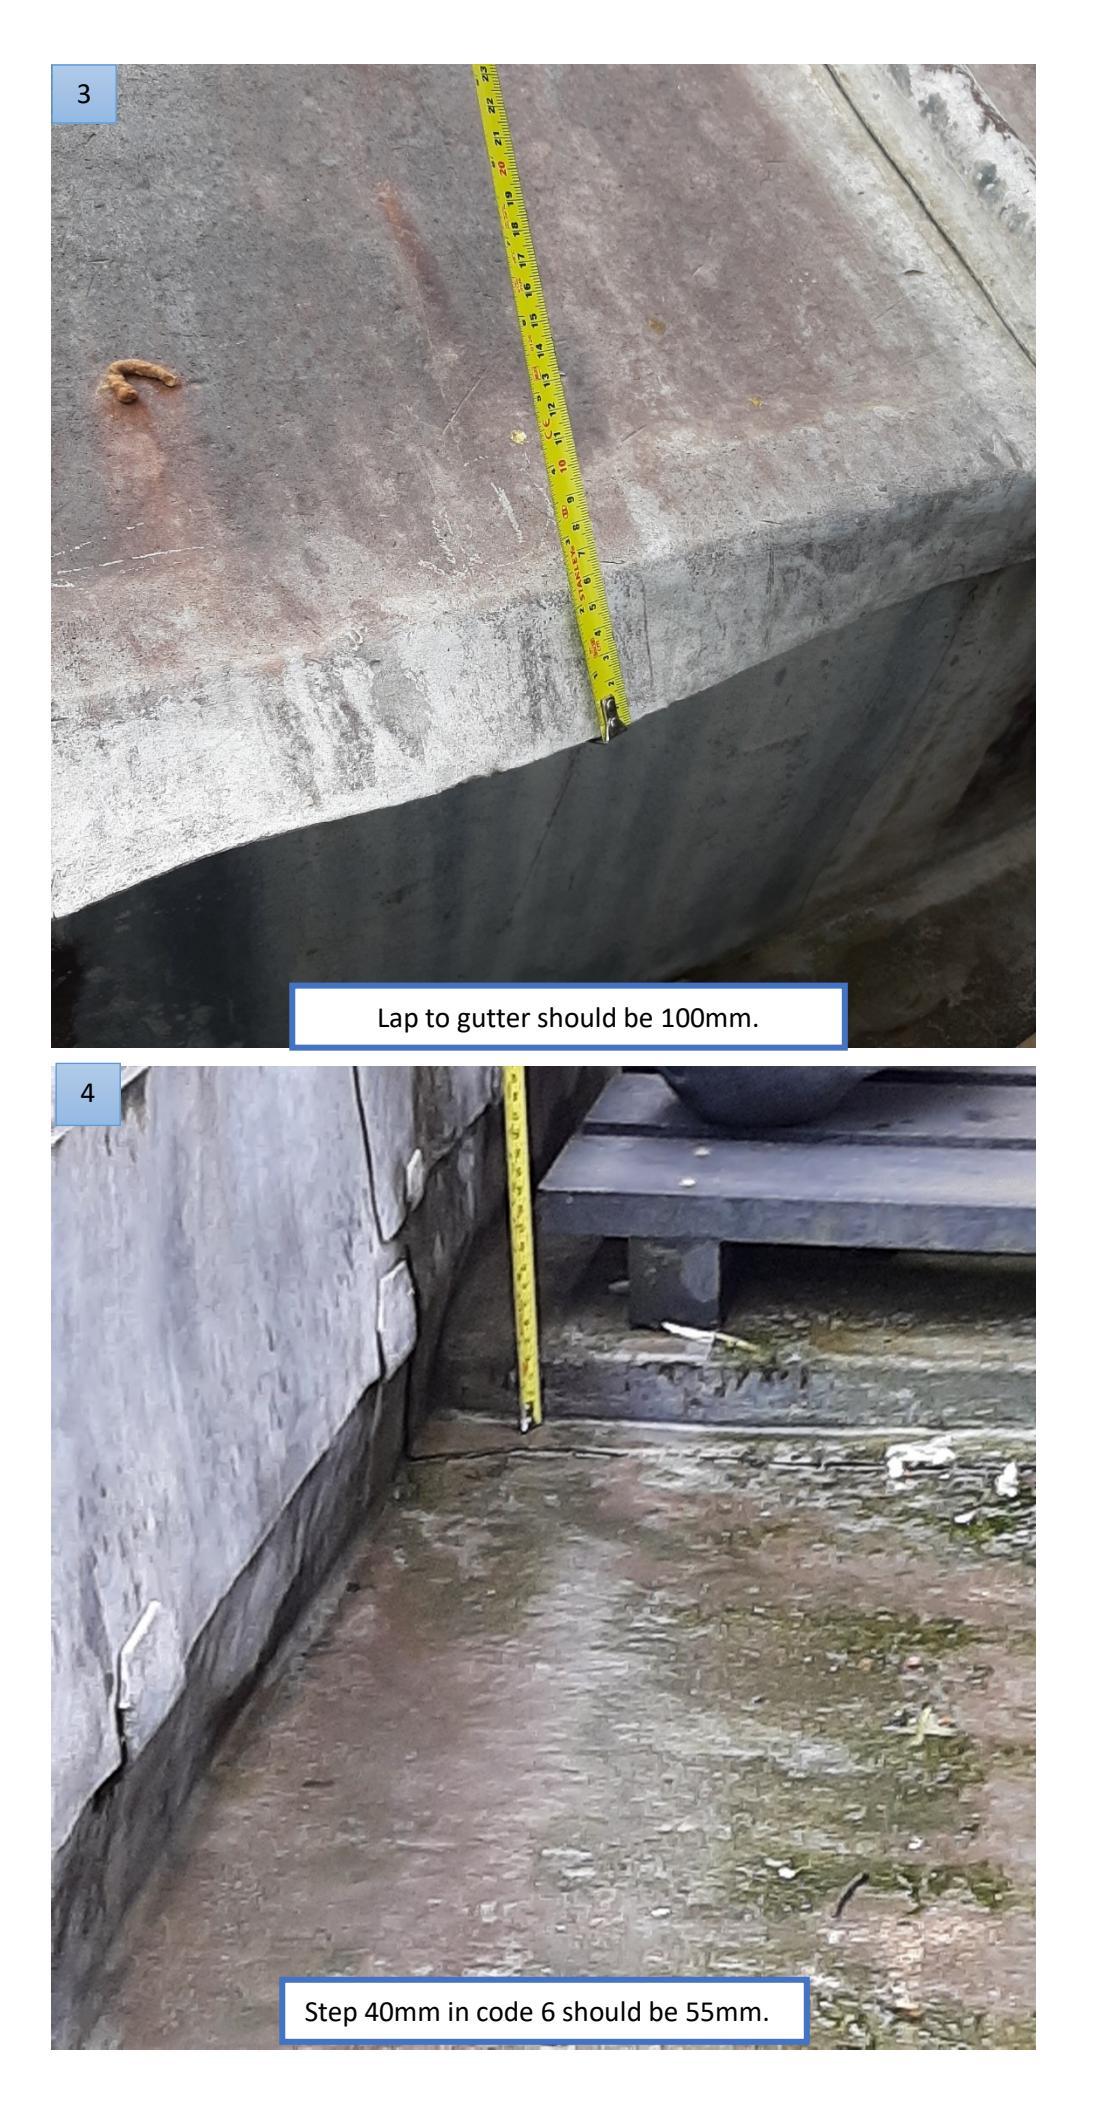
- The lap between the pitched roof and the gutter should be longer, currently 50-55mm see Photograph 3. This ideally should be 100mm.
- The sumps/catchpits/outlets, appear to be in good condition but without access to the outside it is not possible to comment further. The lap into these sumps should ideally be longer, circa 100mm see Photograph 2.

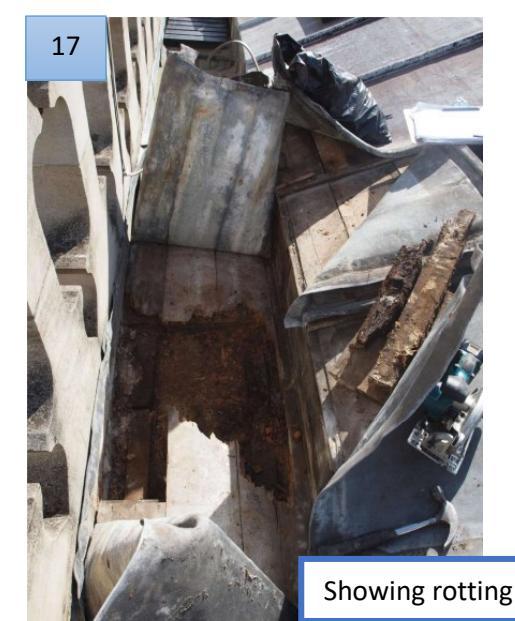
This is at the ridge and was very wet when lifted this could be condensation.
