Treatment Report King's College Chapel Joinery

Kings College Chapel
Kings Parade
Cambridge
CB2 1ST

1 June 2023

Conservator: Tristram Bainbridge ACR

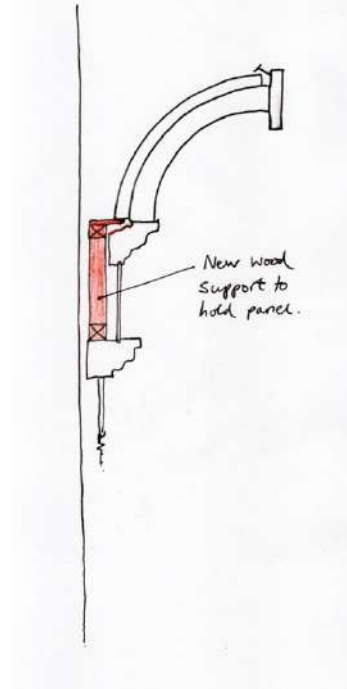
The carved canopy panels are supported on the bottom by the top frieze moulding, simply resting on that and the two arched sides and secured at the top by a nail. The panels had slipped as a large area of the top frieze moulding had been eaten away by furniture beetle. The treatment of these panels was possible as scaffold gave sufficient access to this area. A minimally interventive approach saw the construction of a simple wooden frame that sits on top of the top arms panel rail and provides the correct support along the width of the canopy panel. The top of the new wood was toned out using acrylics. Both panels were supported in this way.

Behind the panelling, with one panel removed.

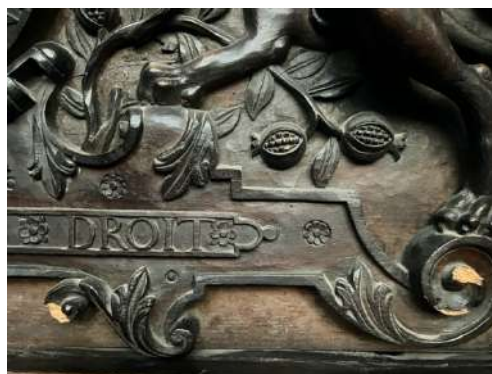
Example areas from E4

- 15 *The great armorial panels, north side: Panel D which has a crack about 300mm up, which runs through, just beneath the armorial surround. Around this, there is worm damage and there appear to be some crystals on the face which may be some past treatment method coming to the surface. Review and provide recommendations.*

It is likely that the crystals are a residue from previous woodworm treatments, but may also be related to historic applications of furniture cleaning wax, candle smoke and moisture. They are readily removable with aliphatic hydrocarbons. Further crystals are evident on the other panels. The worm damage was consolidated using a 5-10% w/v solution of polyvinyl butyral in denatured alcohol. Successively increasing concentrations were applied until the area was stabilised.

As part of this work all the armorial panels were inspected and there were 25 instances of crumbly carving, degraded by historic furniture beetle activity. These were not part of the initial schedule of work but were added as the areas were particularly vulnerable to damage in the near future (ie they were crumbling away if you touched them). These were consolidated using the same method as described above. The panels were: (Panels labelled 1-15 West to East on both sides, along with associated chapel number.)

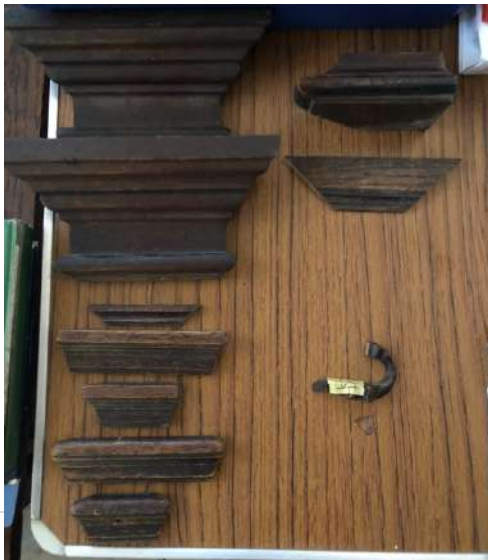
- 28 *Conduct careful review of the north side Quire Stalls to identify any further components which might be loose and need to be re-secured.*

Nine mouldings and one carved element were identified in the 'bits' box and re-adhered using warm hide glue. Various loose mouldings of the same type around the quire were identified and secured.

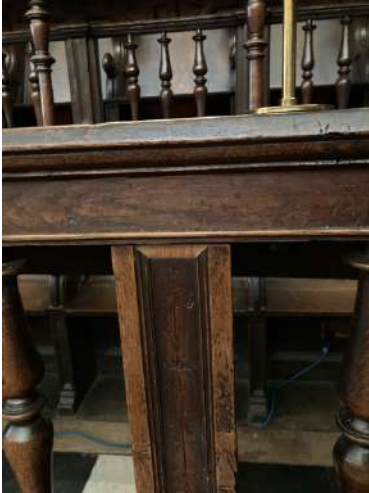
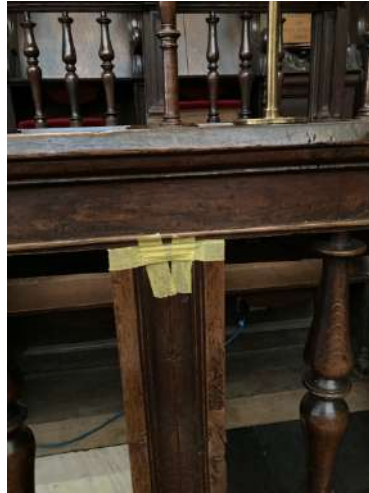
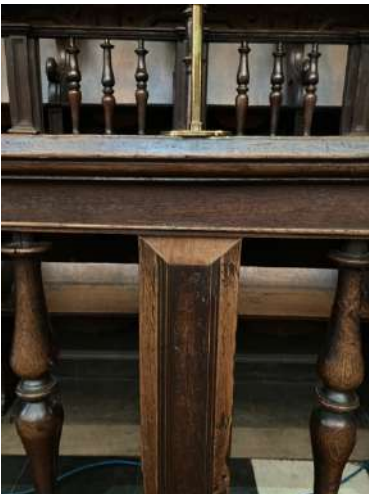
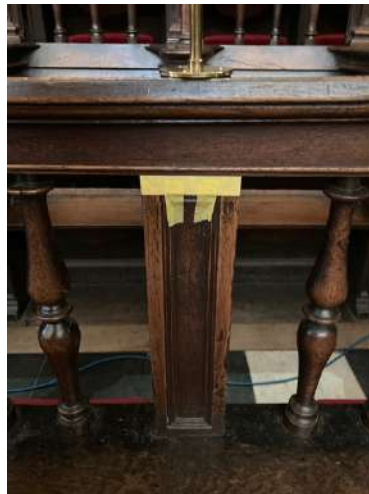
Including: S, Chapel N, choir 1 x 2 mouldings.

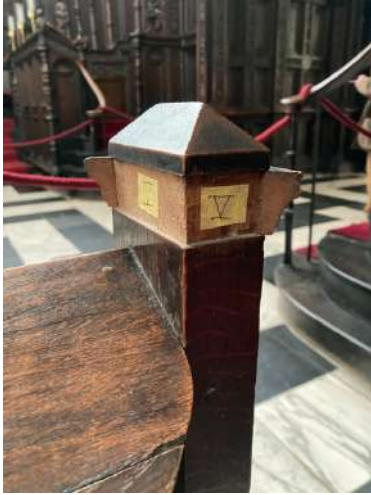
North Chapel E front stall (before)

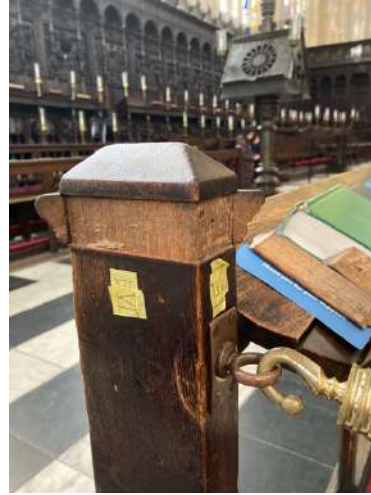
N chapel C front stall (before)

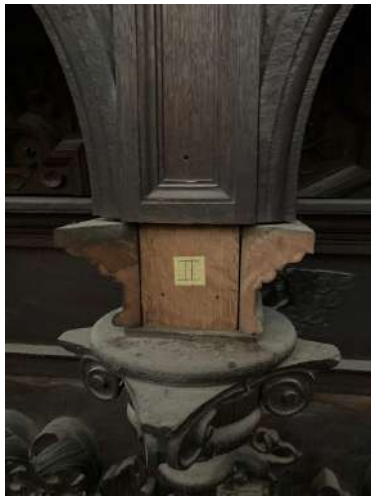
South, Chapel M, bay D middle column
(before)

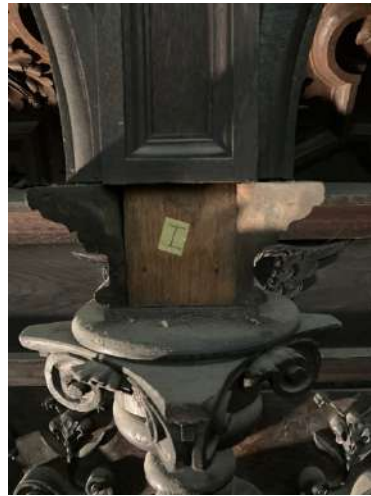
South, Chapel M, Bay B (before)

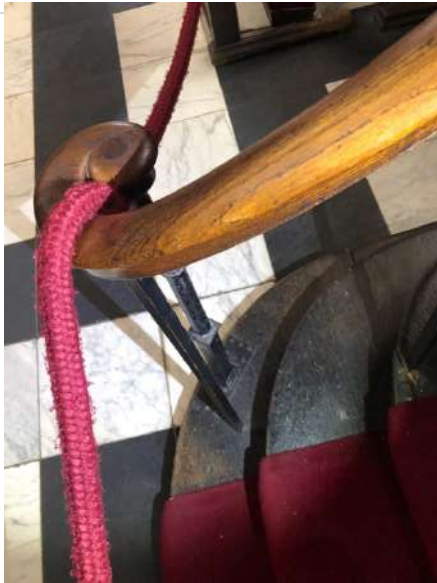
Before treatment

The handrail was wobbling at the newel and at the connection to the stalls (a threaded bolt). It was also missing two spindles. One spindle was found in the stalls and re-attached using bulked epoxy resin and steel pins. The missing spindle was made from new quarter sawn oak and re-attached in the same manner. It was toned to match using black light fast stain, shellac and black earth pigment. The metal newel was secured by inserting thin brass shims under the wobbling connection (due to the age and degradation of the screws, removing the plate would have been difficult and damaging). The shims were secured in place with epoxy resin after an isolation layer of Paraloid B-72 20% w/v had been applied to the areas. The nut holding the threaded bolt connecting the handrail to the stalls was tightened.

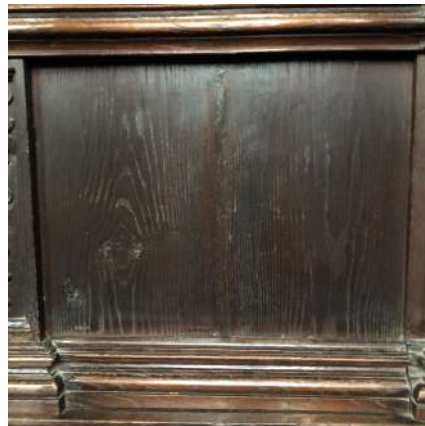
After treatment

- 39 *Bay SN: Repair large wide split in the plain panel beneath carved Panel E in stall 9.
See point 37*
