BAINBRIDGE CONSERVATION

Report and Proposal Kings College Chapel joinery

7 June 2023

Kings College Chapel
Kings Parade
Cambridge
CB2 1ST

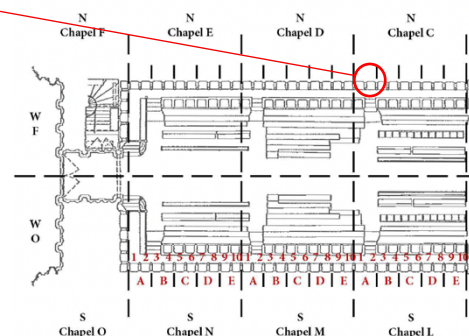
During the February 2023 conservation work a small scaffold was erected in over north, chapel C stalls 1-2, panel A

- A. Repairs to the damaged cartouches in this bay.
- B. Trial cleaning methods
- C. Repairs to the slipped canopies (treatment outlined in main treatment report)

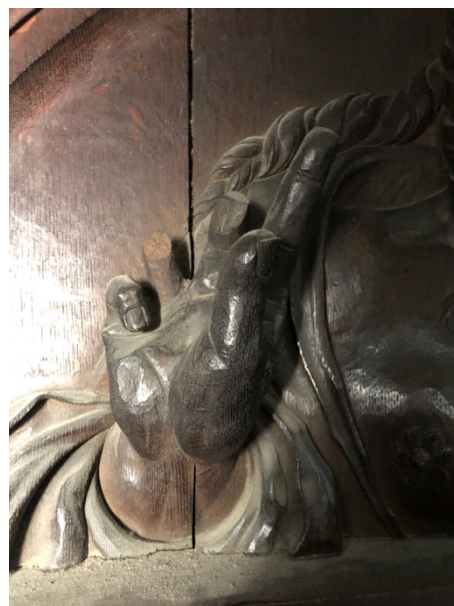
- B. Spear, arm of St George and leg of horse in Provost stall carving
Filling of shrinkage cracks in the boards
