- ### Repairs to Main Roof Parapets and Stair Turrets
1. Internally, review cracking to two quadrant landing stones. Access and inspect from above.
 2. Pin, grout and point to conserve scaling stonework and retain extant fragments of graffiti.
 3. St/sl pin to bond facing stone back to pinnacle.
 4. Allow for renewal here and in the base of the pinnacle where stones are spalling on the facet facing the roof. Additional access requirements for the upper sections.
 5. Consider replicating lead sill detail seen here on the other 3 doors at roof level.

Stage 4 - For Tender		Not for construction	
CLIENT	SCALE	DATE	
King's College, Cambridge	1:100@A1	04.02.22	
PROJECT	DRAWN	CHECKED	
Roof Covering Renewal Project	GH	CAL	
DRAWING TITLE	JOB NUMBER	DRAWING NO.	REVISION
Masonry Repairs - North and East Parapets	099.4.1	WL 400.1	4.00

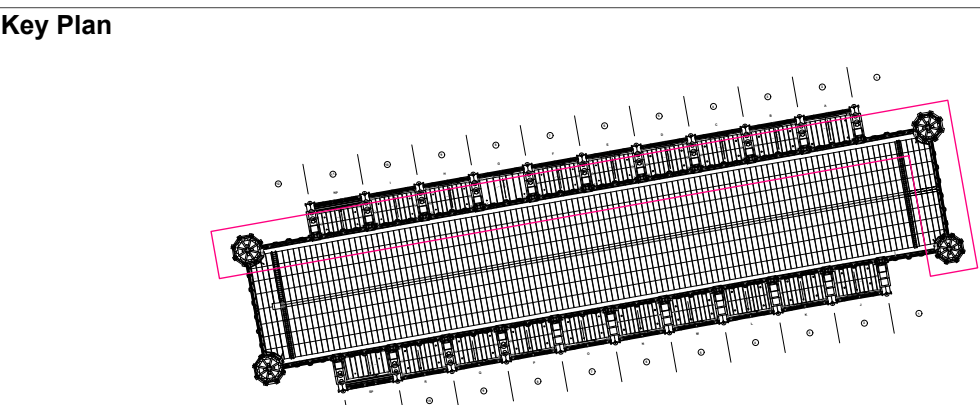
Zone of finial and turrets to be fully assessed at completion of scaffold access. Allow for:
